# **Dogger Bank South Offshore Wind Farms**

**Preliminary Environmental Information Report  
Chapter 20 – Appendix 20.1 Geomorphological  
Baseline Survey Technical Report**

**Document Reference: 004300128**

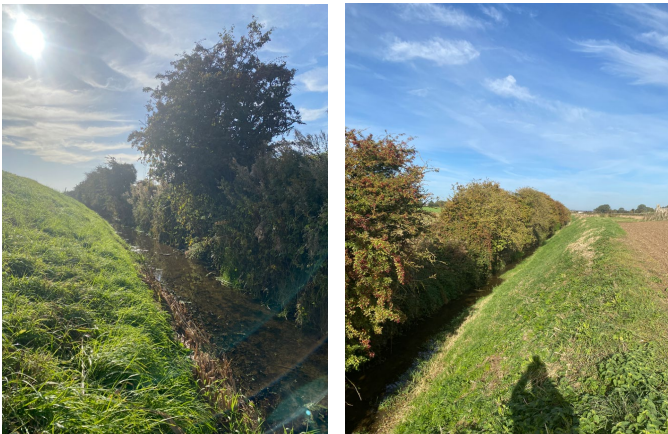
| Parameter | Description |
|---|---|
| Overview | <p>Barnston Sea Drain / Skipsea Drain to Confluence consists of a uniform deep channel that has been artificially straightened and incised adjacent to arable farmland (<b>Plate 1</b>).</p> <p><i>Plate 1 Barnston Sea Drain</i></p> |
| Flow Conditions | <p>Barnston Sea Drain is characterised by low energy glide flows, with some in-channel features potentially providing flow diversity at high flows (see below).</p> <p>The drain at the time of the survey, was characterised by low flows which were relatively clear.</p> |

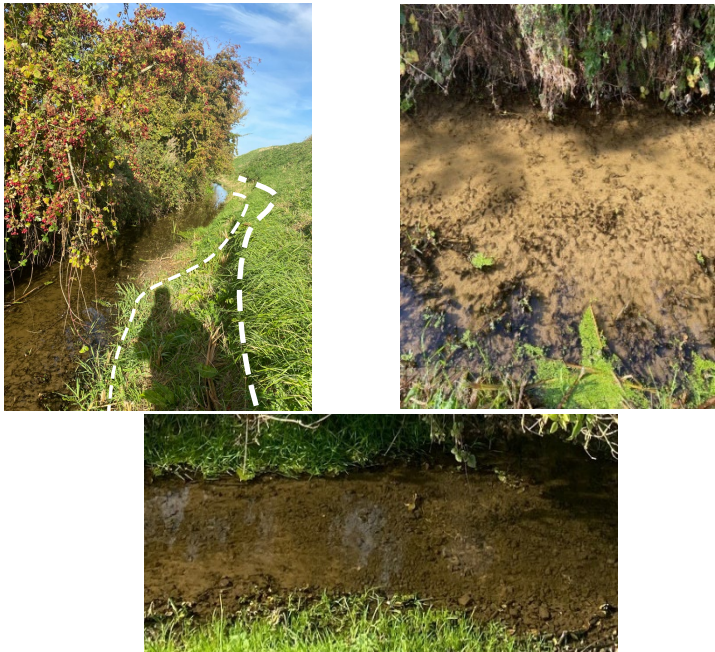
| Parameter | Description |
|---|---|
| Channel Form, Soils and Substrates | <p>The channel has a straight planform. The banks are relatively steep, approximately 8 m – 10 m high, stable (with no signs of erosion) and well vegetated. The channel is approximately 6 m – 8 m wide at the bank top, and 4 m wide at the bank base, displaying a U shape or trapezoidal uniform channel (typical of land drainage channels) (<b>Plate 1</b>). An inset bench was present creating a two-stage channel with local geomorphological complexity (<b>Plate 2</b>). This is likely to be indicative of natural channel narrowing in response to historical channel enlargement and resectioning. The substrate is dominated by sands and silts, although in places these overlaid pebbles and cobbles (<b>Plate 2</b>). Although the proportion of silts are likely to be derived from exposed banks during higher-energy flows, the majority of the fine sediment load is likely to be sourced from the adjacent agricultural field and upstream in the catchment.</p> <p>Overall, the channel appears to be within a typical sediment deposition zone, with slow flows, low gradients and low velocities contributing to the settling out of fine sediments/silts.</p> <div data-bbox="692 1223 1410 1872"> </div> <p><i>Plate 2 Barnston Sea Drain Channel Form Complexity and Substrate</i></p> |

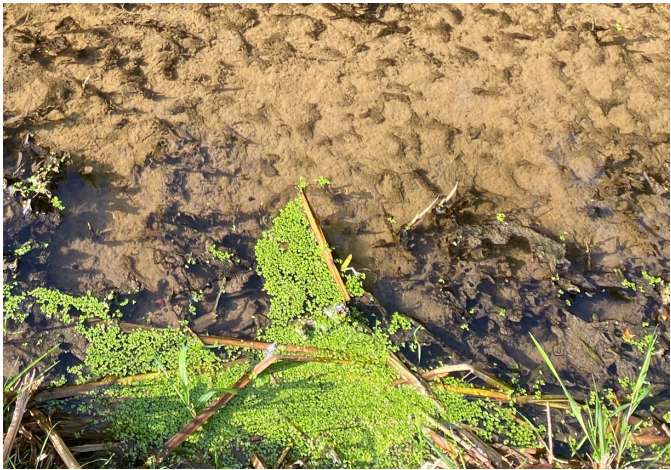
| Parameter | Description |
|---|---|
| In-channel / riparian vegetation | <p>Good riparian vegetation is present, with the banks and margins well vegetated in places with rushes, sedges and reeds. Some in-channel aquatic vegetation growth was also recorded, although this was predominantly duck weed (<i>Lemna minor</i>) and organic leaf material (<b>Plate 3</b>).</p> <p><i>Plate 3 Barnston Sea Drain In-Channel Habitat</i></p> |

| Parameter | Description |
|---|---|
| Modifications/Structures/Pollution | <p>The channel is deeply incised and is likely to have been historically resectioned and enlarged for land drainage purposes.</p> <p>No bank protection works were noted or signs of diffuse or point source pollution, with water quality clear and evidence of small fish.</p> |

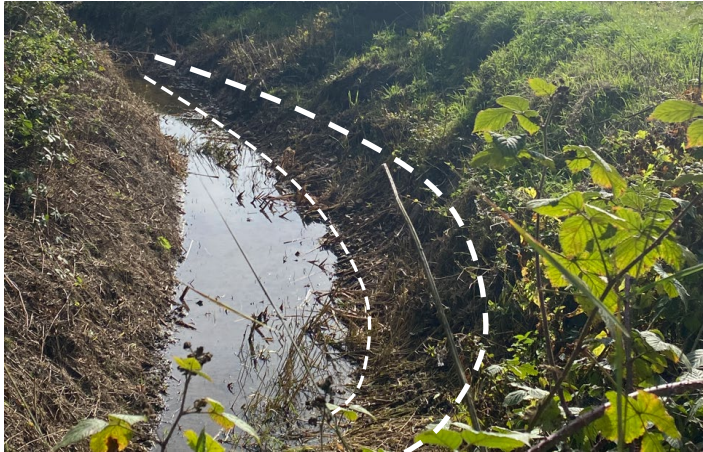
| Parameter | Description |
|---|---|
| Channel Form, Soils and Substrates | <p>The channel has a straight planform. The banks are relatively steep, approximately 5 m – 6 m high, stable (with no signs of erosion) and well vegetated. The channel is approximately 6 m – 8 m wide at the bank top and 4 m wide at the bank base, displaying a U shape or trapezoidal uniform channel cross section (typical of land drainage channels) (<b>Plate 4</b>). An inset bench was present in places, creating a two-stage channel and local geomorphological complexity (<b>Plate 5</b>). This is likely to be indicative of natural channel narrowing in response to historical channel enlargement and resectioning. The substrate is dominated by sands and silts, although in places these overlaid pebbles and cobbles. Although the proportion of silts are likely to be derived from exposed banks during higher-energy flows, the majority of the fine sediment load is likely to be sourced from the adjacent agricultural fields and upstream in the catchment.</p> <p>Overall, the channel appears to be within a typical sediment deposition zone, with slow flows, low gradients and low velocities contributing to the settling out of fine sediments/silts.</p> <p><i>Plate 5 Foredyke Stream Upper Channel Form Complexity</i></p> |

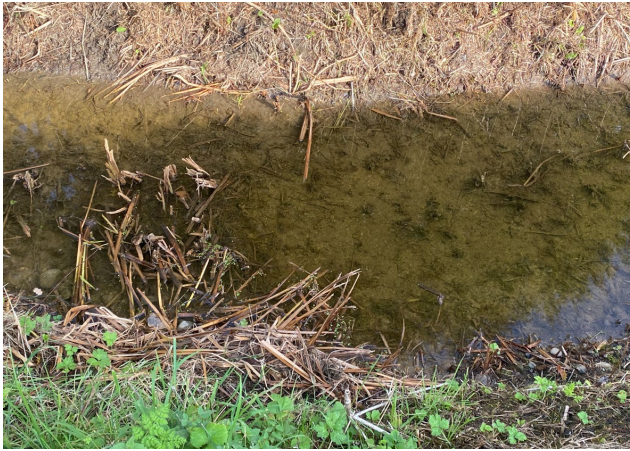
| Parameter | Description |
|---|---|
| In-channel / riparian vegetation | <p>Good riparian vegetation growth was present, with the banks and margins well vegetated in places with rushes, sedges and reeds. Some in-channel aquatic vegetation growth was also recorded, although this was predominantly duck weed (<i>Lemna minor</i>) and organic leaf material (<b>Plate 6</b>), although overall limited in aquatic macrophytes.</p> <p><i>Plate 6 Foredyke Stream Upper In-Channel Habitat</i></p> |

| Parameter | Description |
|---|---|
| Modifications/Structures/Pollution | <p>The channel is deeply incised and is likely to have been historically resectioned and enlarged for land drainage purposes.</p> <p>No bank protection works were noted or signs of diffuse or point source pollution, with water quality clear.</p> |

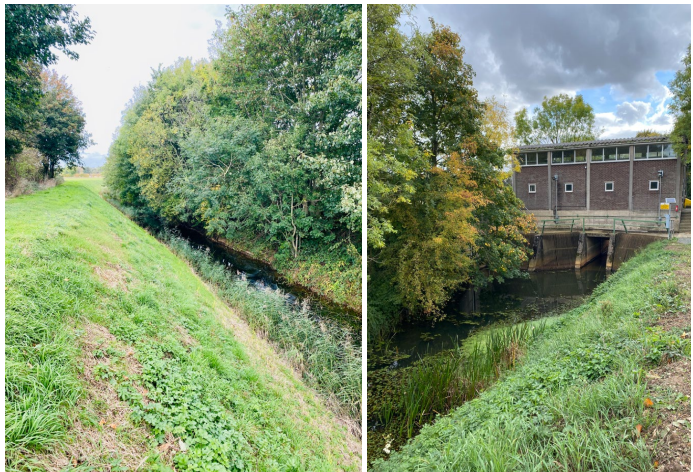
| Parameter | Description |
|---|---|
| Overview | <p>Holderness Drain (North Option) consists of a uniform deep channel that has been artificially straightened and incised adjacent to arable farmland and downstream of Ticton Pumping Station (<b>Plate 7</b>).</p> <div data-bbox="727 1270 1423 1740"> </div> <p>Plate 7 Holderness Drain Source to Foredyke Stream (North Option)</p> |

| Parameter | Description |
|---|---|
| Flow Conditions | <p>Holderness Drain (North Option) is characterised by low energy glide flows, although some flow diversity and in-channel features were observed (see below).</p> <p>The drain at the time of the survey, was characterised by low flows which were relatively clear.</p> |

| Parameter | Description |
|---|---|
| Modifications/Structures/Pollution | <p>The channel is deeply incised and is likely to have been historically resectioned and enlarged for land drainage purposes.</p> <p>No bank protection works were noted or signs of diffuse or point source pollution, with water quality clear.</p> <p>The site is downstream of Ticton Pumping Station (see <b>Plate 7</b>).</p> |

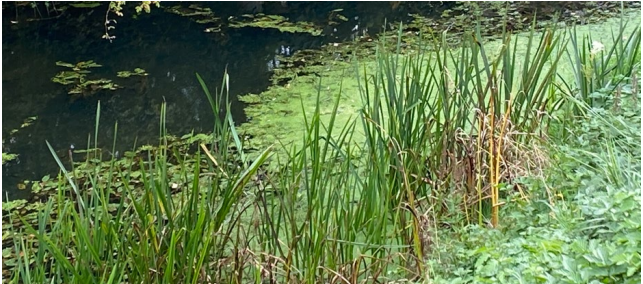
| Parameter | Description |
|---|---|
| In-channel / riparian vegetation | <p>Good riparian vegetation growth was present, with the banks and margins well vegetated in places with rushes, sedges and reeds. Some in-channel aquatic vegetation growth was also recorded, such as duck weed (<i>Lemna mino</i>), Frogbit (<i>Hydrocharis morsus-ranae</i>) and organic leaf material (<b>Plate 9</b>).</p> <p><i>Plate 9 Holderness Drain Source to Foredyke Stream (North Option) In-Channel Habitat</i></p> |

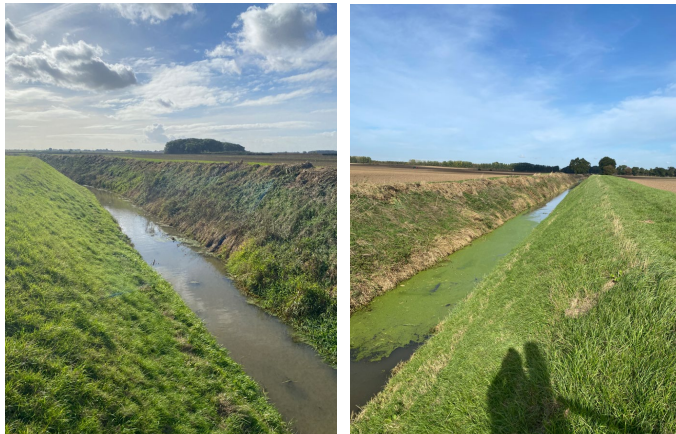
| Parameter | Description |
|---|---|
| Overview | <p>Foredyke Stream Lower to Holderness Drain (Monk Dike) consists of a uniform deep channel that has been artificially straightened and incised adjacent to arable farmland (<b>Plate 10</b>).</p> <div data-bbox="691 1236 1369 1668"> </div> <p><i>Plate 10 Foredyke Stream Lower to Holderness Drain</i></p> |
| Flow Conditions | <p>Foredyke Stream Lower to Holderness Drain is characterised by low energy glide flows, with limited flow diversity or in-channel features observed.</p> <p>The drain at the time of the survey, was characterised by low flows which were turbid.</p> |

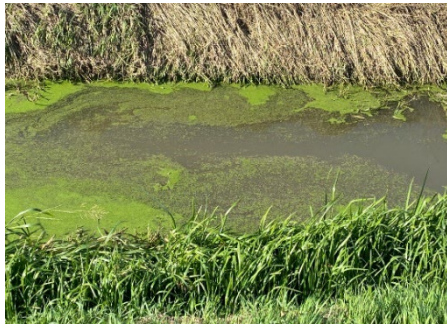
| Parameter | Description |
|---|---|
| In-channel / riparian vegetation | <p>No riparian mature trees were present, although the banks and margins were well vegetated in places with rushes, sedges and reeds. Some in-channel aquatic vegetation growth was also recorded, although this was predominantly duck weed (<i>Lemna minor</i>) and organic leaf material (<b>Plate 11</b>), although overall limited in aquatic macrophytes.</p> <p><i>Plate 11 Foredyke Stream Lower to Holderness Drain<br/>In-Channel Habitat</i></p> |

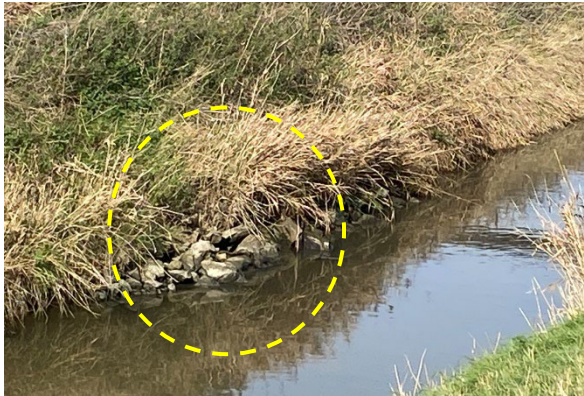
| Parameter | Description |
|---|---|
| Modifications/Structures/Pollution | <p>The channel is deeply incised and is likely to have been historically resectioned and enlarged for land drainage purposes.</p> <p>Minor rock bank protection works were noted along the drain (<b>Plate 12</b>). No signs of diffuse or point source pollution were observed, although the water column was turbid.</p> <p><i>Plate 12 Foredyke Stream Lower to Holderness Drain<br/>Minor Rock Bank Protection</i></p> |

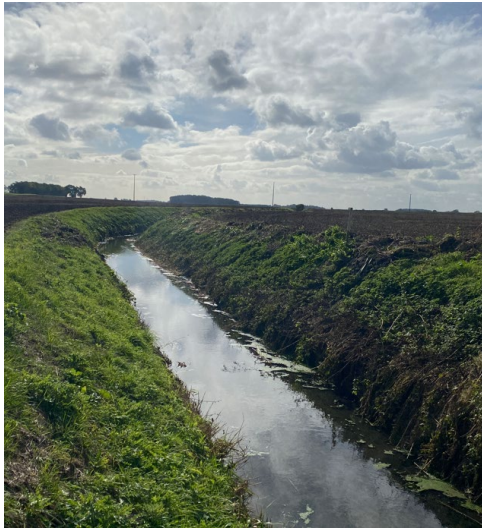
| Parameter | Description |
|---|---|
| Overview | <p>Meaux and Routh East Drain consists of a uniform deep channel that has been artificially straightened and incised adjacent to arable farmland (<b>Plate 13</b>).</p> <p><i>Plate 13 Meaux and Routh East Drain</i></p> |

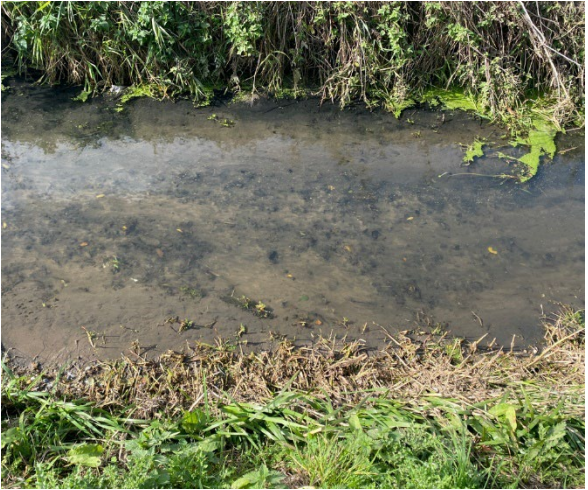
Plate 14 Meaux and Routh East Drain Channel Substrate

| Parameter | Description |
|---|---|
| Channel Form, Soils and Substrates | <p>The channel has a straight planform. The banks are relatively steep, approximately 5 m –6 m high, relatively stable (with some signs of erosion noted) and well vegetated. The channel is approximately 6 m – 8 m wide at the bank top and 2 m wide at the bank base, displaying a U shape or trapezoidal uniform channel (typical of land drainage channels) (<b>Plate 13</b>). The substrate is dominated by sands and silts, although in places these overlaid pebbles and cobbles (<b>Plate 14</b>). Although the proportion of silts are likely to be derived from exposed banks during higher-energy flows, the majority of the fine sediment load is likely to be sourced from the adjacent agricultural field and upstream in the catchment.</p> <p>Overall, the channel appears to be within a typical sediment deposition zone, with slow flows, low gradients and low velocities contributing to the settling out of fine sediments/silts.</p> |

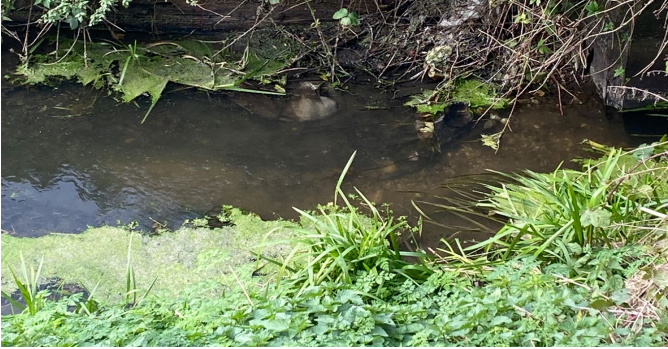
| Parameter | Description |
|---|---|
| In-channel / riparian vegetation | <p>No riparian mature trees were present, although banks and margins were well vegetated in places with rushes, sedges and reeds. Some in-channel aquatic vegetation growth was also recorded with some locations along the drain displaying good in-channel habitat features. Such features included clean gravels and marginal vegetation encroaching into the channel (<b>Plate 15</b>).</p> <p><i>Plate 15 Meaux and Routh East Drain In-Channel Habitat</i></p> |

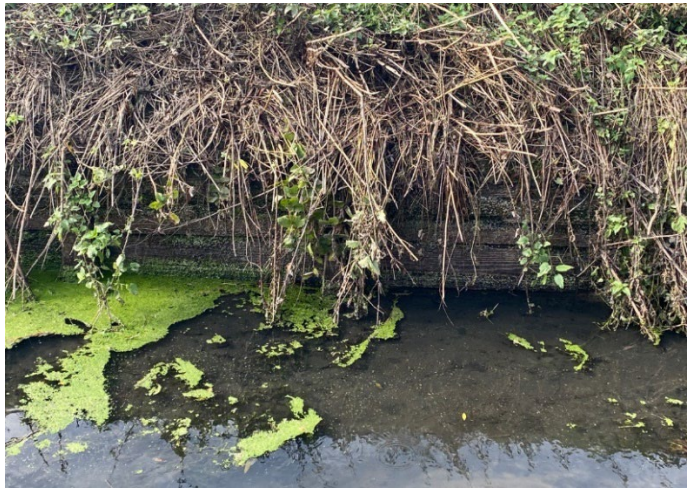
| Parameter | Description |
|---|---|
| Modifications/Structures/Pollution | <p>The channel is deeply incised and is likely to have been historically resectioned and enlarged for land drainage purposes.</p> <p>Minor wooden bank protection works were noted (<b>Plate 16</b>). No signs of significant diffuse or point source pollution were observed, with water quality clear.</p> <p><i>Plate 16 Meaux and Routh East Drain<br/>Minor Wood Bank Protection</i></p> |

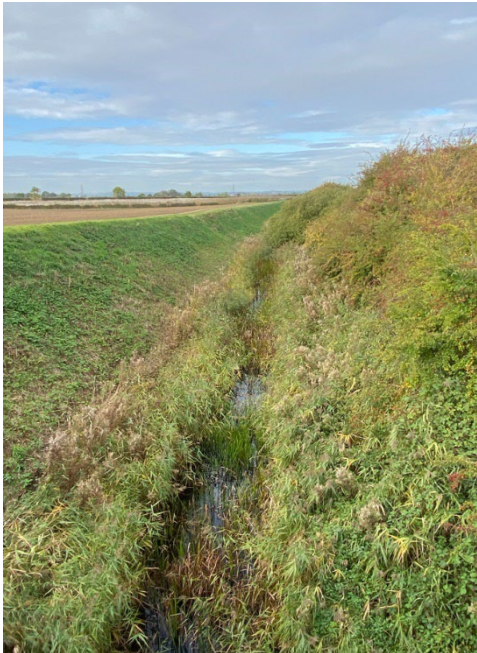
| Parameter | Description |
|---|---|
| Overview | <p>Holderness Drain Source to Foredyke Stream (South Option) consists of a uniform deep channel that has been artificially straightened and incised adjacent to arable farmland (<b>Plate 17</b>).</p> <p><i>Plate 17 Holderness Drain Source to Foredyke Stream (South Option)</i></p> |

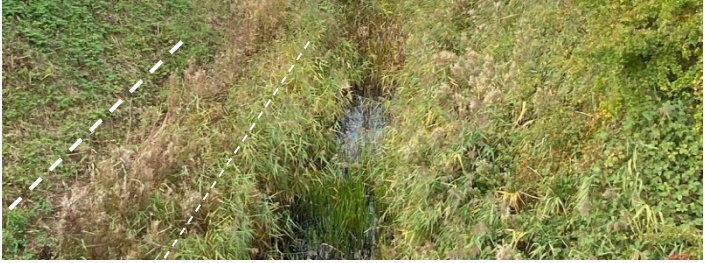
| Parameter | Description |
|---|---|
| Channel Form, Soils and Substrates | <p>The channel has a straight planform. The banks are relatively steep, approximately 8 m –12 m high, stable (with no signs of erosion noted) and well vegetated. The channel is approximately 15 m – 20 m wide at the bank top; and 8 m wide at the bank base, displaying a U shape or trapezoidal uniform channel (typical of land drainage channels). However, in places the channel is encroached by marginal vegetation ,narrowing the channel and providing good channel form complexity in form of habitat benches and low flow channel (<b>Plate 18</b>). This is likely to be indicative of natural channel narrowing in response to historical channel enlargement and resectioning. The substrate is dominated by sands and silts. Although the proportion of silts are likely to be derived from exposed banks during higher-energy flows, the majority of the fine sediment load is likely to be sourced from the adjacent agricultural field and upstream in the catchment.</p> <p>Overall, the channel appears to be within a typical sediment deposition zone, with slow flows, low gradients and low velocities contributing to the settling out of fine sediments/silts.</p> <p><i>Plate 18 Holderness Drain Source to Foredyke Stream (South Option)<br/>Channel Form Complexity</i></p> |

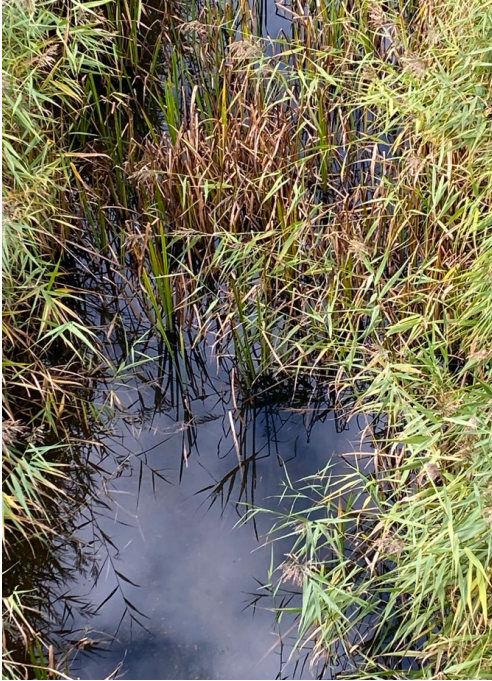
| Parameter | Description |
|---|---|
| In-channel / riparian vegetation | <p>No riparian present, although banks and margins are well vegetated in places with rushes, sedges and reeds. Some good in-channel habitat features, such as clean gravels and marginal vegetation encroaching into the channel (<b>Plate 19</b>).</p> <p><i>Plate 19 Holderness Drain Source to Foredyke Stream (South Option) In-Channel Habitat</i></p> |

| Parameter | Description |
|---|---|
| Modifications/Structures/<br>Pollution | <p>The channel is deeply incised and is likely to have been historically resectioned and enlarged for land drainage purposes.</p> <p>No signs of bank protection or diffuse or point source pollution, with water quality clear.</p> |

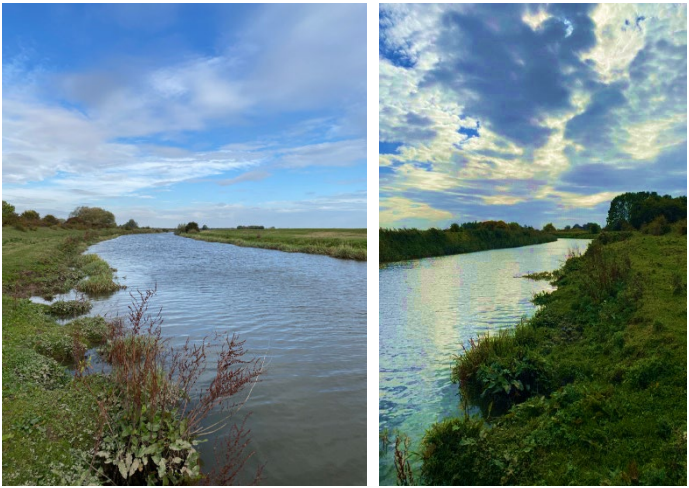
| Parameter | Description |
|---|---|
| Overview | <p>Hull from Arram Beck to Humber (South Option) consists of a uniform deep channel that has been artificially straightened and incised adjacent to arable farmland (<b>Plate 20</b>).</p> <p>Plate 20 Hull from Arram Beck to Humber (South Option)</p> |

| Parameter | Description |
|---|---|
| Modifications/Structures/Pollution | <p>The channel is over widened and straight; and confined within flood embankments (<b>Plate 20</b>).</p> <p>No bank protection works were noted or signs of diffuse or point source pollution, with water quality turbid.</p> |

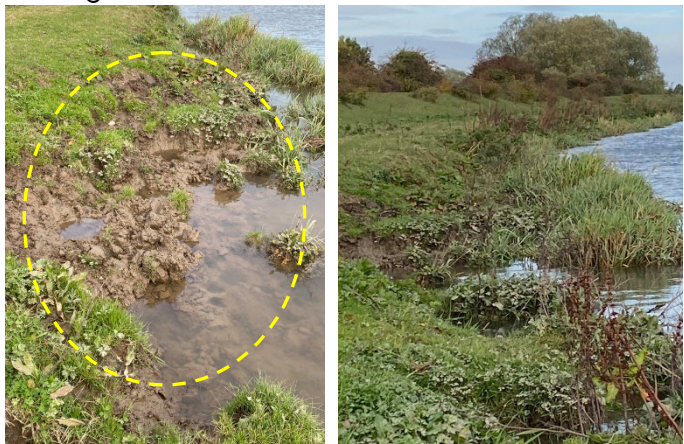
| Parameter | Description |
|---|---|
| Channel Form, Soils and Substrates | <p>The channel has a straight planform. The banks are relatively shallow, approximately 1 m – 2 m high, with some minor signs of erosion noted in response to cattle, although both banks well vegetated. The channel is approximately 20 m – 25 m wide at the bank top; and 20 m wide at the bank base, displaying a U shape or trapezoidal uniform channel (typical of land drainage channels) (<b>Plate 20</b>). Although an inset bench was present in places in response to good marginal vegetation encroaching into the channel increasing the degree of channel margin complexity (<b>Plate 21</b>). This is likely to be indicative of natural channel narrowing in response to historical channel enlargement and resectioning. The substrate is dominated by sands and silts. Although the proportion of silts are likely to be derived from exposed banks during higher-energy flows and cattle eroding the banks (<b>Plate 21</b>), the majority of the fine sediment load is likely to be sourced from the adjacent agricultural field and upstream in the catchment. This was evident by the turbid nature of the flows.</p> <p>Overall, the channel appears to be within a typical sediment deposition zone, with slow flows, low gradients and low velocities contributing to the settling out of fine sediments/silts.</p> <div data-bbox="730 1350 1417 1792"> </div> <p><i>Plate 21 Hull from Arram Beck to Humber (South Option)<br/>Channel Margin Complexity</i></p> |

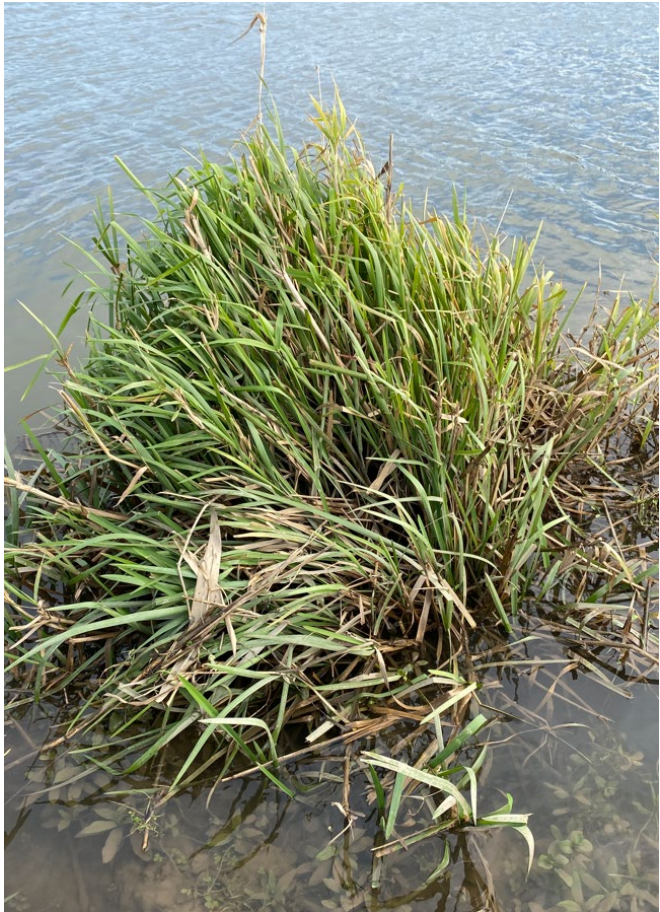
| Parameter | Description |
|---|---|
| In-channel / riparian vegetation | <p>Patches of riparian present, with banks and margins vegetated in places with small pockets of rushes and sedges (<b>Plate 22</b>) although overall limited in aquatic macrophytes.</p> <p><i>Plate 22 Hull from Arram Beck to Humber (South Option)<br/>In-Channel Habitat</i></p> |

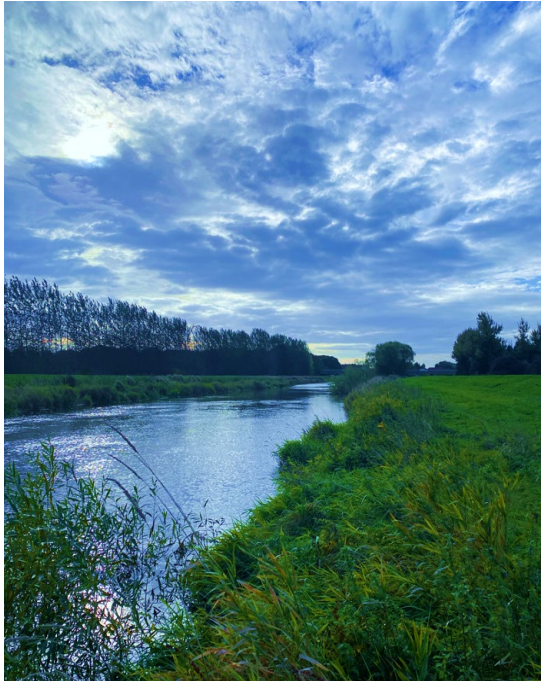
| Parameter | Description |
|---|---|
| Overview | <p>Hull from Arram Beck to Humber (North Option) consists of a uniform deep channel that has been artificially straightened and incised adjacent to arable farmland (<b>Plate 23</b>).</p> <p>Plate 23 Hull from Arram Beck (North Option)</p> |

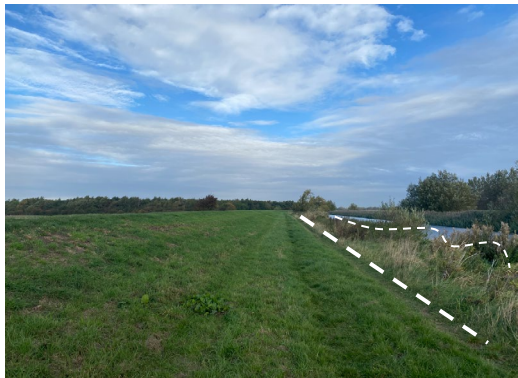
| Parameter | Description |
|---|---|
| Channel Form, Soils and Substrates | <p>The channel has a straight planform. The banks are relatively steep, approximately 1 m – 2 m high, stable (with no signs of erosion noted) and well vegetated. The channel is approximately 25 m – 30 m wide at the bank top and 20 m wide at the bank base, displaying a wide but shallow uniform channel. However, in places the channel is encroached by marginal vegetation narrowing the channel and providing good channel margin complexity (<b>Plate 24</b>). This is likely to be indicative of natural channel narrowing in response to historical channel enlargement and resectioning. The substrate is dominated by sands and silts. Although the proportion of silts are likely to be derived from exposed banks during higher-energy flows, the majority of the fine sediment load is likely to be sourced from the adjacent agricultural field and upstream in the catchment.</p> <p>Overall, the channel appears to be within a typical sediment deposition zone, with slow flows, low gradients and low velocities contributing to the settling out of fine sediments/silts.</p> <p><i>Plate 24 Hull from Arram Beck (North Option)<br/>Channel Margin Complexity</i></p> |

| Parameter | Description |
|---|---|
| Floodplain Characteristics | Floodplain connectivity is relatively good in response to the wide but shallow nature of the channel, although the channel is confined within flood embankments ( <b>Plate 24</b> ). |
| Modifications/Structures/Pollution | <p>The channel is over widened and straight; and confined within flood embankments (<b>Plate 24</b>).</p> <p>No bank protection works were noted or signs of diffuse or point source pollution, with water quality clear.</p> |

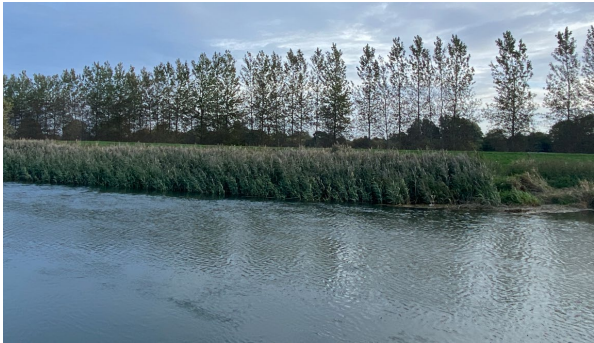
| Parameter | Description |
|---|---|
| In-channel / riparian vegetation | <p>Patches of riparian present, although banks and margins are well vegetated in places with rushes, sedges and reed which line the margins of the watercourse (<b>Plate 25</b>).</p> <p><i>Plate 25 Hull from Arram Beck (North Option)<br/>In-Channel Habitat</i></p> |

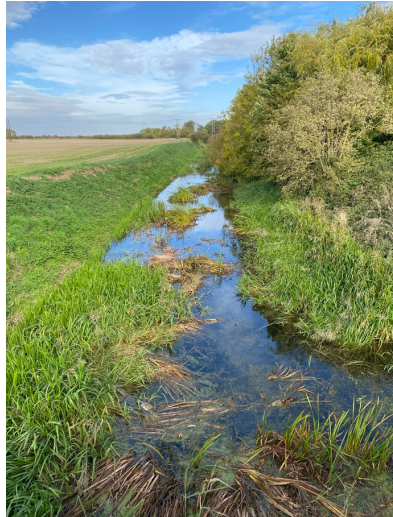
| Parameter | Description |
|---|---|
| Overview | <p>Beverley and Barmston Drain (South Option) consists of a uniform deep channel that has been artificially straightened and incised adjacent to arable farmland and the River Hull (<b>Plate 26</b>).</p> <p><i>Plate 26 Beverley and Barmston Drain (South Option)</i></p> |

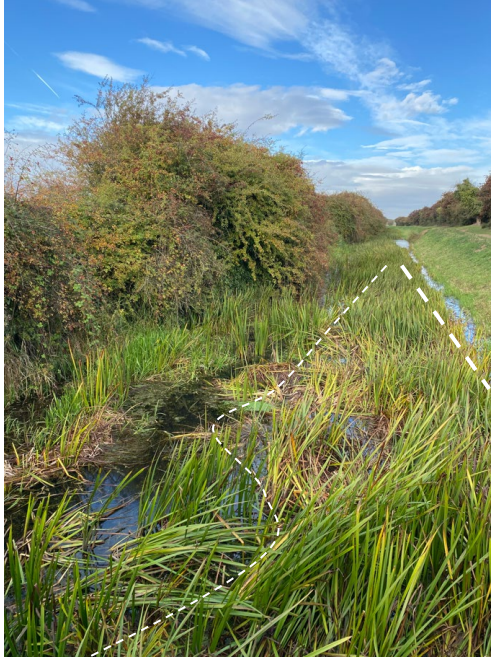
| Parameter | Description |
|---|---|
| Channel Form, Soils and Substrates | <p>The channel has a straight planform. The banks are relatively steep, approximately 1 m – 2 m high, and stable (with some signs of erosion noted) and well vegetated. The channel is approximately 10 m – 15 m wide at the bank top and 8 m wide at the bank base, displaying a wide but shallow uniform channel. However, in places the channel is encroached by marginal vegetation narrowing the channel and providing excellent complexity to the channel margins (<b>Plate 27</b>). This is likely to be indicative of natural channel narrowing in response to historical channel enlargement and resectioning. The substrate is dominated by sands and silts. Although the proportion of silts are likely to be derived from exposed banks during higher-energy flows, the majority of the fine sediment load is likely to be sourced from the adjacent agricultural field and upstream in the catchment.</p> <p>Overall, the channel appears to be within a typical sediment deposition zone, with slow flows, low gradients and low velocities contributing to the settling out of fine sediments/silts.</p> <p><i>Plate 27 Beverley and Barmston Drain (South Option)<br/>Channel Margin Complexity</i></p> |

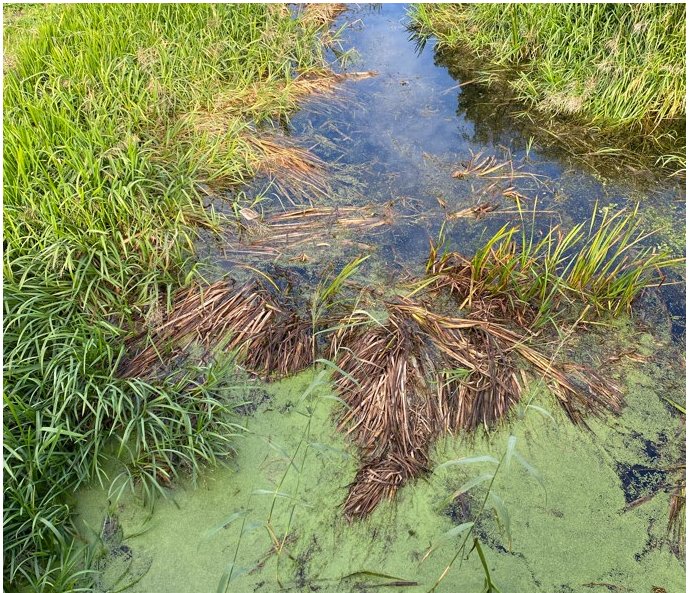
| Parameter | Description |
|---|---|
| In-channel / riparian vegetation | <p>Patches of riparian present, although banks and margins are well vegetated in places with rushes, sedges and reed which line the margins of both banks providing a mosaic of in-channel wetland habitat of prime importance to wildlife (<b>Plate 28</b>). Duck weed (<i>Lemna minor</i>) and organic leaf material was also observed.</p> <p><i>Plate 28 Beverley and Barmston Drain (South Option)<br/>In-Channel Habitat</i></p> |

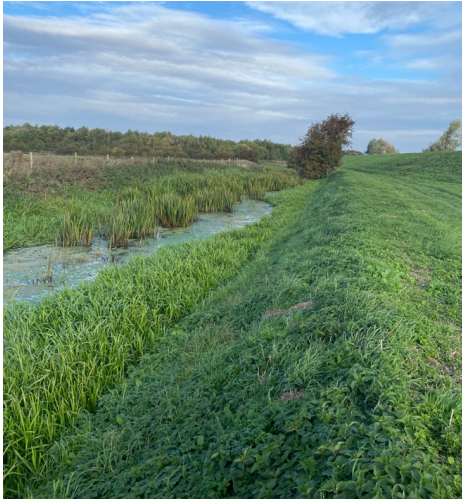
| Parameter | Description |
|---|---|
| Overview | <p>Beverley and Barmston Drain (North Option) consists of a uniform deep channel that has been artificially straightened and incised adjacent to arable farmland and the River Hull (<b>Plate 29</b>).</p> <p><i>Plate 29 Beverley and Barmston Drain (North Option)</i></p> |

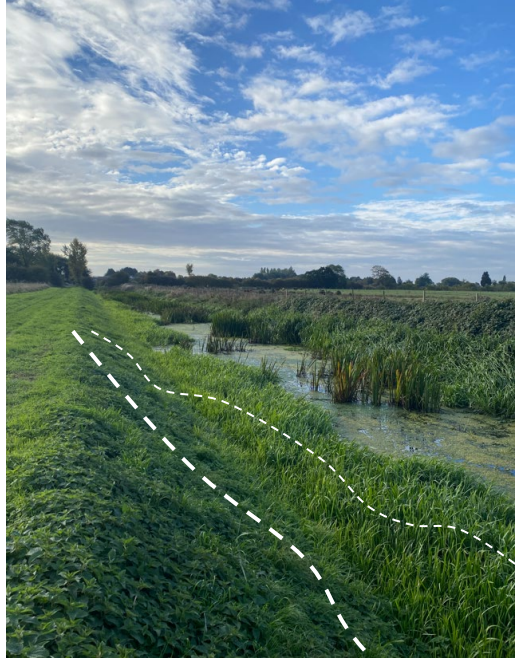
| Parameter | Description |
|---|---|
| Channel Form, Soils and Substrates | <p>The channel has a straight planform. The banks are relatively steep, approximately 1 m – 2 m high, stable (with no signs of erosion noted) and well vegetated. The channel is approximately 10 m – 15 m wide at the bank top and 8 m wide at the bank base, displaying a wide but shallow uniform channel. However, in places the channel is encroached by marginal vegetation narrowing the channel and providing excellent channel form complexity (<b>Plate 30</b>). This is likely to be indicative of natural channel narrowing in response to historical channel enlargement and resectioning. The substrate is dominated by sands and silts. Although the proportion of silts are likely to be derived from exposed banks during higher-energy flows, the majority of the fine sediment load is likely to be sourced from the adjacent agricultural field and upstream in the catchment.</p> <p>Overall, the channel appears to be within a typical sediment deposition zone, with slow flows, low gradients and low velocities contributing to the settling out of fine sediments/silts.</p> <p><i>Plate 30 Beverley and Barmston Drain (North Option)<br/>Channel Margin Complexity</i></p> |

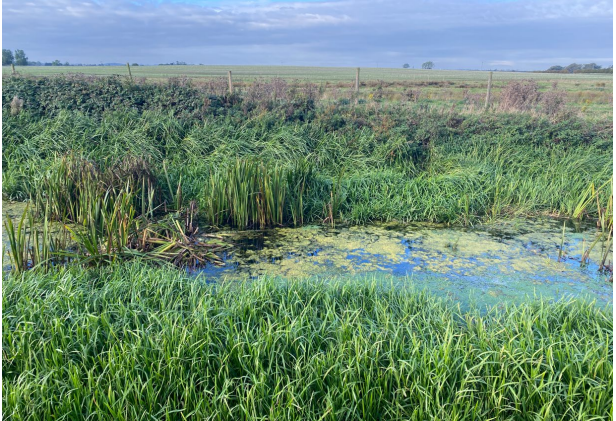
| Parameter | Description |
|---|---|
| In-channel / riparian vegetation | <p>Patches of riparian present, although banks and margins are well vegetated in places with rushes, sedges and reed which line the margins of both banks providing a mosaic of in-channel wetland habitat of prime importance to wildlife (<b>Plate 31</b>).</p> <p><i>Plate 31 Beverley and Barmston Drain (North Option)<br/>In-Channel Habitat</i></p> |

| Parameter | Description |
|---|---|
| Floodplain Characteristics | Floodplain connectivity is relatively good in response to the wide but shallow nature of the channel, although the channel is adjacent a flood embankment which is shared with the River Hull ( <b>Plate 29</b> ). |
| Modifications/Structures/Pollution | <p>The channel is over widened and straight; and confined within flood embankments (<b>Plate 29</b>).</p> <p>No bank protection works were noted or signs of diffuse or point source pollution, with water quality clear.</p> |

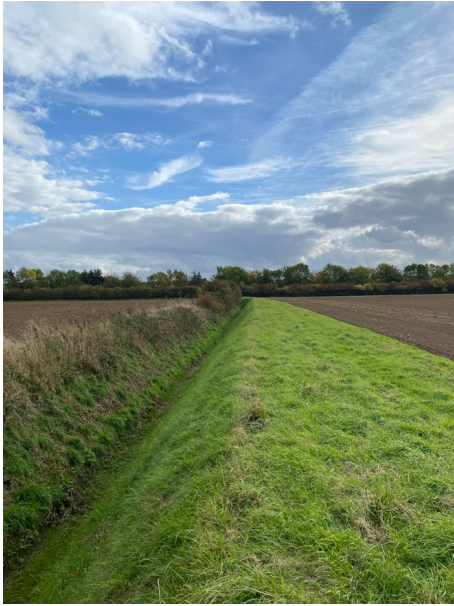
| Parameter | Description |
|---|---|
| Overview | <p>High Hunsley to Arram Area (Reach 1) consists of a uniform deep channel that has been artificially straightened and incised adjacent to arable farmland (<b>Plate 32</b>).</p> <p>Plate 32 High Hunsley to Arram Area (Reach 1)</p> |

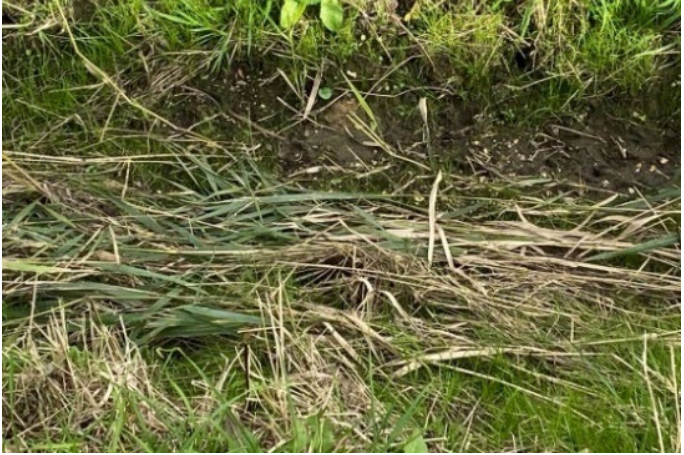
| Parameter | Description |
|---|---|
| Channel Form, Soils and Substrates | <p>The channel has a straight planform. The banks are steep, approximately 5 m – 6 m high, stable (with no signs of erosion noted) and well vegetated. The channel is approximately 6 m – 8 m wide at the bank top and 2 m wide at the bank base, displaying a U shape or trapezoidal uniform channel (typical of land drainage channels) (<b>Plate 32</b>). The substrate is dominated by sands, silts and long grasses, although in places these overlaid pebbles and cobbles (<b>Plate 33</b>). Although the proportion of silts are likely to be derived from exposed banks during higher-energy flows, the majority of the fine sediment load is likely to be sourced from the adjacent agricultural field and upstream in the catchment.</p> <p>Overall, the channel would appear to be within a typical sediment deposition zone, with slow flows, low gradients and low velocities contributing to the settling out of fine sediments/silts.</p> <p><i>Plate 33 High Hunsley to Arram Area (Reach 1)<br/>Channel Substrate</i></p> |

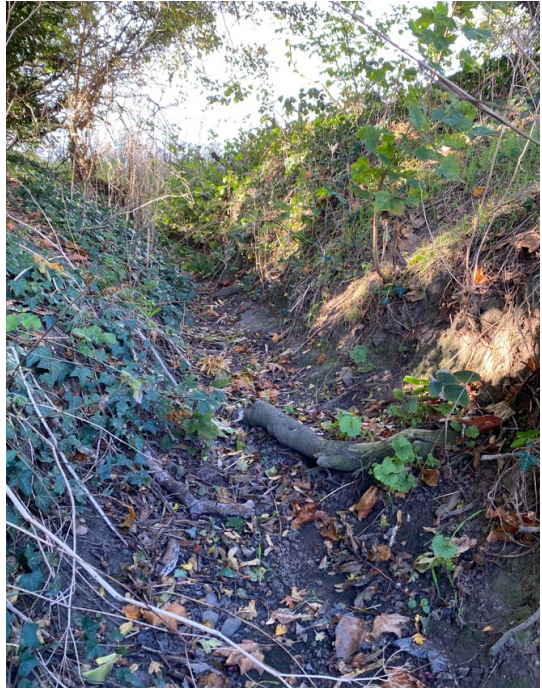
| Parameter | Description |
|---|---|
| Overview | <p>High Hunsley to Arram Area (Reach 2) consists of a uniform relatively deep, narrow channel that has been artificially straightened and incised adjacent to arable farmland (<b>Plate 34</b>).</p> <p>Plate 34 High Hunsley to Arram Area (Reach 2)</p> |

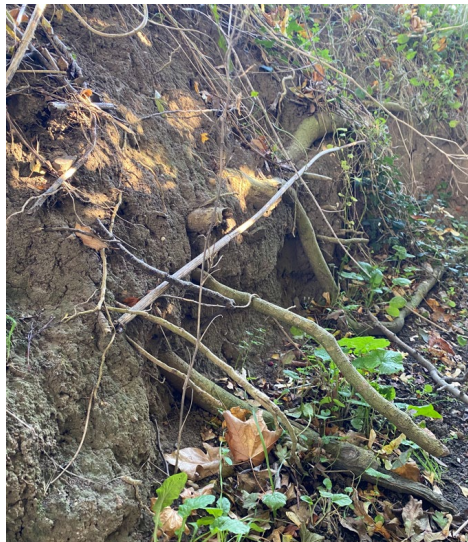
| Parameter | Description |
|---|---|
| Channel Form, Soils and Substrates | <p>The channel has a straight planform. The banks are relatively deep, approximately 2 m –3 m high, with signs of bank erosion along the drain noted. The channel is approximately 2 m –3 m wide at the bank top; and 0.5 m wide at the bank base, displaying a U shape or trapezoidal uniform channel (typical of land drainage channels) (<b>Plate 32</b>). The substrate is dominated by sands, silts and pebbles. Although the proportion of silts are likely to be derived from exposed banks (<b>Plate 35</b>) during higher-energy flows, the majority of the fine sediment load is likely to be sourced from the adjacent agricultural field and upstream in the catchment.</p> <p>Overall, the channel would appear to be within a typical sediment deposition zone, with slow flows, low gradients and low velocities contributing to the settling out of fine sediments/silts.</p> <p><i>Plate 35 Exposed Banks of High Hunsley to Arram Area (Reach 2)</i></p> |

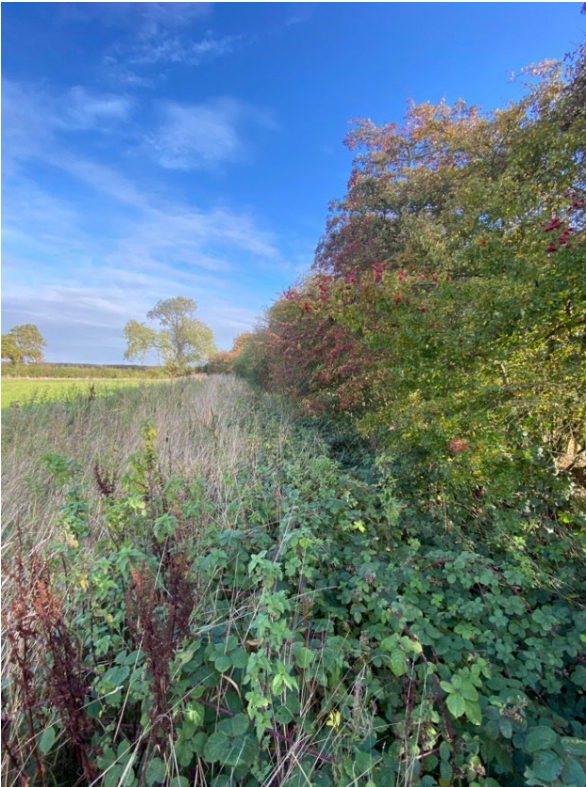
| Parameter | Description |
|---|---|
| In-channel / riparian vegetation | <p>Riparian vegetation is present, although the majority of the channel is overgrown with Bramble (<i>Rubus fruticosus</i>) (<b>Plate 36</b>).</p> <p><i>Plate 36 High Hunsley to Arram Area In-Channel Habitat</i></p> |

| Parameter | Description |
|---|---|
| Modifications/Structures/Pollution | <p>The channel is deeply incised and is likely to have been historically resectioned and enlarged for land drainage purposes.</p> <p>No bank protection works were noted or signs of diffuse or point source pollution, although a discharge pipe was noted in the bank of the channel.</p> |

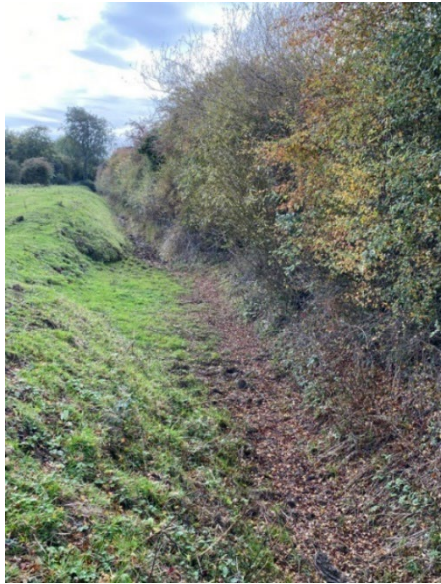
| Parameter | Description |
|---|---|
| Overview | <p>High Hunsley to Woodmansey Area consists of a uniform relatively deep, narrow channel that has been artificially straightened and incised adjacent to arable farmland (<b>Plate 37</b>).</p> <p>Plate 37 High Hunsley to Woodmansey</p> |

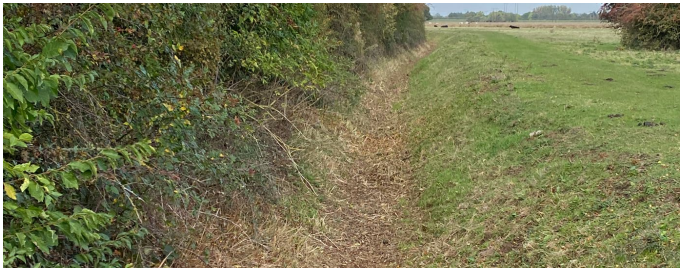
| Parameter | Description |
|---|---|
| Channel Form, Soils and Substrates | <p>The channel has a straight planform. The banks are relatively deep, approximately 1 m –2 m high, with signs of bank erosion along the drain noted. The channel is approximately 2 m –3 m wide at the bank top and 0.5 m wide at the bank base, displaying a U shape or trapezoidal uniform channel (typical of land drainage channels) (<b>Plate 37</b>). Although the channel was dry, the complexity of the channel appeared low, with no diversity of in-channel features observed (<b>Plate 38</b>). The substrate is dominated by sands, silts and pebbles. Although the proportion of silts are likely to be derived from exposed banks (which were noted) during higher-energy flows, the majority of the fine sediment load is likely to be sourced from the adjacent agricultural field and upstream in the catchment.</p> <p>Overall, the channel would appear to be within a typical sediment deposition zone, with slow flows, low gradients and low velocities contributing to the settling out of fine sediments/silts.</p> <p><i>Plate 38 High Hunsley to Woodmansey Channel Form Complexity</i></p> |

| Parameter | Description |
|---|---|
| Modifications/Structures/Pollution | <p>The channel is deeply incised and is likely to have been historically resectioned and enlarged for land drainage purposes.</p> <p>No bank protection works were noted or signs of diffuse or point source pollution, although a discharge pipe was noted in the bank of the channel.</p> |
