# **Dogger Bank South Offshore Wind Farms**

**Preliminary Environmental Information Report  
Appendix 9-1 Intertidal Survey Report**

### Intertidal Survey Report

Reference: PC2340-RHD-ZZ-XX-RP-Z-0071

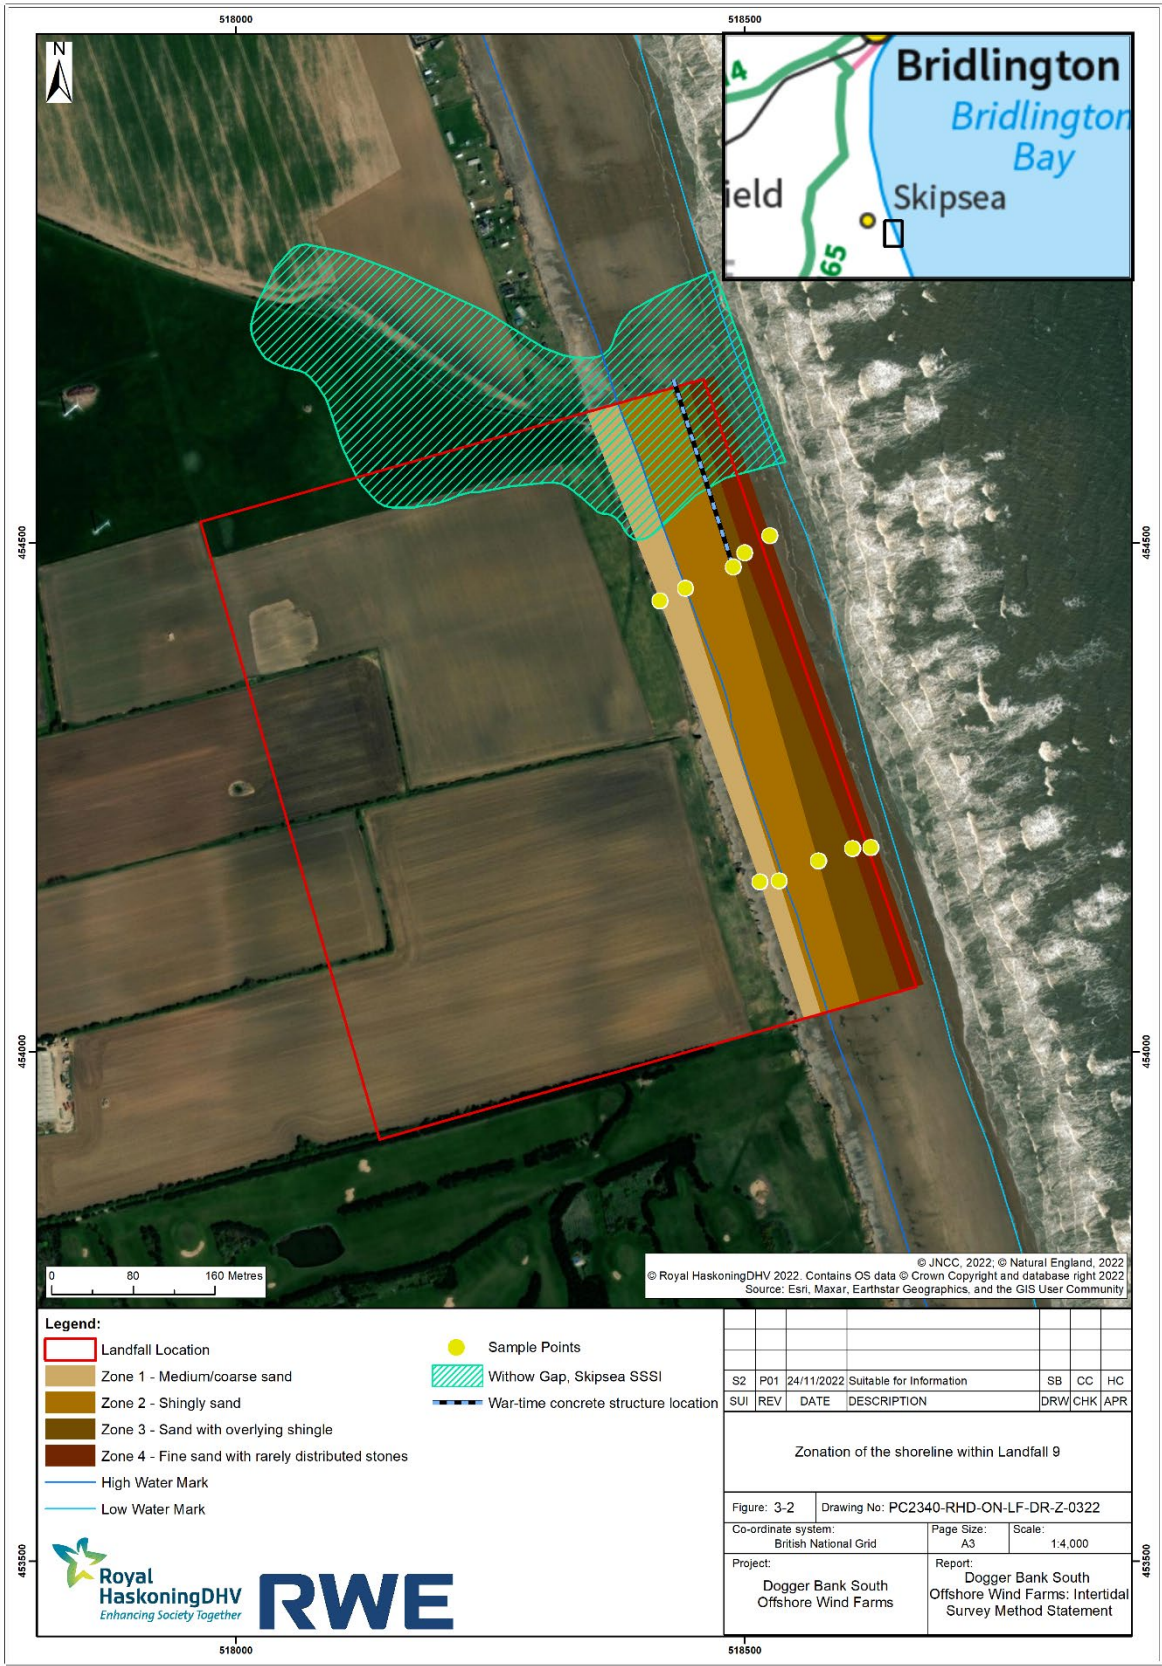
Figure 3-2 Zonation of the shoreline within Landfall 9

An overall profile of the shore within each landfall is detailed in **Figure 3-1** and **Figure 3-2** below, outlining the intertidal boundaries identified and sampling station locations. Based upon the substrata and abundance of species present along each transect, biotope(s) have been assigned to areas of shore within each transect according to Connor et al. (2004).

This initial walkover, and subsequent surveys conducted along the five selected transects, identified three distinct habitats within Landfall 8 and four within Landfall 9 (**Figure 3-1** and **Figure 3-2** respectively). Predominantly the beach comprised sand and shingle habitat interspersed with occasional hard anthropogenic structures.

Also located within Landfall 9 (but outside of the transects undertaken for the survey) is the Withow Gap, Skipsea SSSI (see **Figure 3-2** above). The site is designated for its geological features, namely the evidence of an ancient mere (lake) being located here (WildNatureBlog 2019). The site has no ecological relevance to this survey, however, with the overlying sediments found within the site boundary characterised by the same medium/coarse sand as the other sample points recorded along the upper shore of this landfall area.

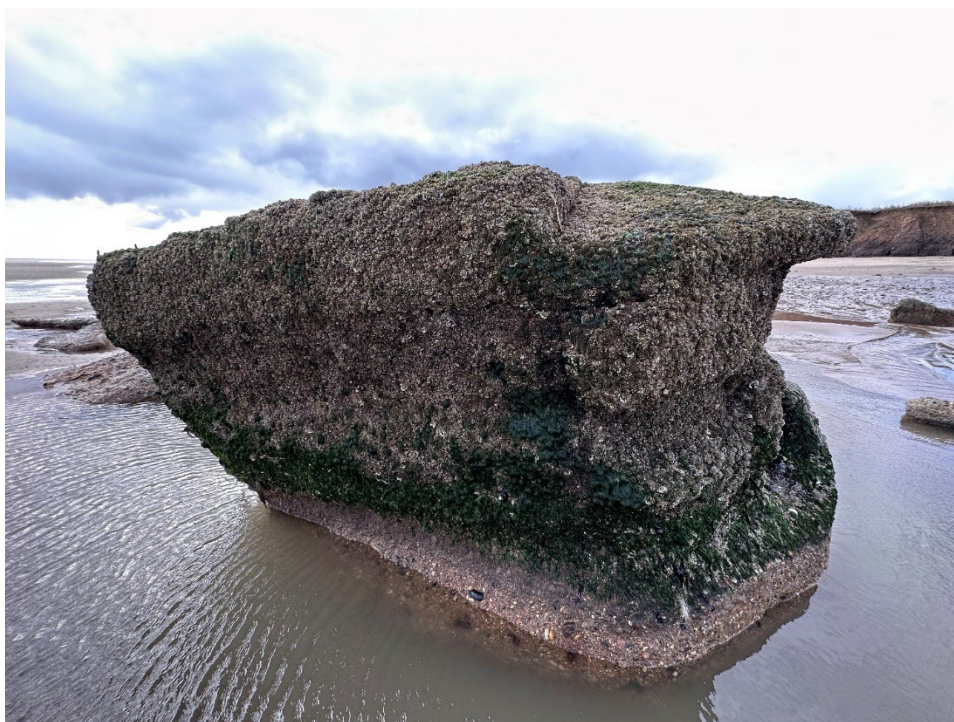
Concrete structures, likely remnants of war-time anti-tank beach defences (UrbanRim 2022), were found within the northern extent of Landfall 9 (see **Plate 3-2** and **Figure 3-2**). The larger concrete structures had been colonised by barnacles and green and red algae (*Ulva* sp and *Porphyra*), with low abundances of limpets also present (see **Plate 3-3** below). **Plate 3-2** shows a typical example of one of these structures and the associated flora and fauna found along the shoreline. **Plate 3-3** provides a close-up illustration of the biota associated with the relict concrete structures. In addition there were occasional concrete and metal structures heading seawards at a 90 degree angle from these concrete structures (see Plate below).

*Plate 3-1 Example of the concrete structures found within Landfall 9*

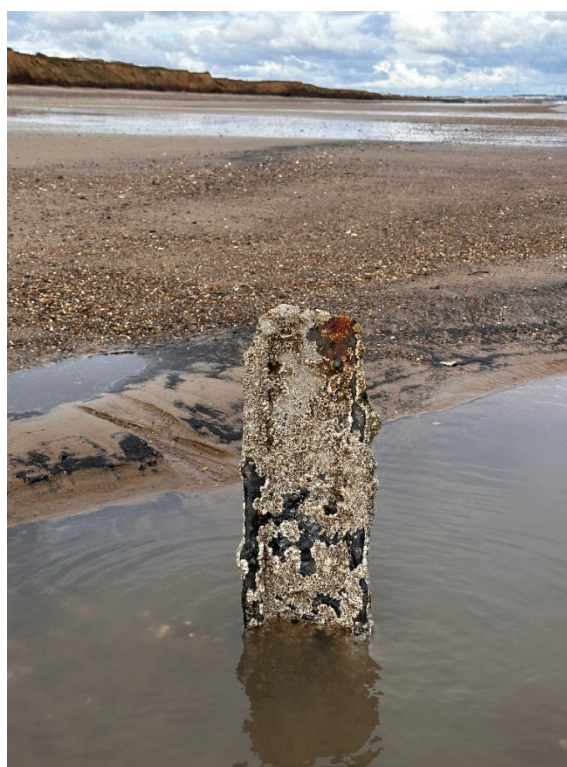
*Plate 3-2 Close-up of the concrete structure and the species inhabiting its surface, and an example of the metal / concrete structures found seaward from the existing line of concrete blocks*

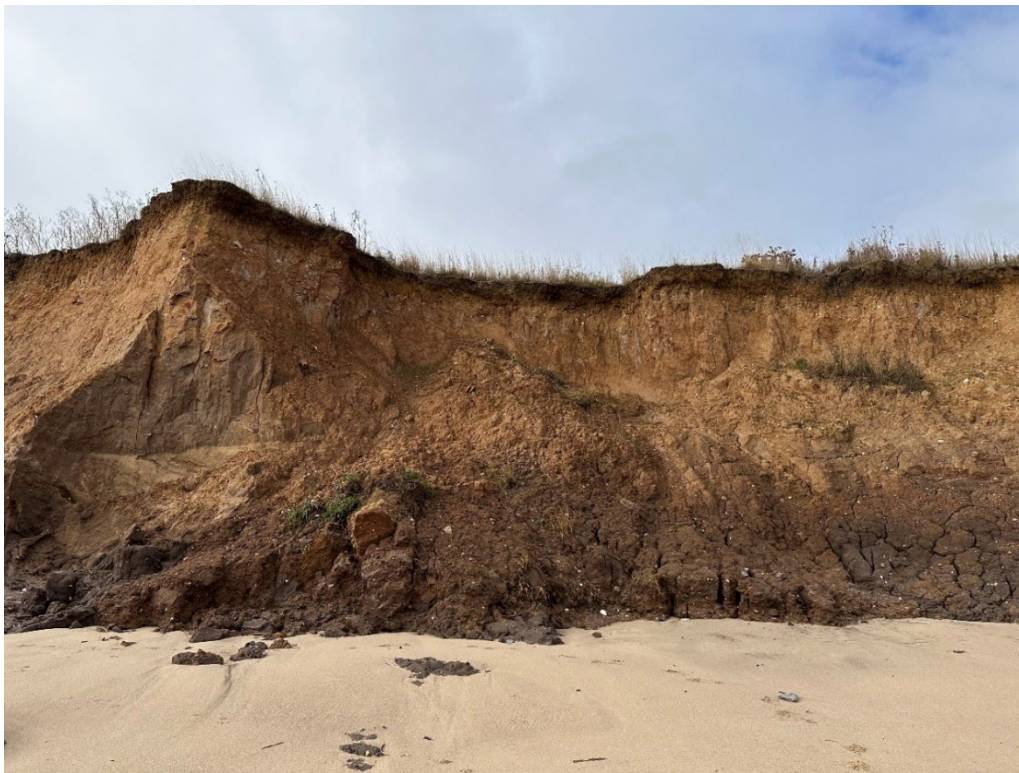
The cliff face was largely characterised as soft sediment cliff comprising clay with coarser cliff habitat above the clay layer. The cliff face was partly vegetated (mostly where it had slumped and cliff top vegetation had fallen with the cliff top), but with large areas of recently eroded bare slopes. It should be noted that the Maritime Cliff And Slopes data layer (part of the Priority Habitat Inventory (England) dataset from Natural England and last updated in August 2022), appears to be outdated, with the GPS co-ordinates recorded at the base of the cliff being found further inland than the extent of the current publicly available dataset. For example, the initial GPS point for Transect 1 is set approximately 30m back from the currently recorded cliff location in the Natural England dataset.

*Plate 3-3 Example of the slumped clay cliff-face present along the shoreline*

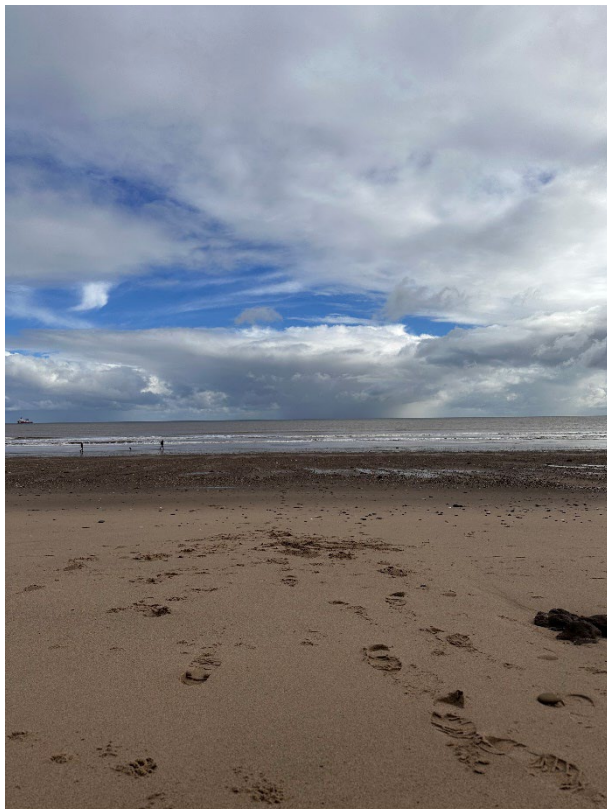
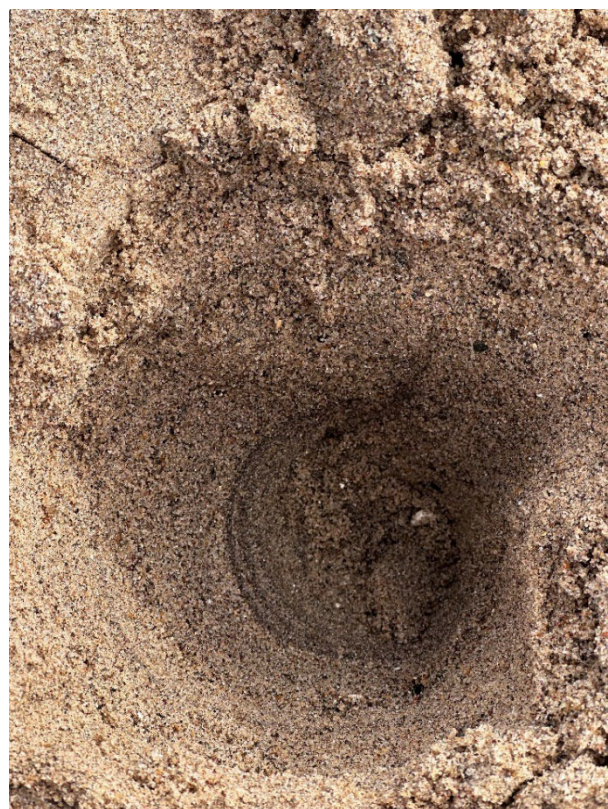
*Plate 3-4 Example of the medium / coarse sand zone found in Landfall 8 & 9 and representative dig-over*

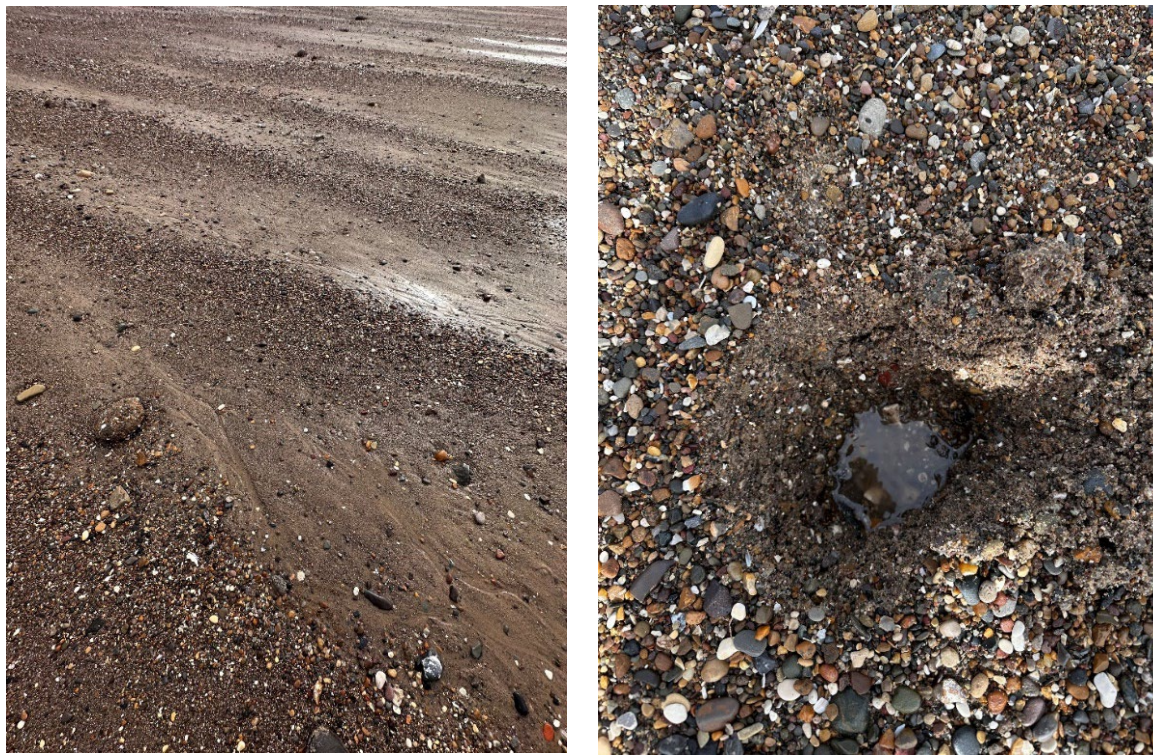
*Plate 3-5 Example of shingly sand zone found in Landfall 8 & 9 and representative dig-over*

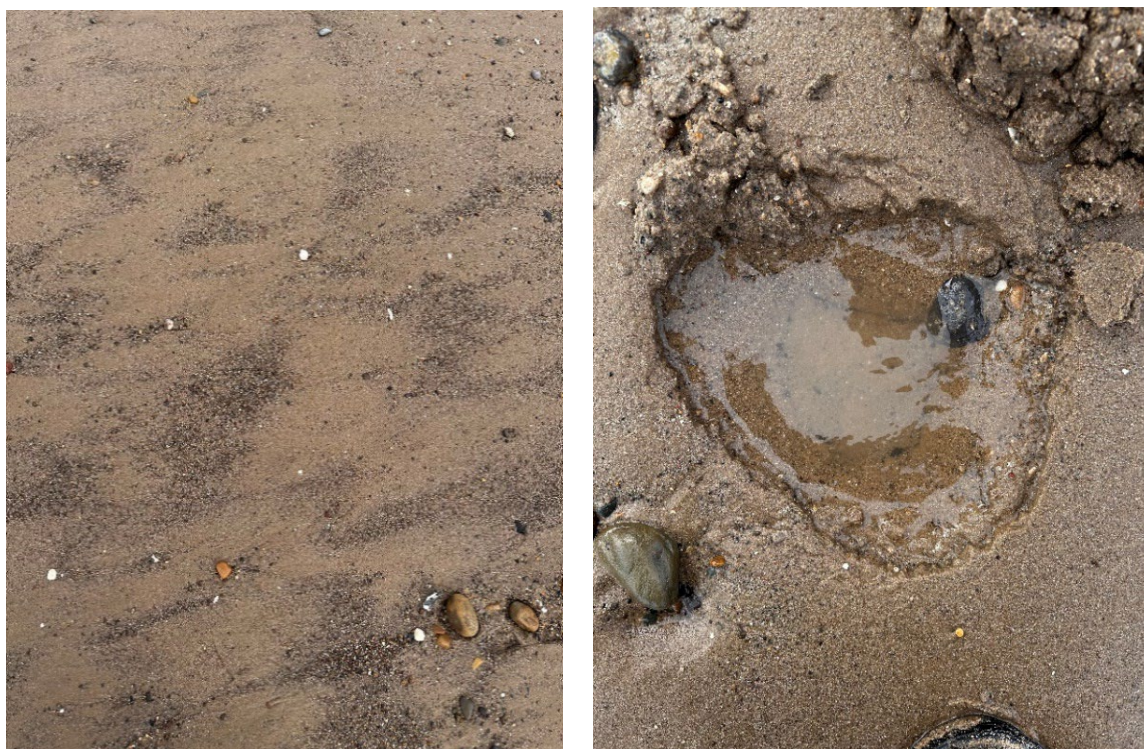
*Plate 3-6 Example of the sand with overlying shingle zone found in Landfall 8 & 9 and representative dig-over*

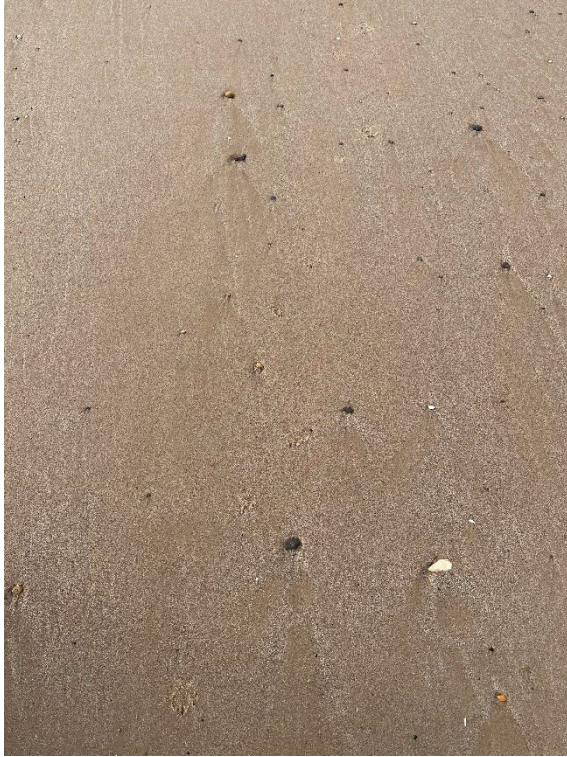
*Plate 3-7 Example of the fine sand with rarely distributed stones zone found in Landfall 9 and representative dig-over*
