# **Dogger Bank South Offshore Wind Farms**

**Preliminary Environmental Information Report  
Appendix 9-3 Environmental Features Report**

# **DBS WPM1 WPM2 WPM3 – Environmental Features Report**

Dogger Bank South Site Investigation | Southern North Sea  
Survey Period: 6 to 19 August 2022

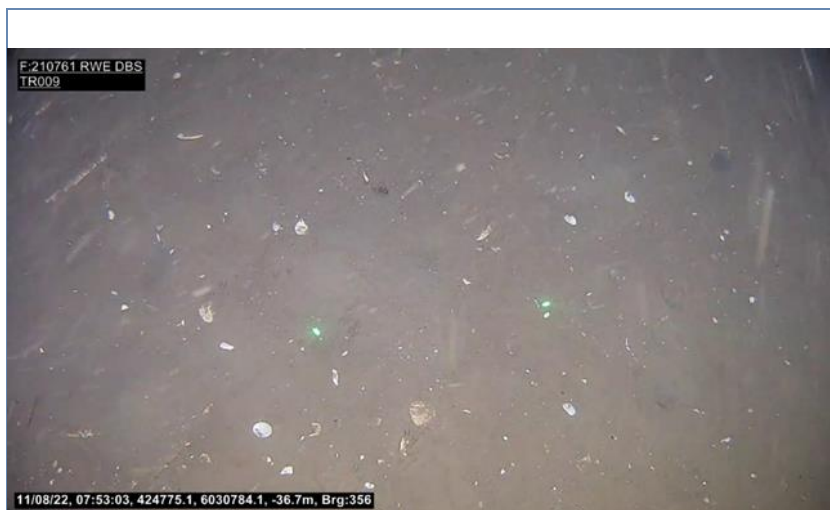
**Photograph:**  
210761\_ST009\_001

**Sediment Type:**  
Muddy sand with shell fragments

**Fauna:**  
No fauna identified

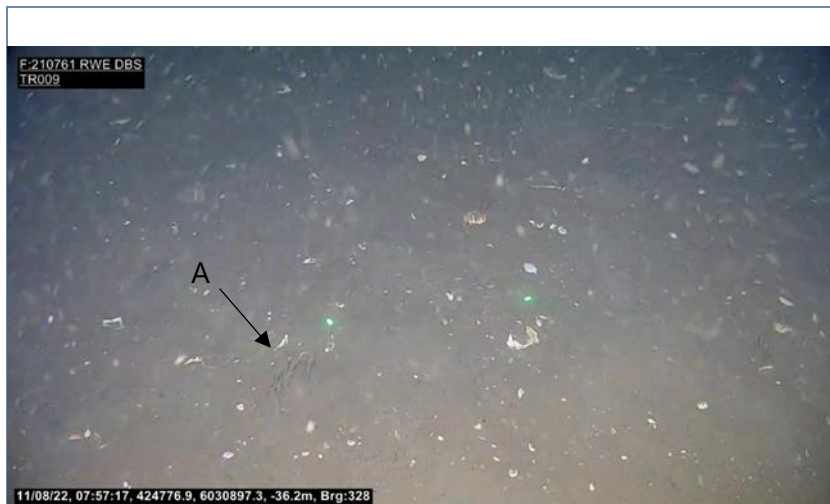
**Photograph:**  
210761\_ST009\_019

**Sediment Type:**  
Muddy sand with shell fragments

**Fauna:**  
A: Faunal turf (Hydrozoan/Bryozoan)

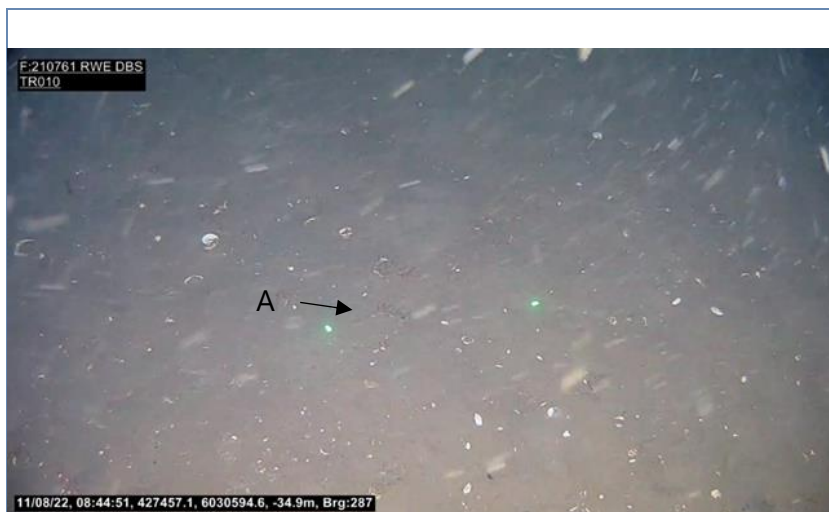
**Photograph:**  
210761\_ST010\_002

**Sediment Type:**  
Muddy sand with shell fragments and pebbles

**Fauna:**  
A: Faunal turf (Hydrozoa/Bryozoa)

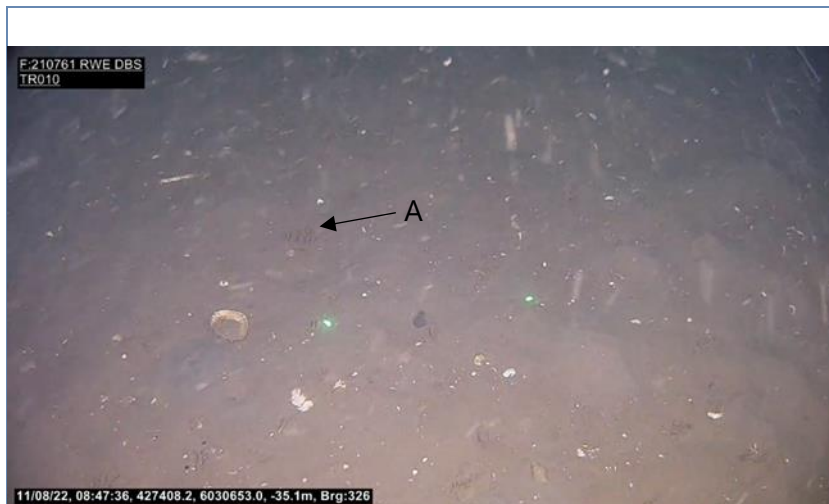
**Photograph:**  
210761\_ST010\_015

**Sediment Type:**  
Muddy sand with shell fragments and pebbles

**Fauna:**  
A: Faunal turf (Hydrozoa/Bryozoa)

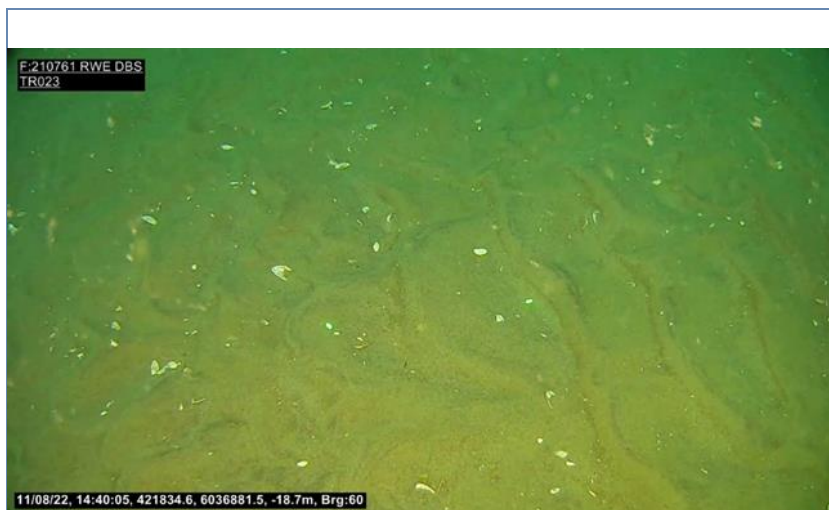
**Photograph:**  
210761\_ST023\_002

**Sediment Type:**  
Rippled sand with shell fragments  
and occasional pebbles

**Fauna:**  
No fauna identified

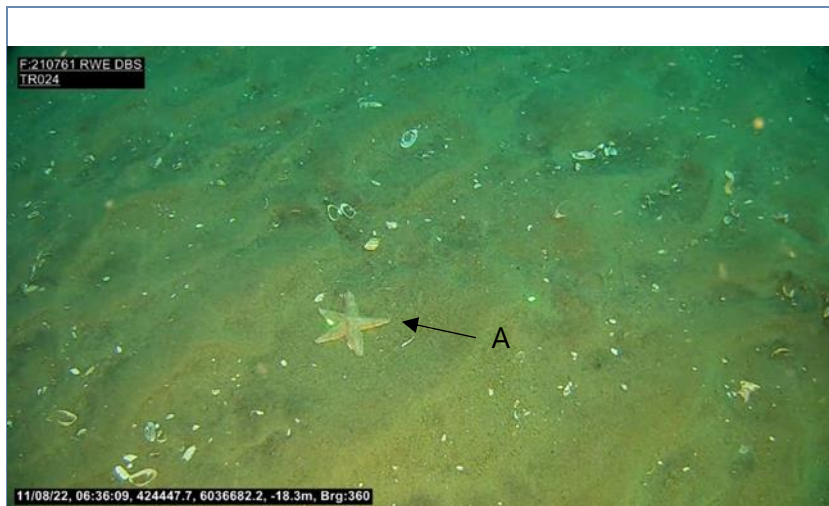
**Photograph:**  
210761\_ST024\_019

**Sediment Type:**  
Rippled sand with shell fragments  
and occasional pebbles

**Fauna:**  
A: Starfish (*Astropecten irregularis*)

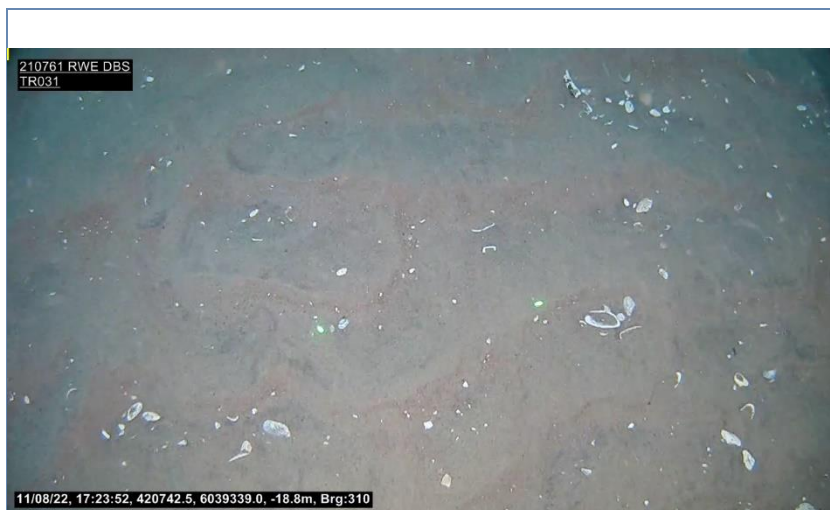
**Photograph:**  
210761\_ST031\_002

**Sediment Type:**  
Rippled sand/muddy sand with shell fragments and pebbles

**Fauna:**  
No fauna identified

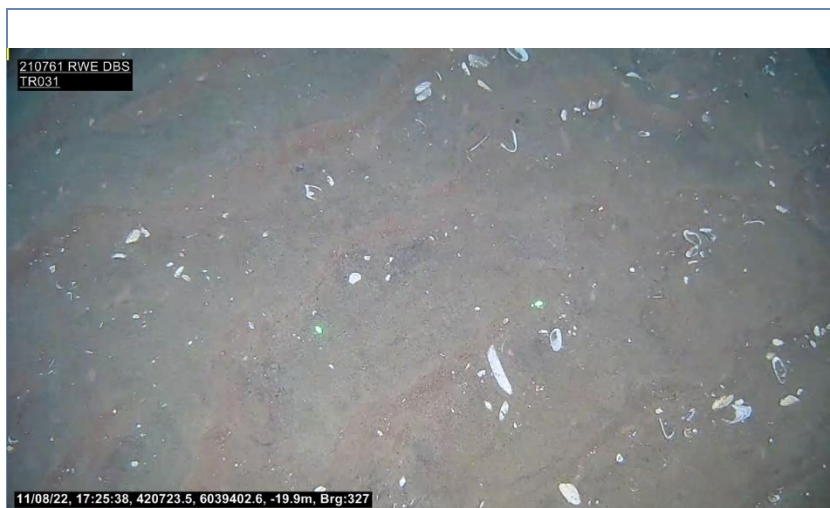
**Photograph:**  
210761\_ST031\_019

**Sediment Type:**  
Rippled sand/muddy sand with shell fragments and pebbles

**Fauna:**  
No fauna identified

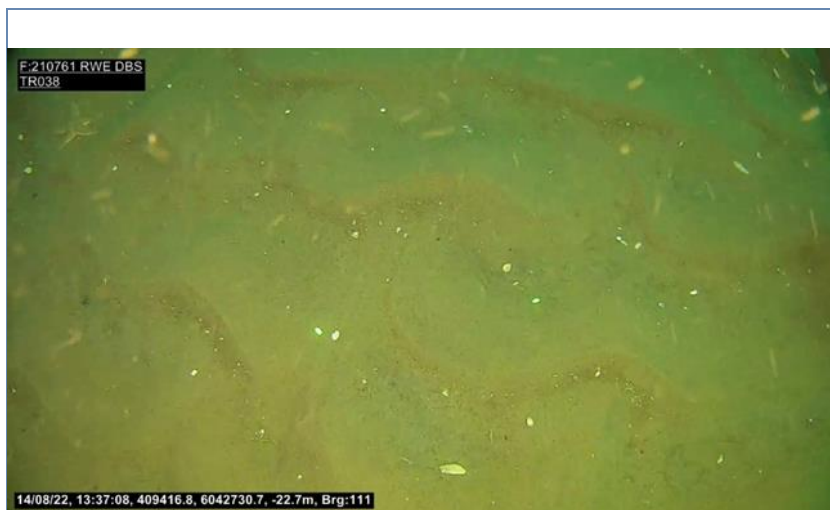
**Photograph:**  
210761\_ST038\_001

**Sediment Type:**  
Rippled sand with shell fragments

**Fauna:**  
A: Starfish (*Astropecten irregularis*)

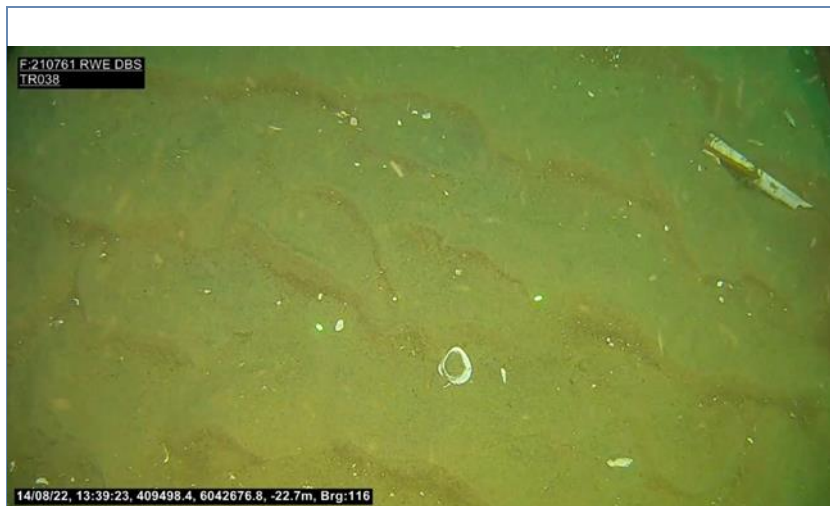
**Photograph:**  
210761\_ST038\_016

**Sediment Type:**  
Rippled sand with shell fragments

**Fauna:**  
No fauna identified

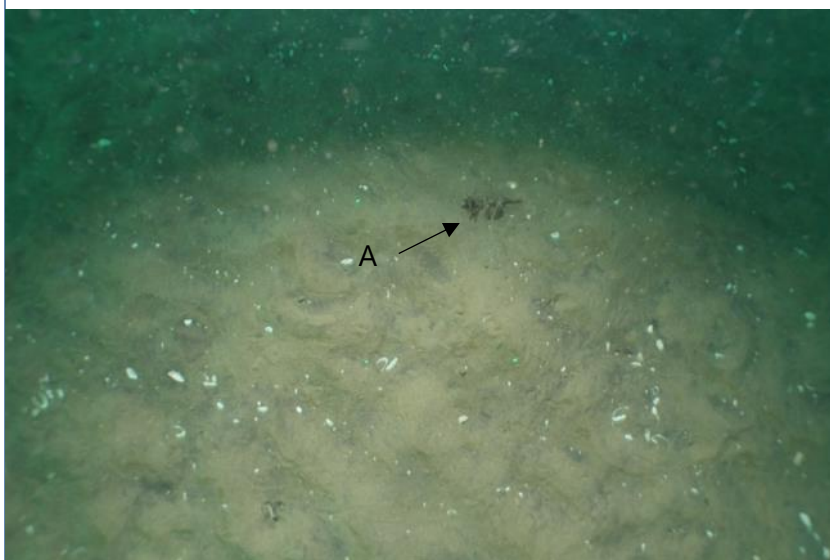
210761\_TR041\_001

A: Faunal turf (Hydrozoa/Bryozoa)

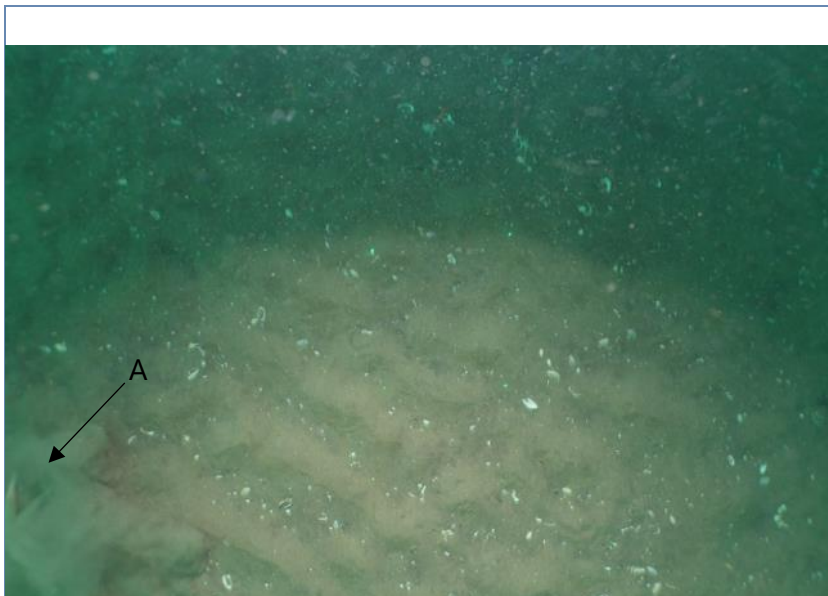
210761\_TR042\_001

Rippled muddy sand/sandy mud with shell fragments

**Fauna:**A: Starfish (*Asterias rubens*)

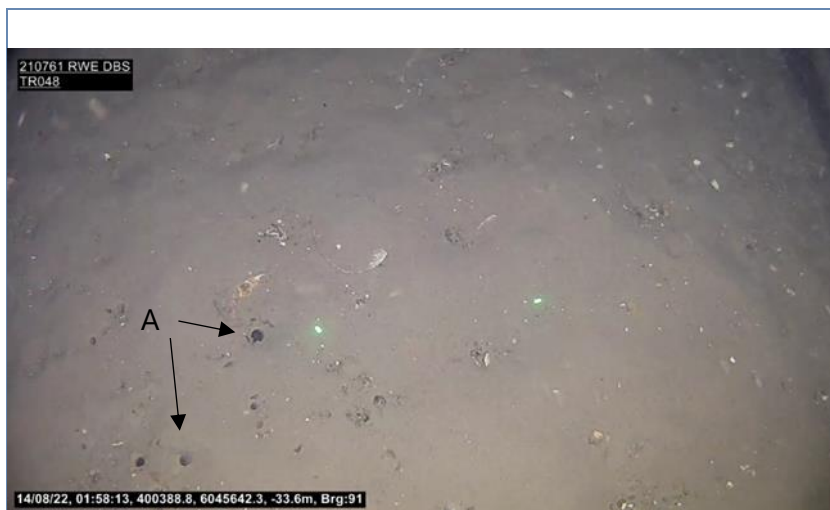
210761\_ST048\_001

A: Piddock burrows (Imparidentia)

Clay exposures, potentially representing the UK BAP listed habitat, were observed from the seabed photographic data at six stations (stations ST001, ST003, ST048, ST061, ST124 and ST181). No peat was observed from the seabed photographic data or samples.

Consolidated mud was observed at six stations (stations ST001, ST003, ST048, ST061, ST124 and ST181). Round holes characteristic of piddock burrows were observed patchily in these sediments, and therefore the UK BAP listed priority habitat ‘Peat and clay exposures with piddocks’ is potentially present at these stations.

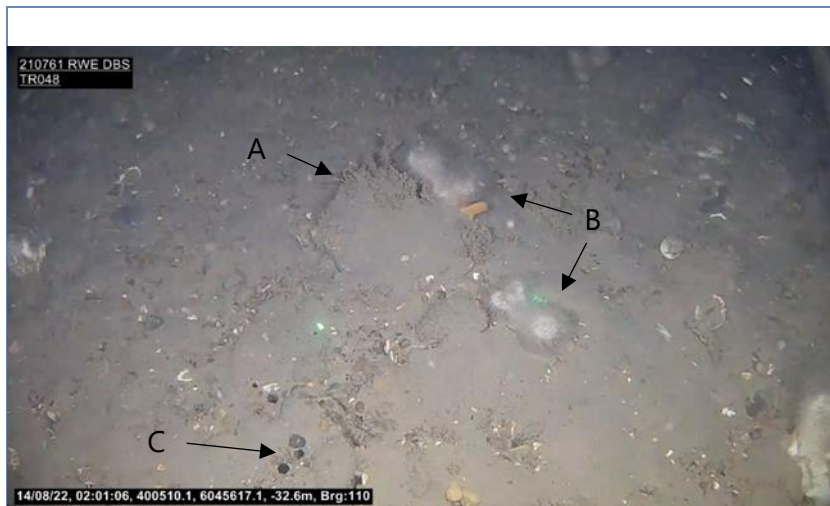
210761\_ST048\_012

C: Piddock burrows (Imparidentia)

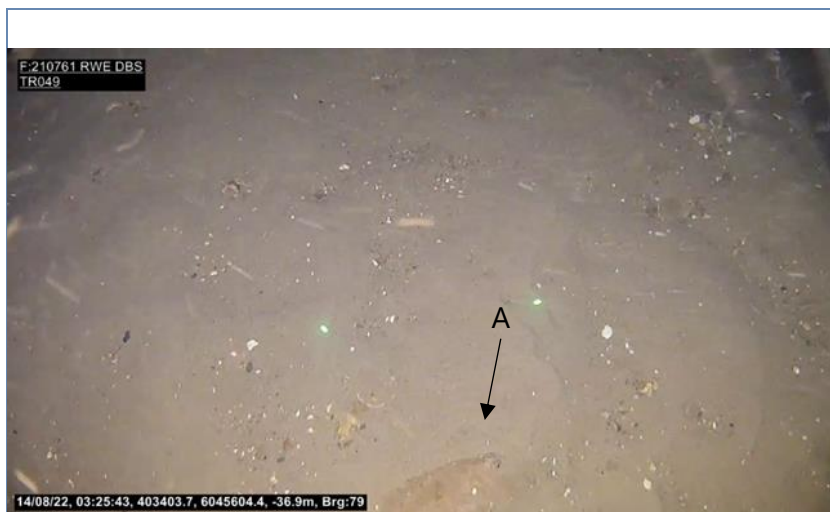
**Photograph:**  
210761\_ST049\_001

**Sediment Type:**  
Muddy sand with shell fragments and varying proportions of coarser sediment (pebbles and sporadic cobbles)

**Fauna:**  
A: Flatfish (Pleuronectiformes)

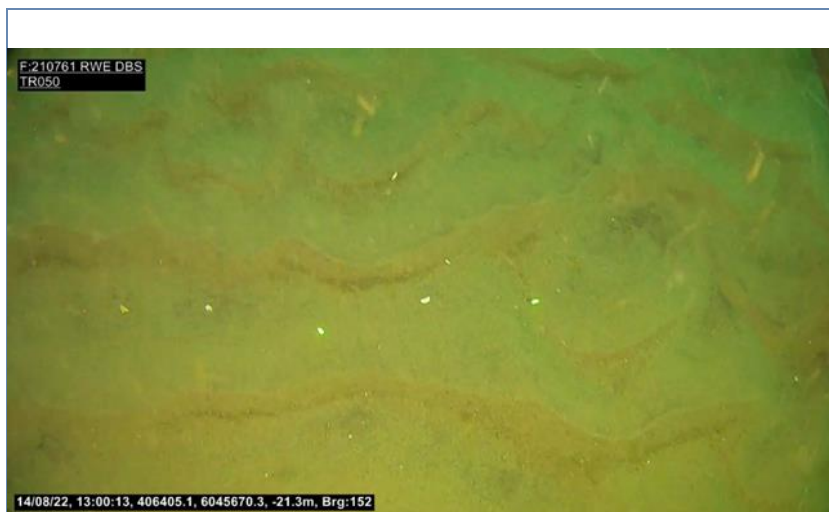
**Photograph:**  
210761\_ST050\_001

**Sediment Type:**  
Rippled sand with shell fragments

**Fauna:**  
No fauna identified

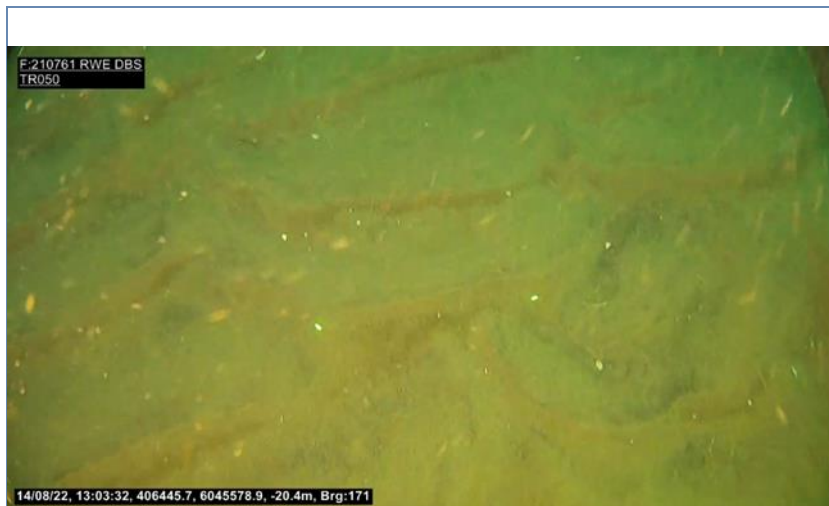
**Photograph:**  
210761\_ST050\_022

**Sediment Type:**  
Rippled sand with shell fragments

**Fauna:**  
No fauna identified

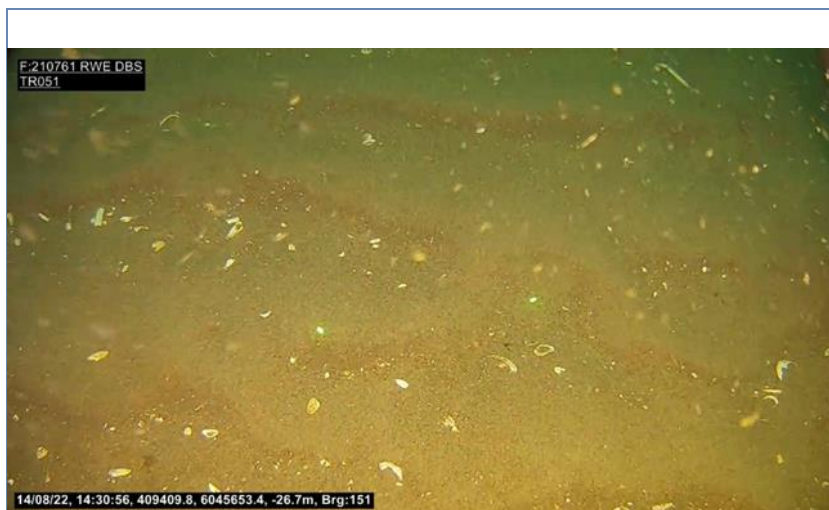
**Photograph:**  
210761\_ST51\_001

**Sediment Type:**  
Rippled sand with shell fragments

**Fauna:**  
No fauna identified

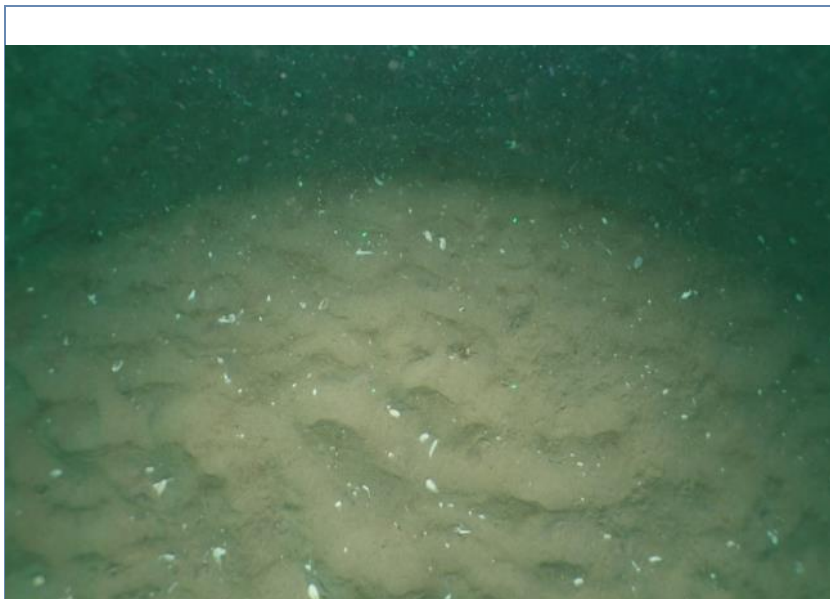
**Photograph:**  
210761\_TR054\_001

**Sediment Type:**  
Rippled sand/muddy sand with shell fragments

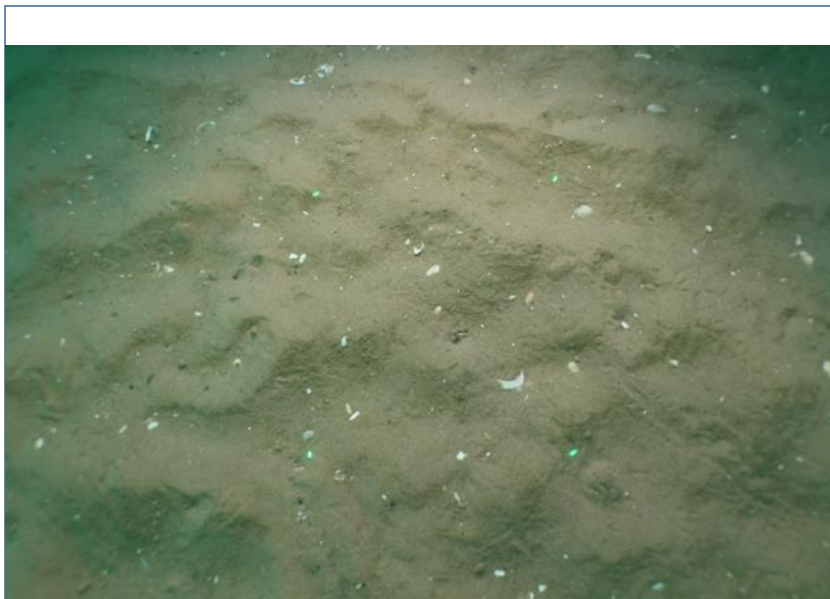
**Photograph:**  
210761\_TR055\_01

**Sediment Type:**  
Rippled sand/muddy sand with shell fragments

**Fauna:**  
Faunal tracks. No fauna identified

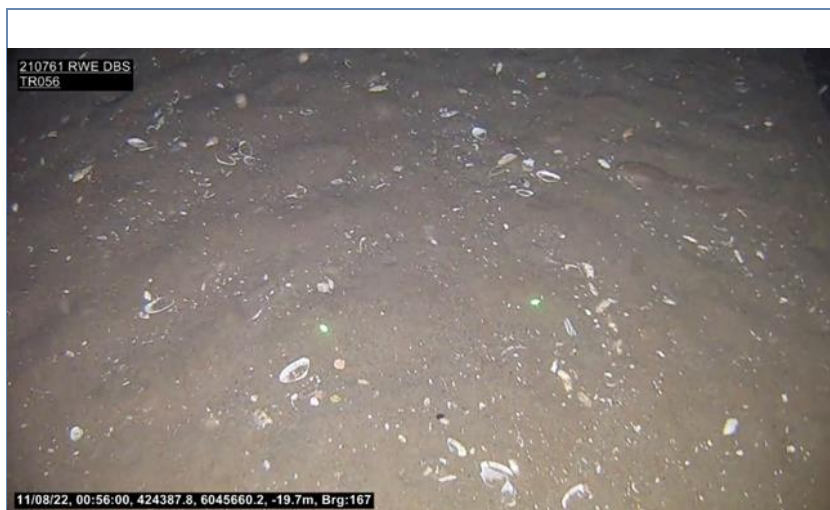
**Photograph:**  
210761\_ST056\_001

**Sediment Type:**  
Rippled sand/muddy sand with shell fragments

**Fauna:**  
No fauna identified

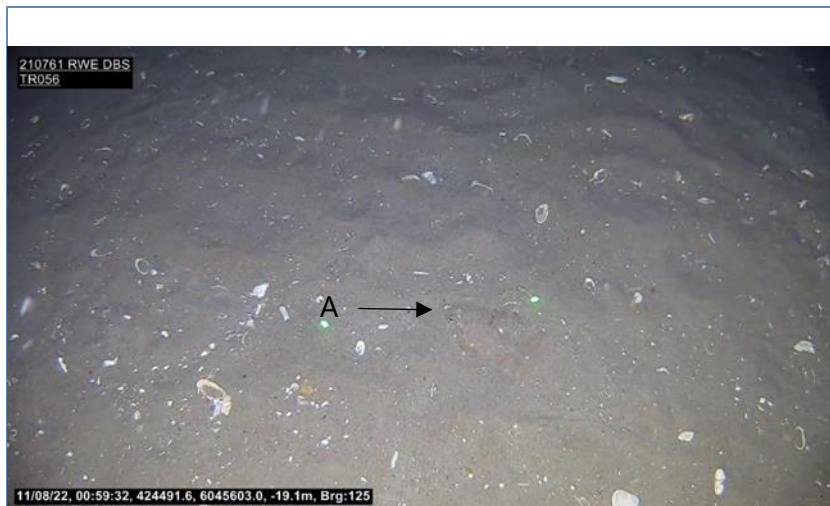
**Photograph:**  
210761\_ST056\_018

**Sediment Type:**  
Rippled sand/muddy sand with shell fragments

**Fauna:**  
A: Flatfish (Pleuronectiformes)

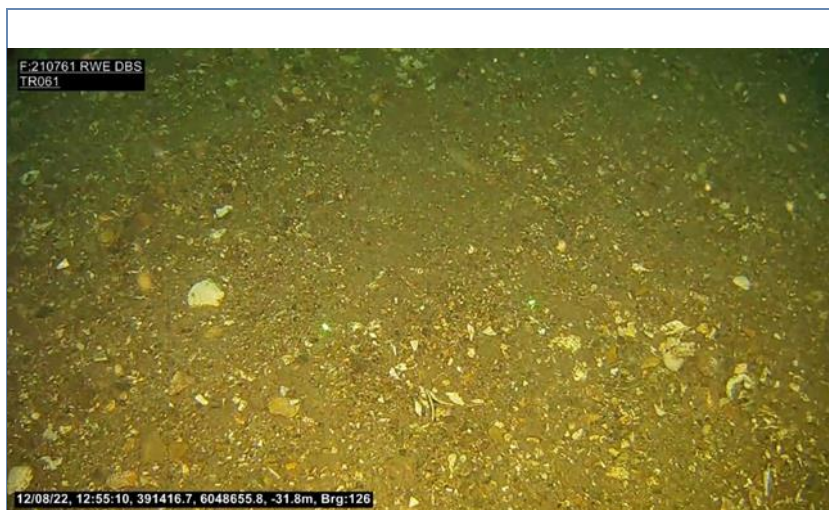
210761\_ST061\_001

- A: Faunal turf (Hydrozoa/bryozoa inc. Flustridae)
- B: Crab (Brachyura)
- C: Soft coral (*Alcyonium digitatum*)
- D: Piddock burrows (Imparidentia)

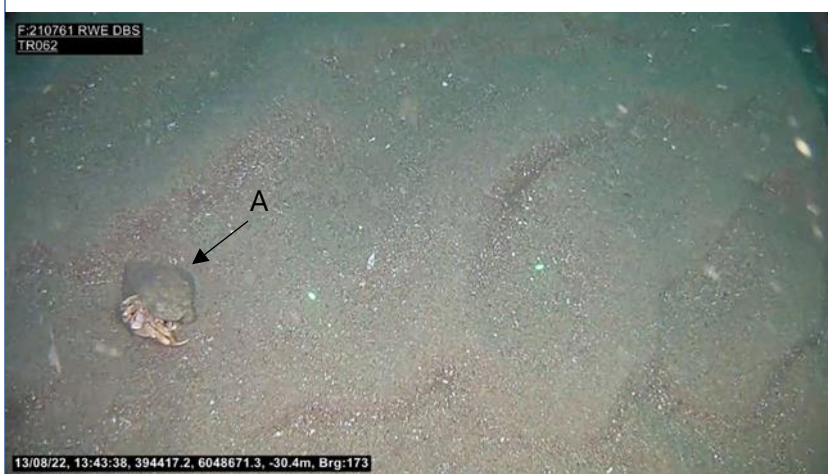
210761\_ST062\_001

A: Hermit crab (Paguridae) with associated hydrozoan (*Hydractinia* sp.)

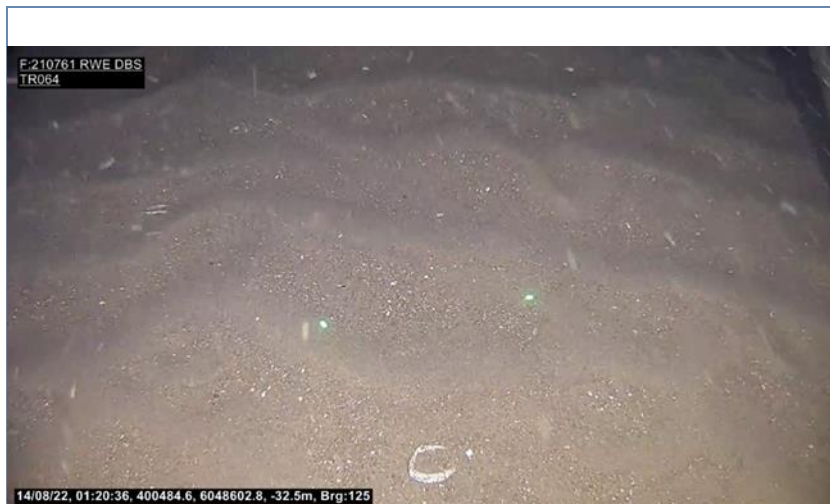
**Photograph:**  
210761\_ST064\_010

**Sediment Type:**  
Rippled sand with shell fragments  
and patches of coarser sediment  
(gravelly sand)

**Fauna:**  
No fauna identified

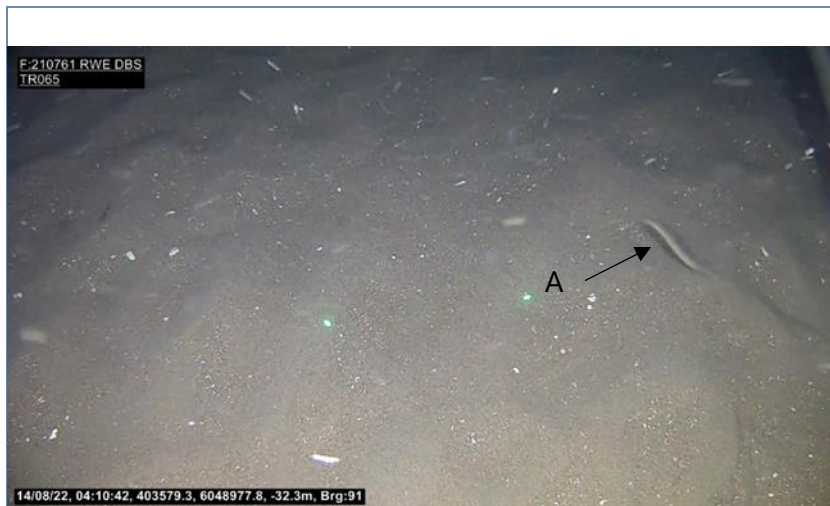
**Photograph:**  
210761\_ST065\_16

**Sediment Type:**  
Rippled sand/muddy sand with shell fragments

**Fauna:**  
A: Sandeel (Ammodytidae)

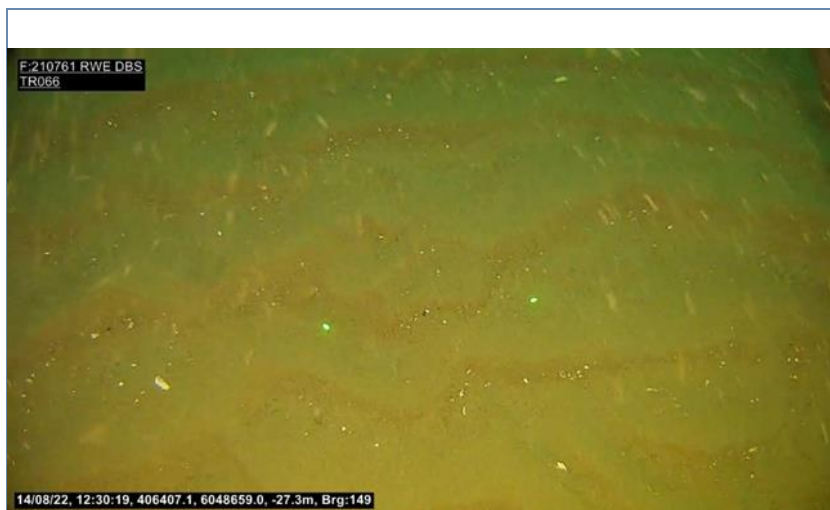
**Photograph:**  
210761\_ST066\_01

**Sediment Type:**  
Rippled sand/muddy sand with shell fragments

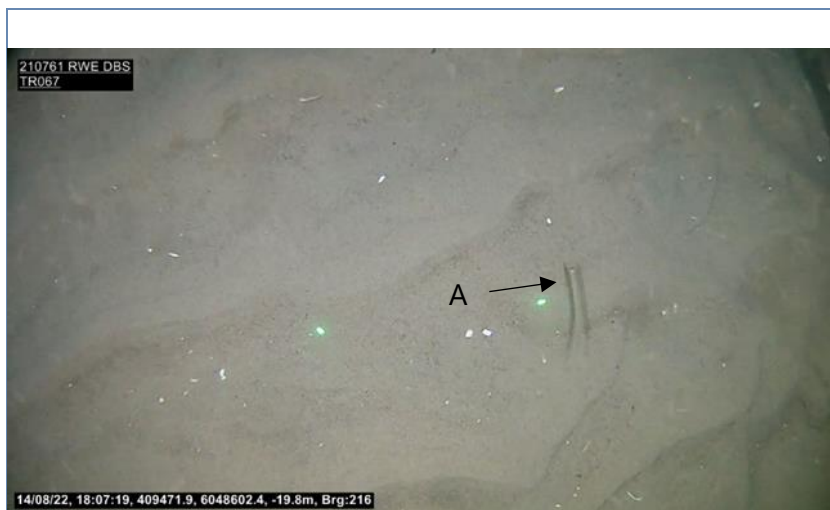
**Photograph:**  
210761\_ST067\_01

**Sediment Type:**  
Rippled sand/muddy sand with shell fragments

**Fauna:**  
A: Sandeel (Ammodytidae)

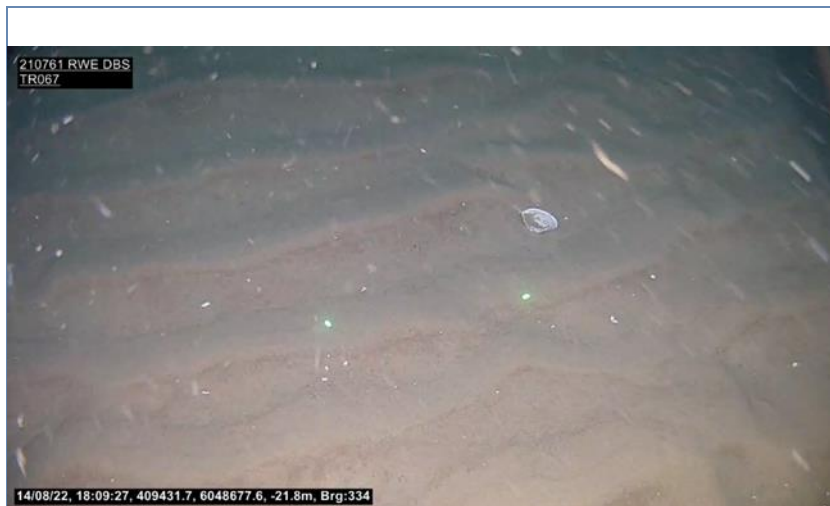
**Photograph:**  
210761\_ST067\_18

**Sediment Type:**  
Rippled sand/muddy sand with shell fragments

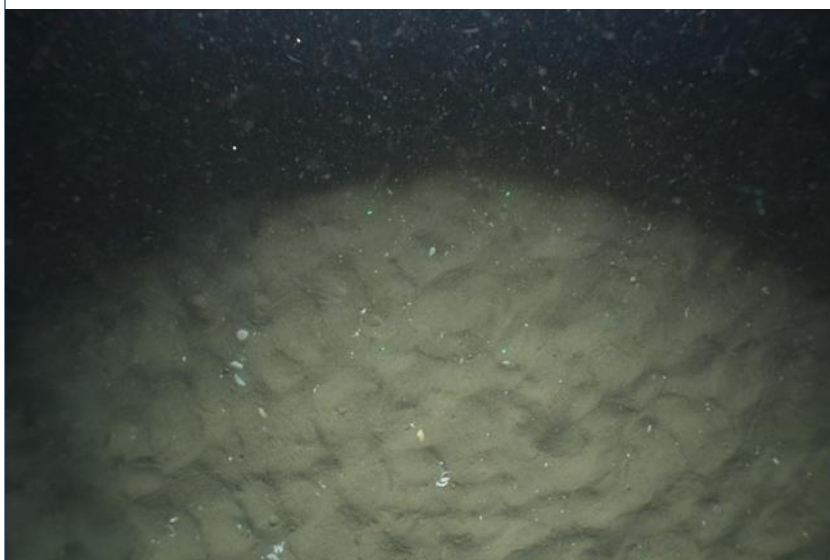
**Photograph:**  
210761\_ST069\_01

**Sediment Type:**  
Rippled sand/muddy sand with shell fragments

**Fauna:**  
No fauna identified

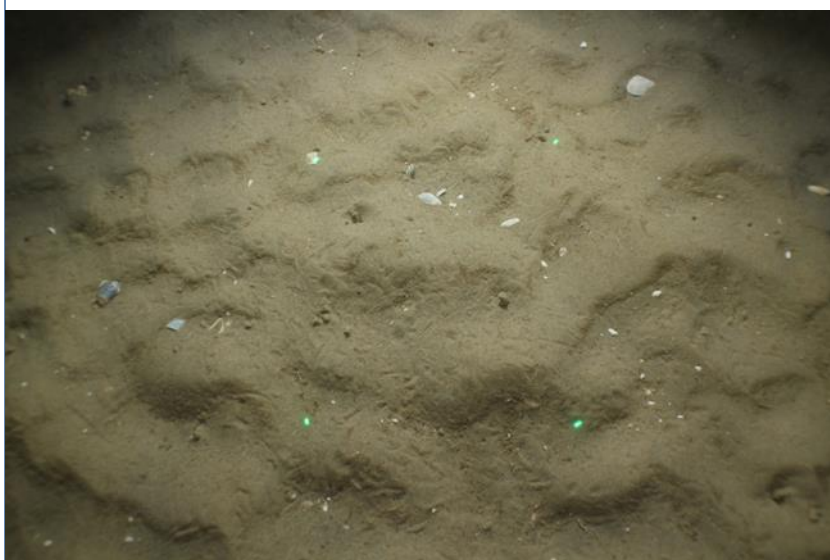
**Photograph:**  
210761\_ST069\_04

**Sediment Type:**  
Rippled sand/muddy sand with shell fragments

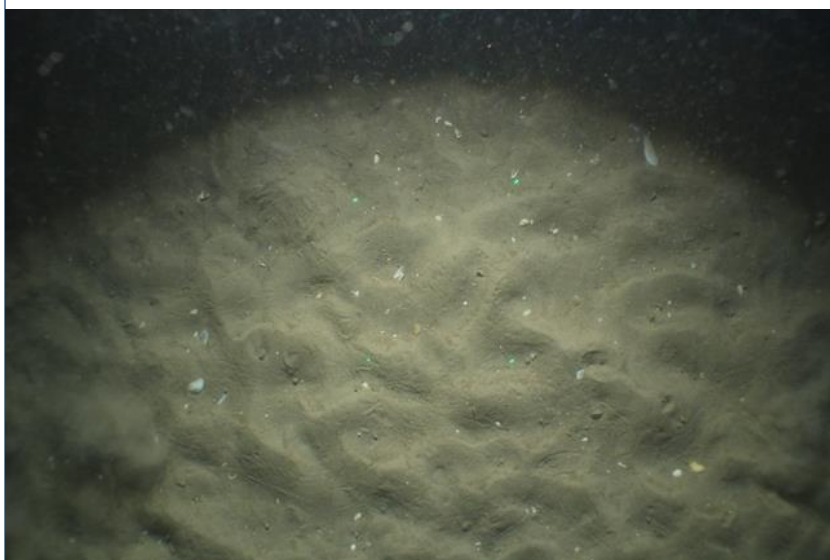
**Photograph:**  
210761\_ST069A\_01

**Sediment Type:**  
Rippled muddy sand with shell fragments

**Fauna:**  
No fauna identified

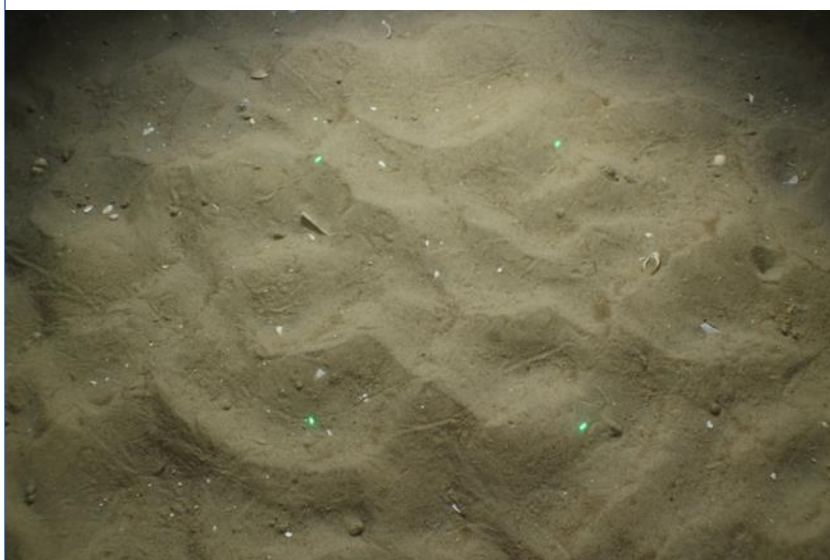
**Photograph:**  
210761\_ST069A\_11

**Sediment Type:**  
Rippled muddy sand with shell fragments

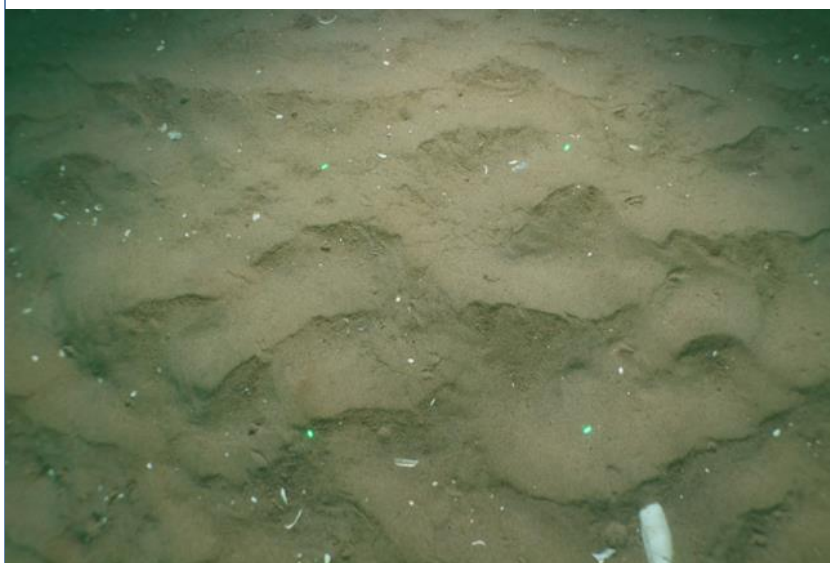
**Photograph:**  
210761\_ST070\_01

**Sediment Type:**  
Rippled sand/muddy sand with shell fragments pebbles

**Fauna:**  
No fauna identified

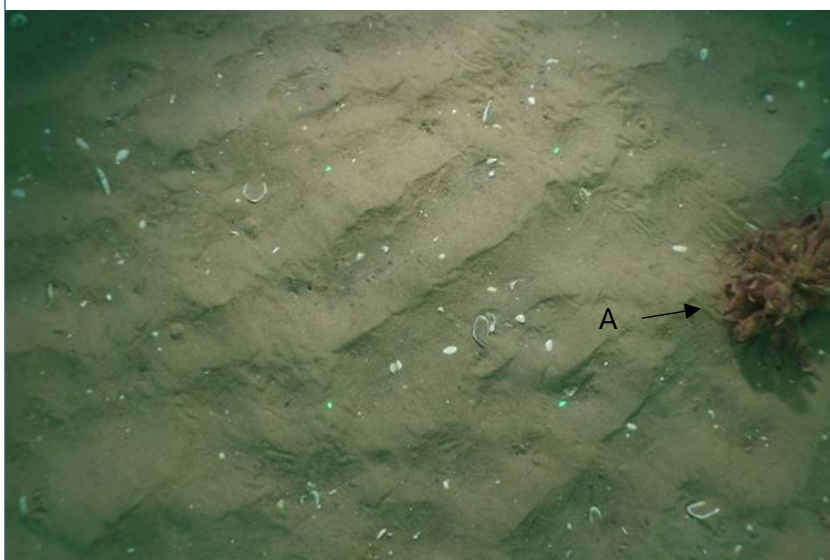
**Photograph:**  
210761\_ST070\_11

**Sediment Type:**  
Rippled sand/muddy sand with shell fragments pebbles

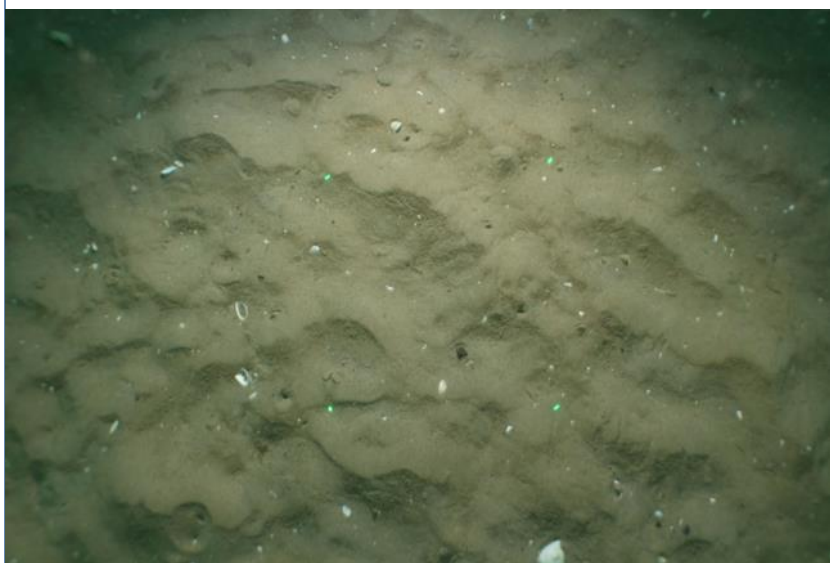
**Photograph:**  
210761\_ST071\_01

**Sediment Type:**  
Rippled sand/muddy sand with shell fragments and pebbles

**Fauna:**  
Faunal burrows. No fauna identified

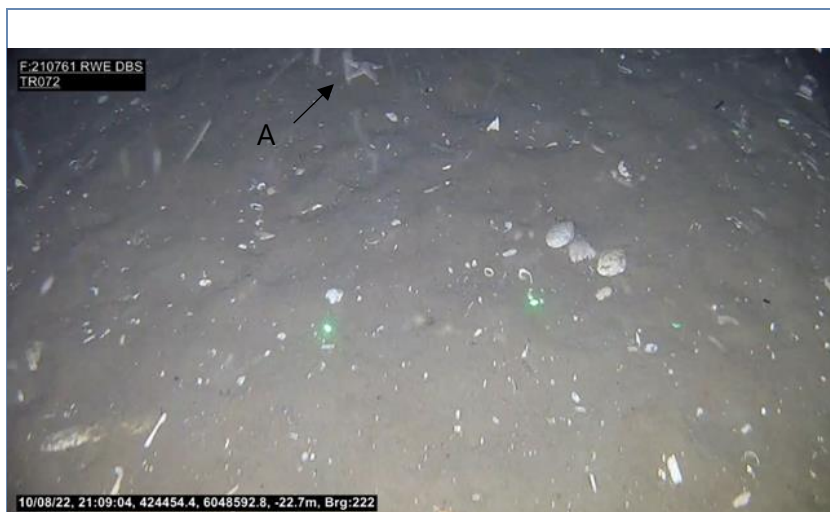
**Photograph:**  
210761\_ST072\_01

**Sediment Type:**  
Rippled sand/muddy sand with shell fragments and pebbles

**Fauna:**  
A: Starfish (*Astropecten irregularis*)

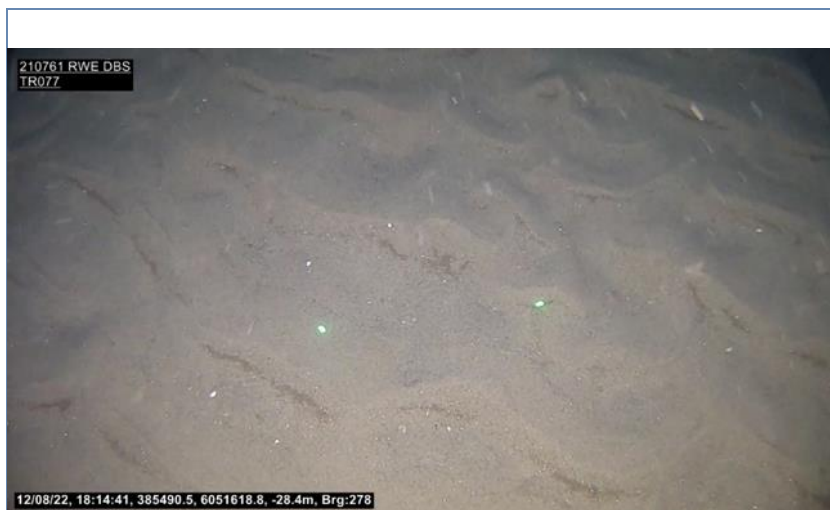
**Photograph:**  
210761\_ST077\_03

**Sediment Type:**  
Rippled sand/muddy sand with shell fragments

**Fauna:**  
No fauna identified

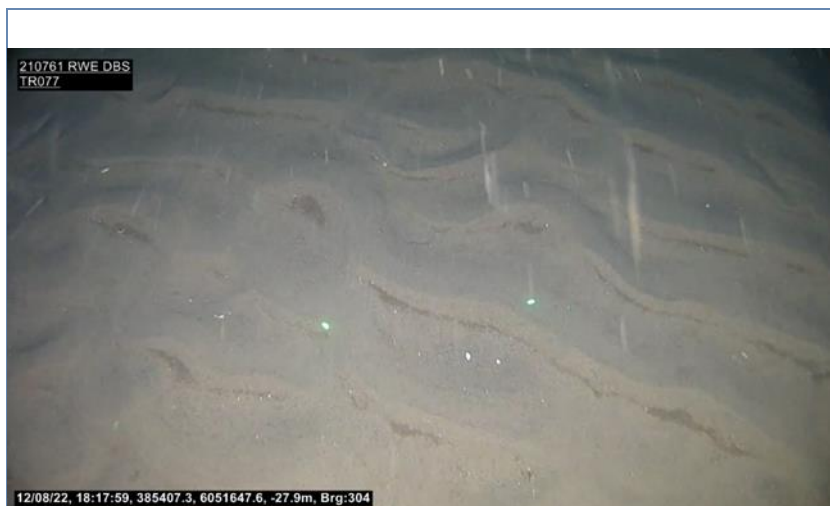
**Photograph:**  
210761\_ST077\_21

**Sediment Type:**  
Rippled sand/muddy sand with shell fragments

**Fauna:**  
No fauna identified.

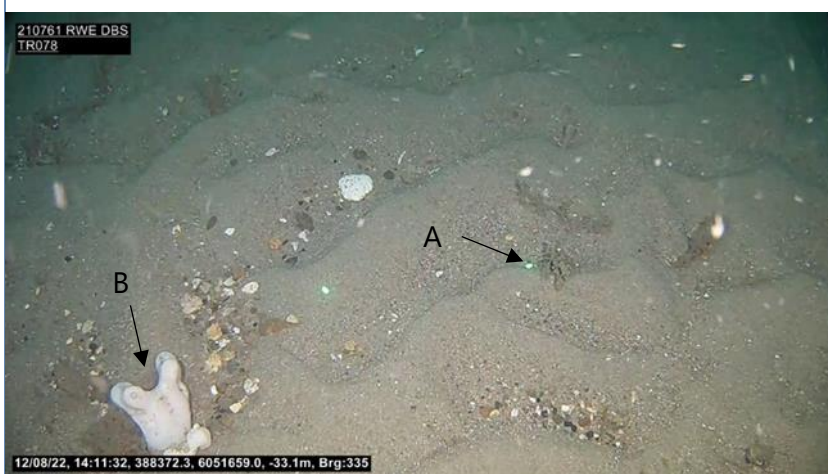
**Photograph:**  
210761\_ST078\_01

A: Faunal turf (Hydrozoa/Bryozoa)

B: Soft coral (*Alcyonium digitatum*)

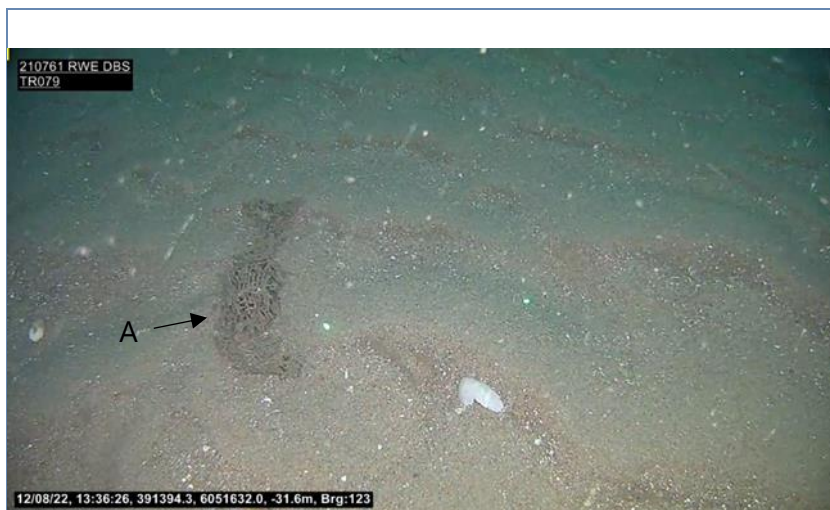
**Photograph:**  
210761\_ST079\_01

**Sediment Type:**  
Rippled sand/muddy sand with shell fragments

**Fauna:**  
A: Anthropogenic debris

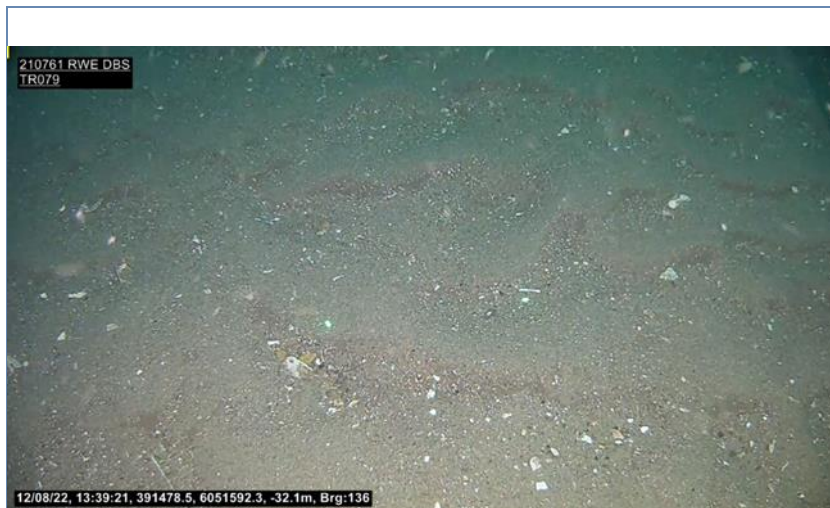
**Photograph:**  
210761\_ST079\_13

**Sediment Type:**  
Rippled sand/muddy sand with shell fragments

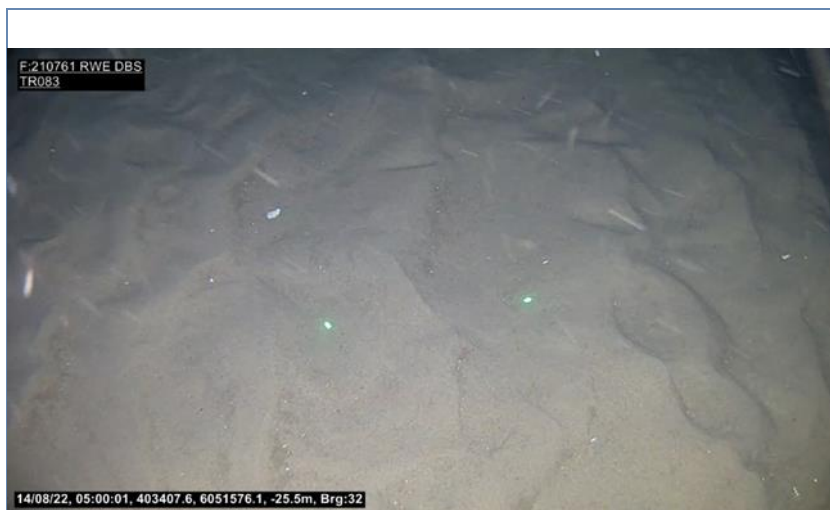
**Photograph:**  
210761\_ST083\_01

**Sediment Type:**  
Rippled sand/muddy sand with shell fragments

**Fauna:**  
No fauna identified

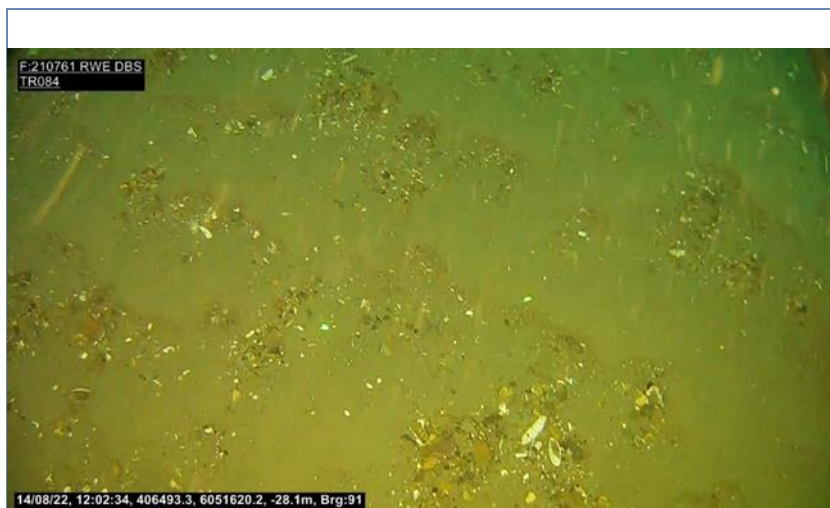
**Photograph:**  
210761\_ST084\_17

**Sediment Type:**  
Rippled slightly gravelly (?muddy)  
sand with shell fragments and  
pebbles

**Fauna:**  
No fauna identified

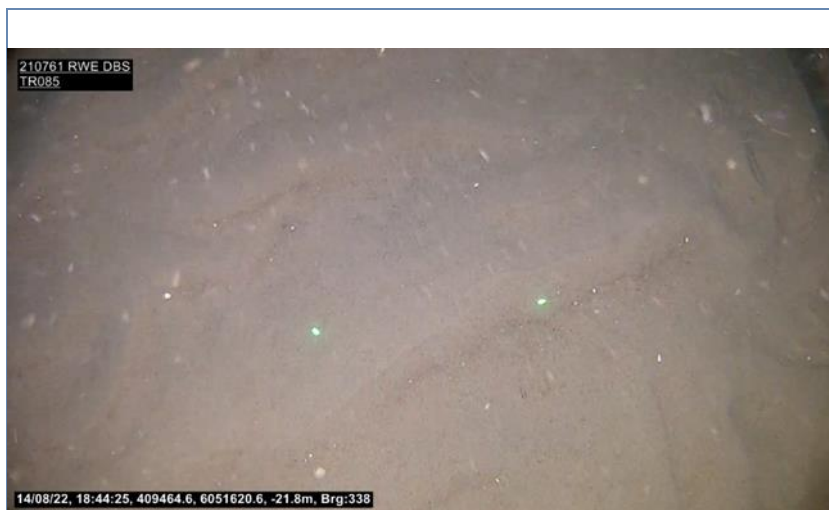
**Photograph:**  
210761\_ST085\_03

**Sediment Type:**  
Rippled sand/muddy sand with shell fragments

**Fauna:**  
No fauna identified

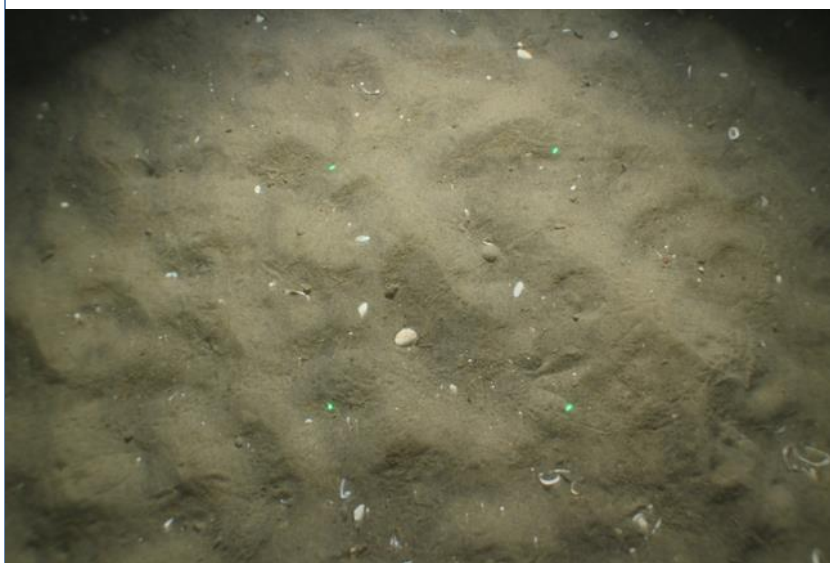
**Photograph:**  
210761\_ST087\_01

**Sediment Type:**  
Rippled sand/muddy sand with shell fragments

**Fauna:**  
Faunal tracks. No fauna identified

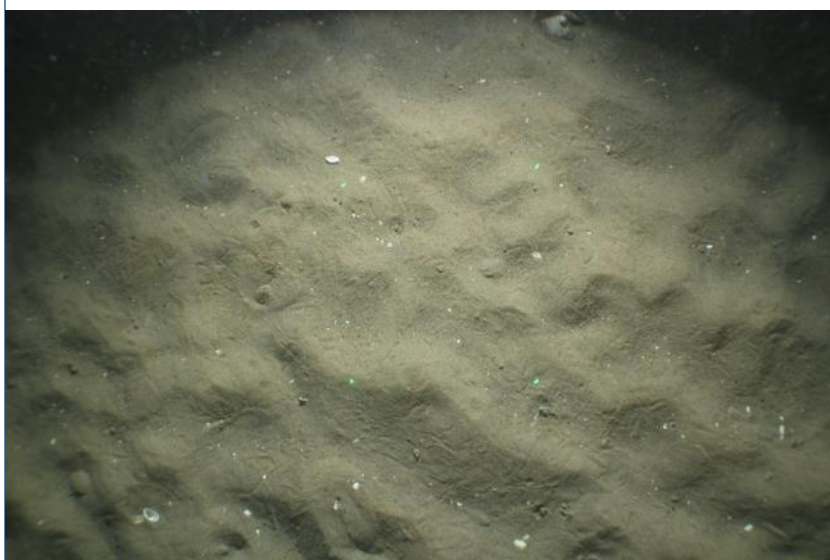
**Photograph:**  
210761\_ST087\_13

**Sediment Type:**  
Rippled sand/muddy sand with shell fragments

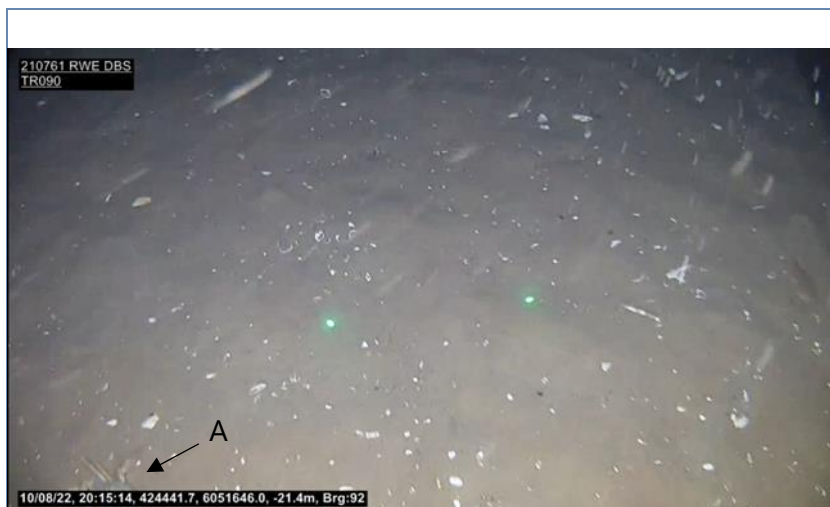
**Photograph:**  
210761\_ST090\_03

**Sediment Type:**  
Rippled sand/muddy sand with a  
varying proportion of shell fragments

**Fauna:**  
A: Crab (Brachyura)
