# **Dogger Bank South Offshore Wind Farms**

**Preliminary Environmental Information Report  
Appendix 9-3 Environmental Features Report**

# **DBS WPM1 WPM2 WPM3 – Environmental Features Report**

Dogger Bank South Site Investigation | Southern North Sea  
Survey Period: 6 to 19 August 2022

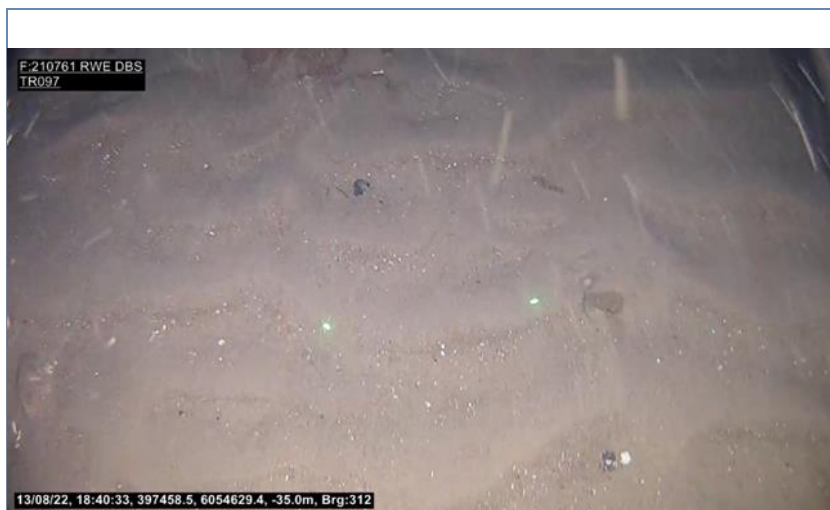
**Photograph:**  
210761\_ST097\_02

**Sediment Type:**  
Rippled sand/gravelly sand with a varying proportion of shell fragments, pebbles and infrequent cobbles

**Fauna:**  
No fauna identified

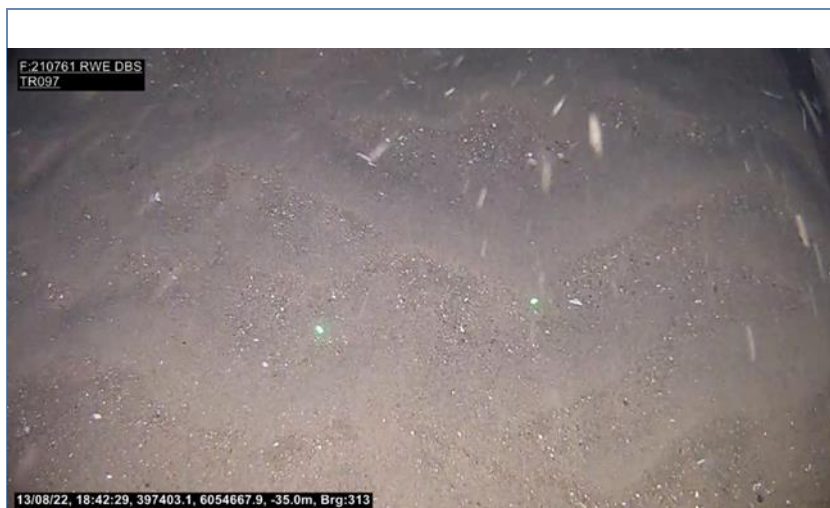
**Photograph:**  
210761\_ST097\_16

**Sediment Type:**  
Coarse sediment (Gravelly sand/sandy gravel with shell fragments and pebbles)

**Fauna:**  
No fauna identified

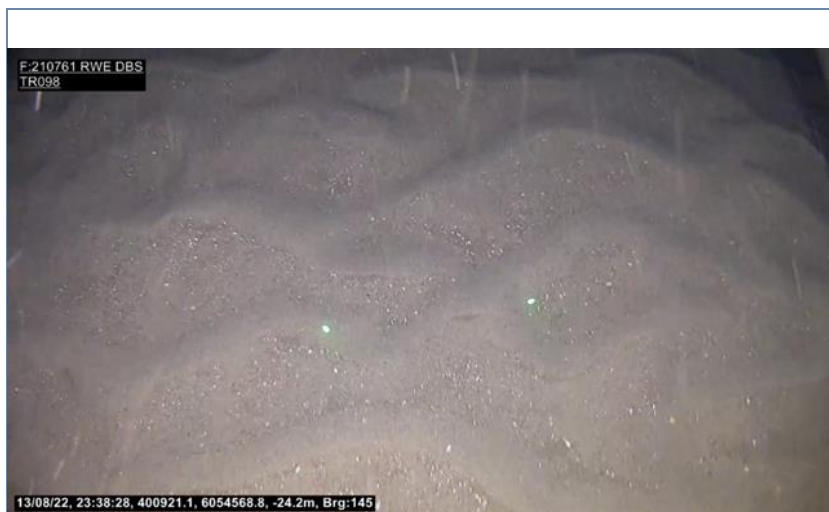
**Photograph:**  
210761\_ST098\_01

**Sediment Type:**  
Rippled sand/sandy mud with shell fragments

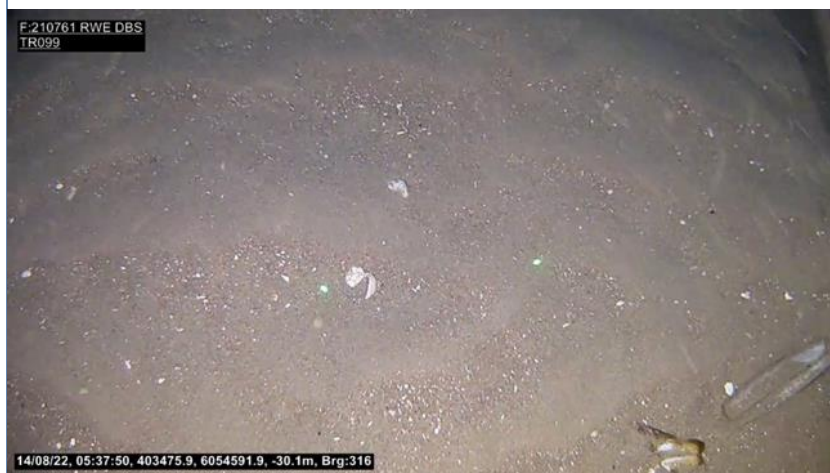
**Photograph:**  
210761\_ST099\_02

**Sediment Type:**  
Rippled sand/muddy sand with a varying proportion of shell fragments and pebbles

**Fauna:**  
No fauna identified

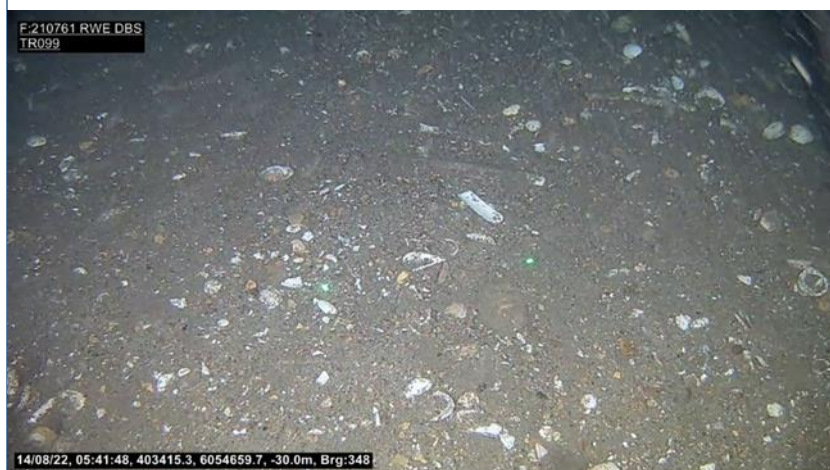
**Photograph:**  
210761\_ST099\_12

**Sediment Type:**  
Rippled sand/muddy sand with a varying proportion of shell fragments and pebbles

**Fauna:**  
No fauna identified

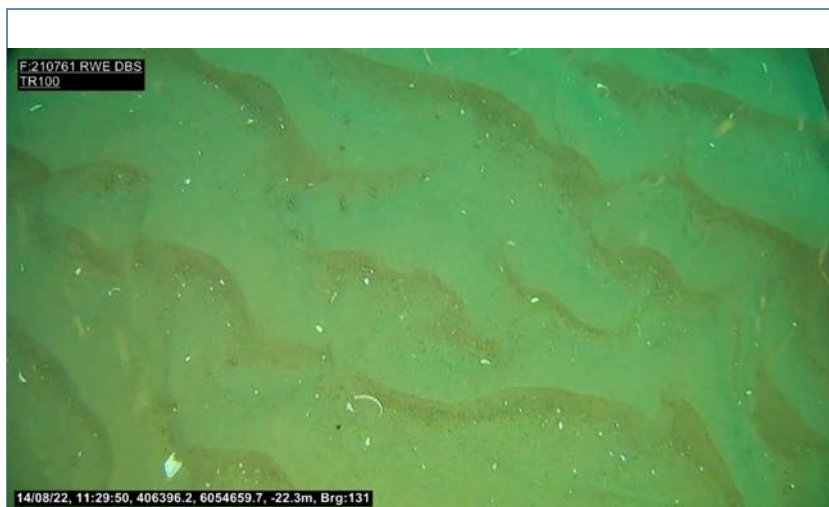
**Photograph:**  
210761\_ST100\_01

**Sediment Type:**  
Rippled sand/sandy mud with shell fragments

**Fauna:**  
No fauna identified

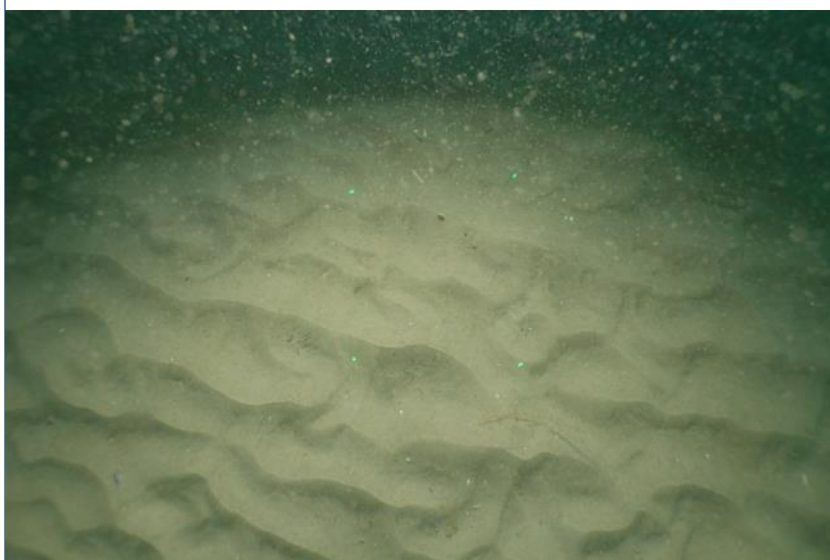
**Photograph:**  
210761\_ST101\_18

**Sediment Type:**  
Rippled sand/muddy sand with shell fragments

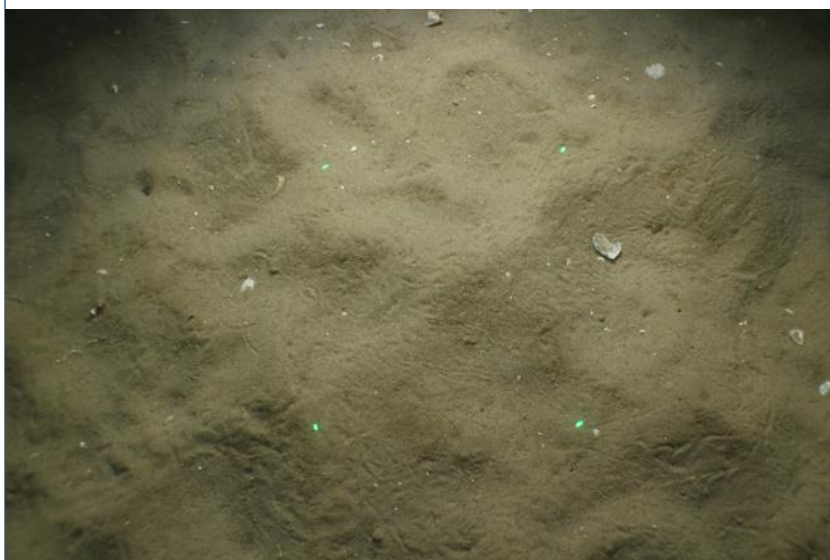
**Photograph:**  
210761\_ST103\_01

**Sediment Type:**  
Rippled muddy sand/sandy mud with shell fragments

**Fauna:**  
Faunal tracks and burrows. No fauna identified

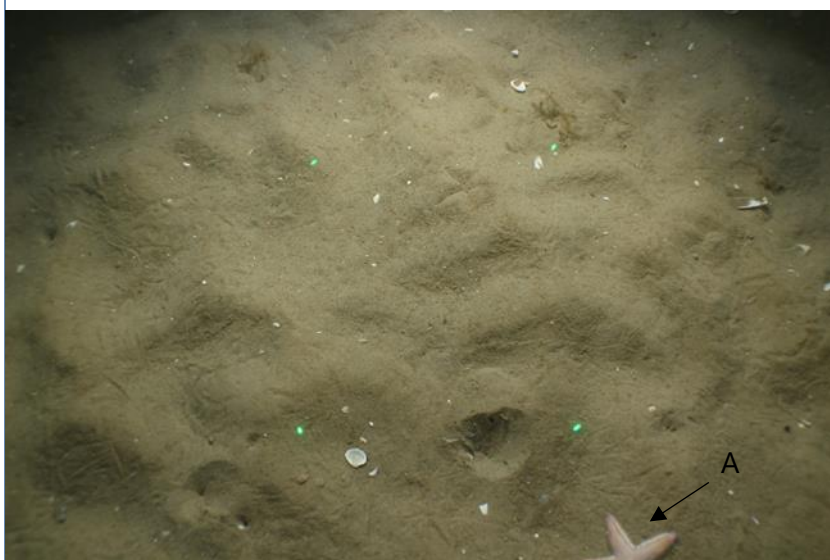
**Photograph:**  
210761\_ST103\_10

**Sediment Type:**  
Rippled muddy sand/sandy mud with shell fragments

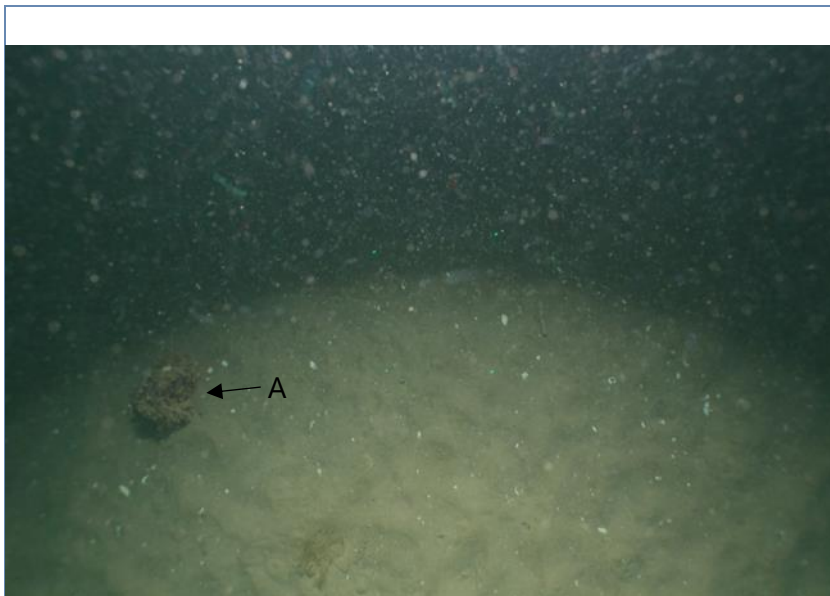
**Photograph:**  
210761\_ST104\_01

**Sediment Type:**  
Rippled muddy sand/sandy mud with shell fragments

**Fauna:**  
A: Faunal turf (Hydrozoa/Bryozoa inc. Flustridae)

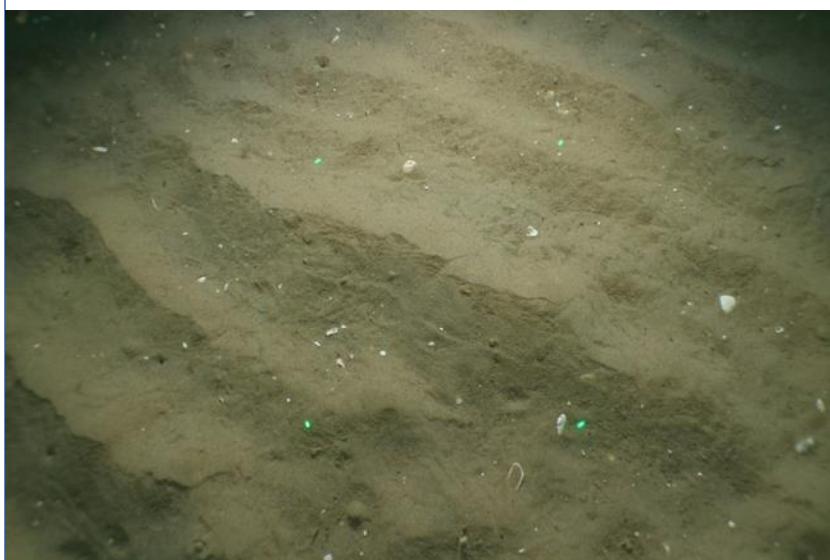
**Photograph:**  
210761\_ST104\_10

**Sediment Type:**  
Rippled muddy sand/sandy mud with shell fragments

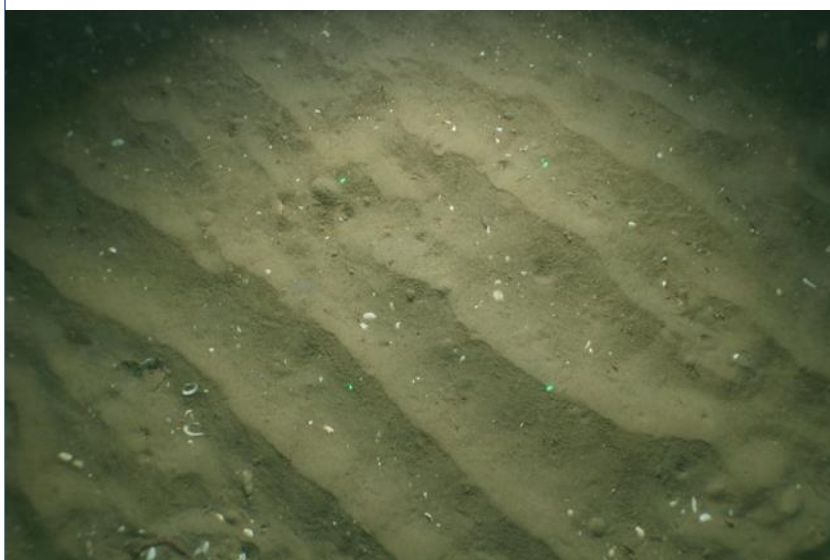
**Photograph:**  
210761\_ST105\_11

**Sediment Type:**  
Rippled muddy sand/sandy mud with shell fragments

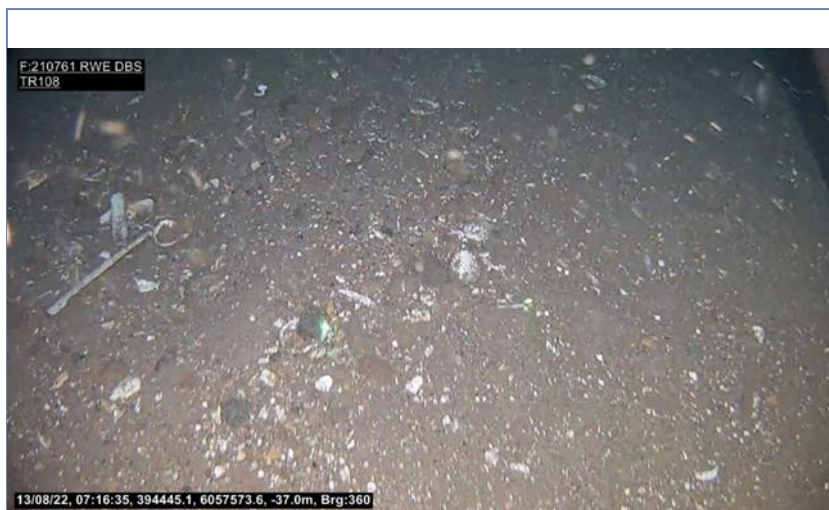
**Photograph:**  
210761\_ST108\_01

**Sediment Type:**  
Rippled sand/muddy sand with a varying proportion of shell fragments and pebbles

**Fauna:**  
No fauna identified

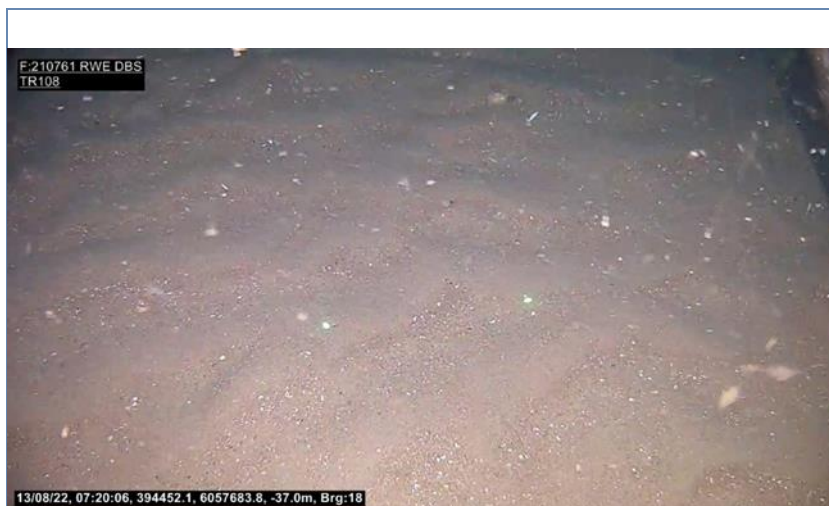
**Photograph:**  
210761\_ST108\_14

**Sediment Type:**  
Rippled sand/muddy sand with a varying proportion of shell fragments and pebbles

**Fauna:**  
No fauna identified

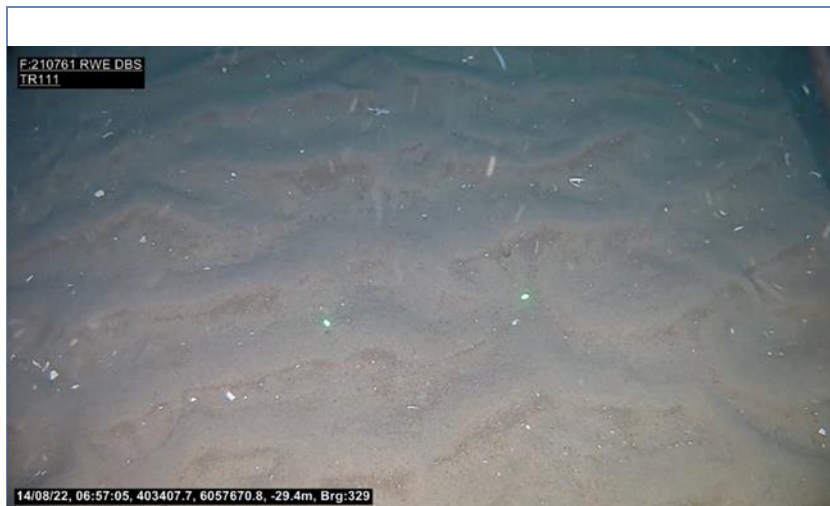
**Photograph:**  
210761\_ST111\_10

**Sediment Type:**  
Rippled sand/muddy sand with shell fragments

**Fauna:**  
No fauna identified

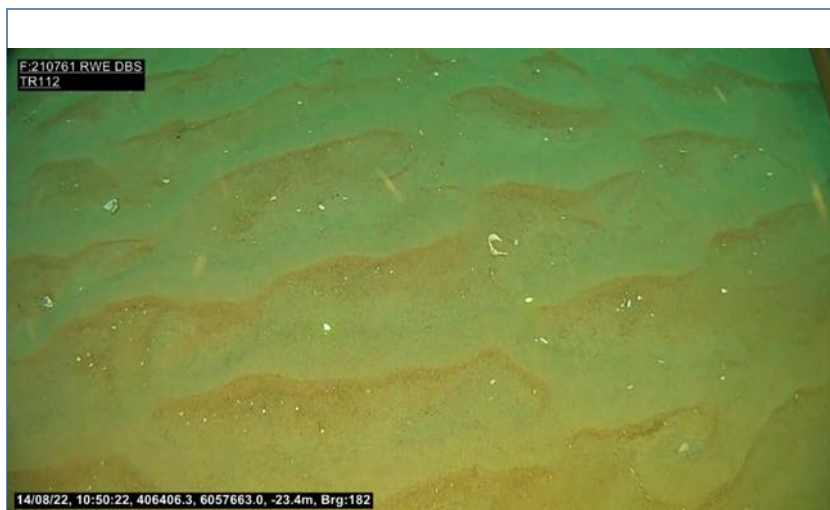
**Photograph:**  
210761\_ST112\_01

**Sediment Type:**  
Rippled sand/muddy sand with shell fragments

**Fauna:**  
No fauna identified

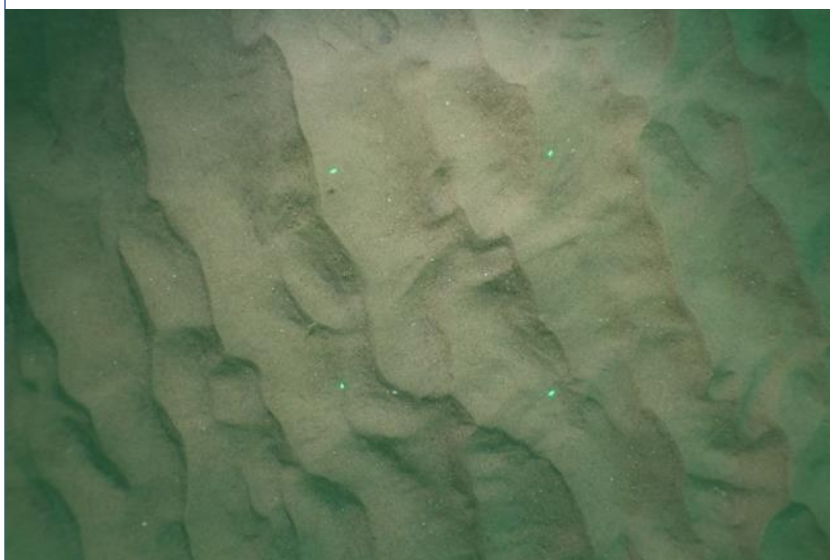
**Photograph:**  
210761\_ST113\_01

**Sediment Type:**  
Rippled sand/muddy sand with shell fragments

**Fauna:**  
No fauna identified

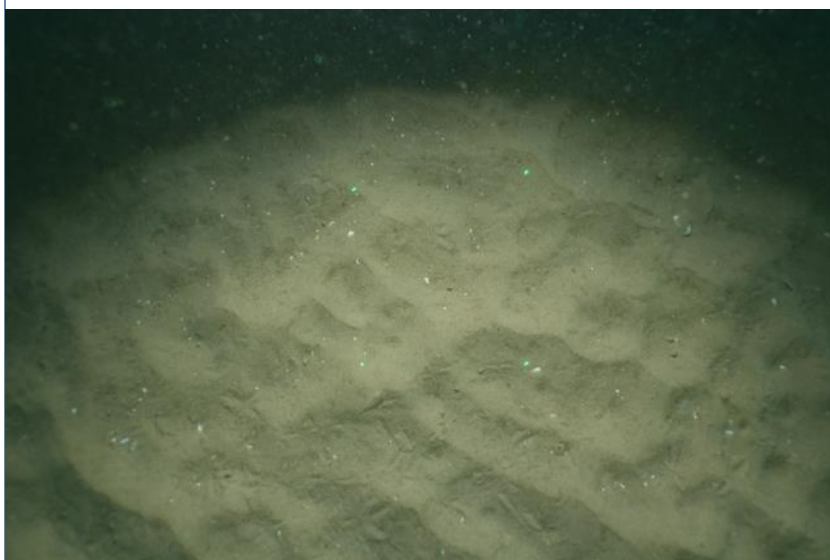
**Photograph:**  
210761\_ST115\_01

**Sediment Type:**  
Rippled muddy sand/sandy mud with  
shell fragments

**Fauna:**  
No fauna identified

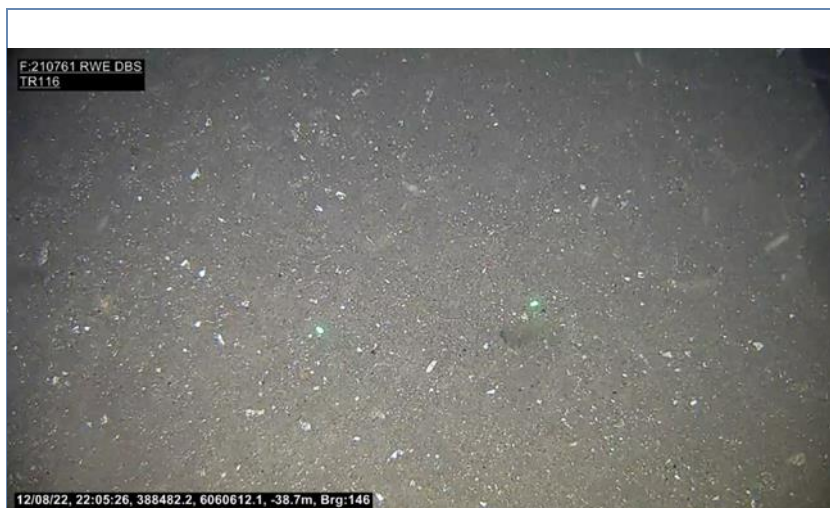
**Photograph:**  
210761\_ST116\_17

**Sediment Type:**  
Rippled sand/muddy sand with a varying proportion of shell fragments and pebbles

**Fauna:**  
No fauna identified

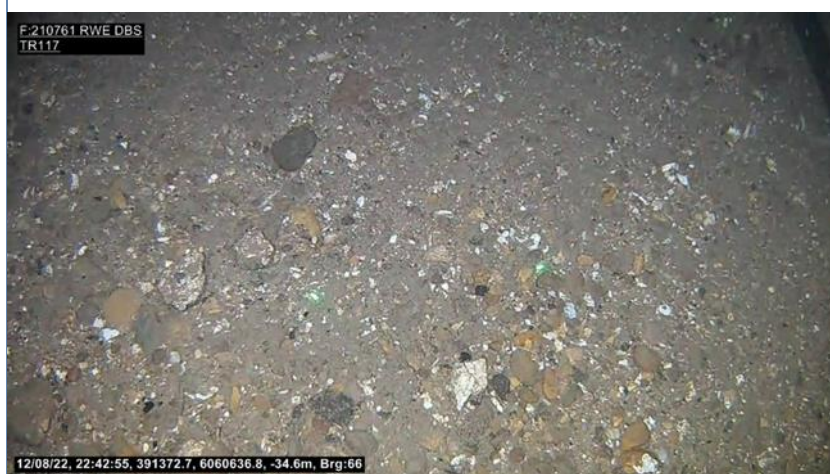
**Photograph:**  
210761\_ST117\_02

**Sediment Type:**  
?Muddy sandy gravel inc. shell fragments, pebbles and cobbles

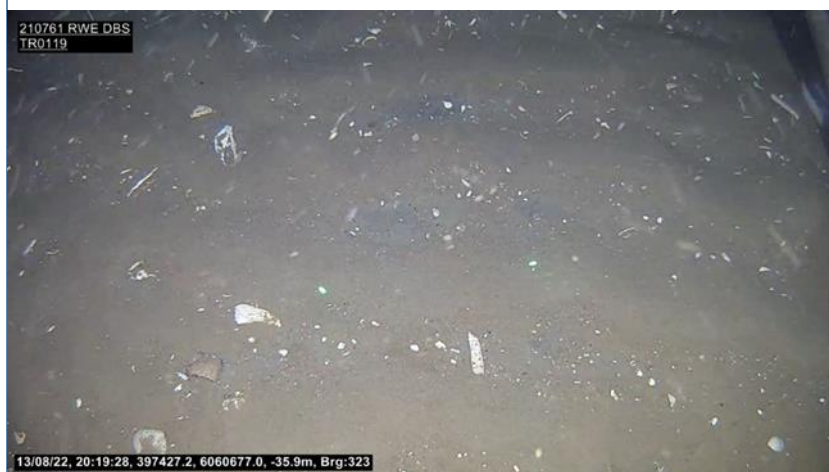
**Photograph:**  
210761\_ST119\_13

**Sediment Type:**  
Rippled sand/muddy sand with shell fragments

**Fauna:**  
No fauna identified

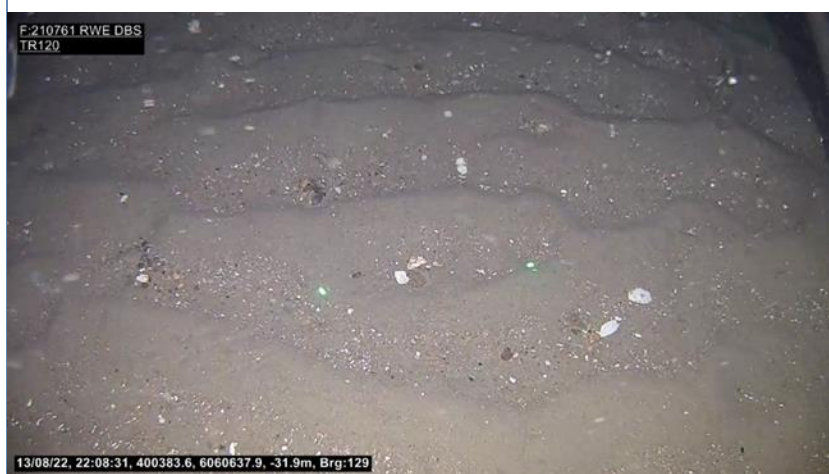
**Photograph:**  
210761\_ST120\_02

No fauna identified

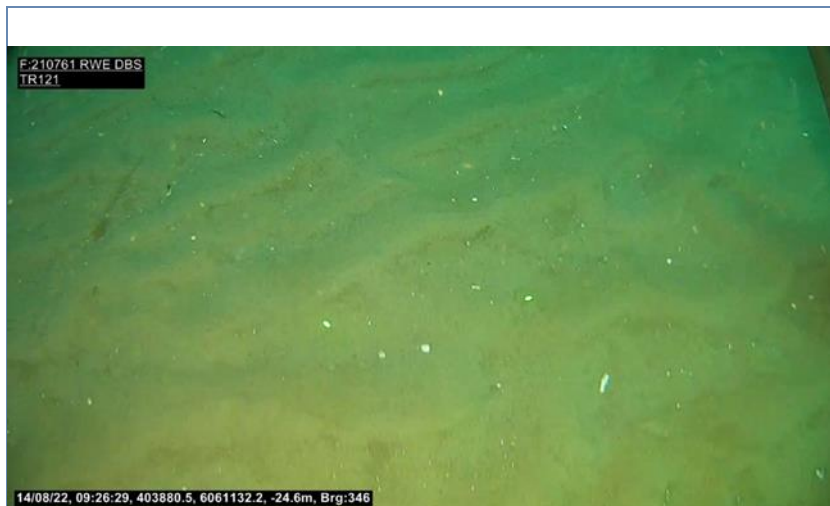
**Photograph:**  
210761\_ST121\_06

**Sediment Type:**  
Rippled sand/muddy sand with shell fragments

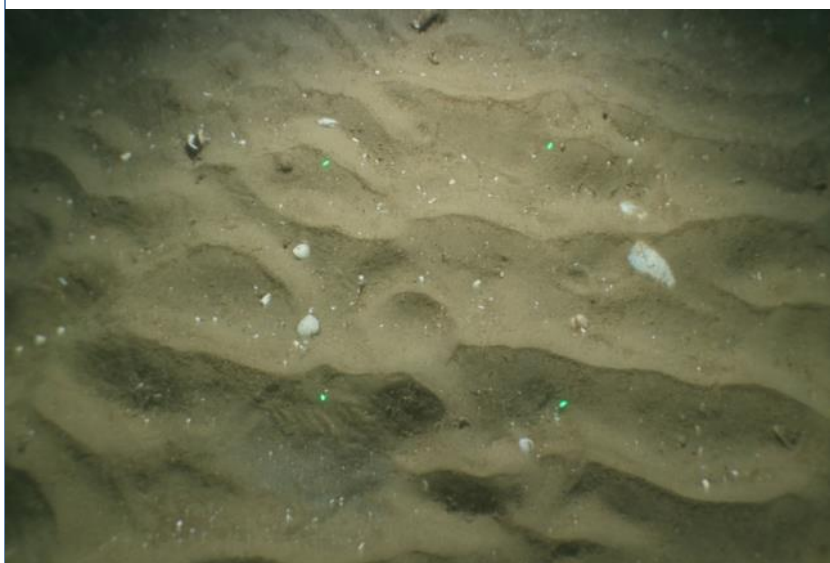
**Photograph:**  
210761\_ST123\_01

**Sediment Type:**  
Rippled sand/muddy sand with shell fragments

**Fauna:**  
No fauna identified

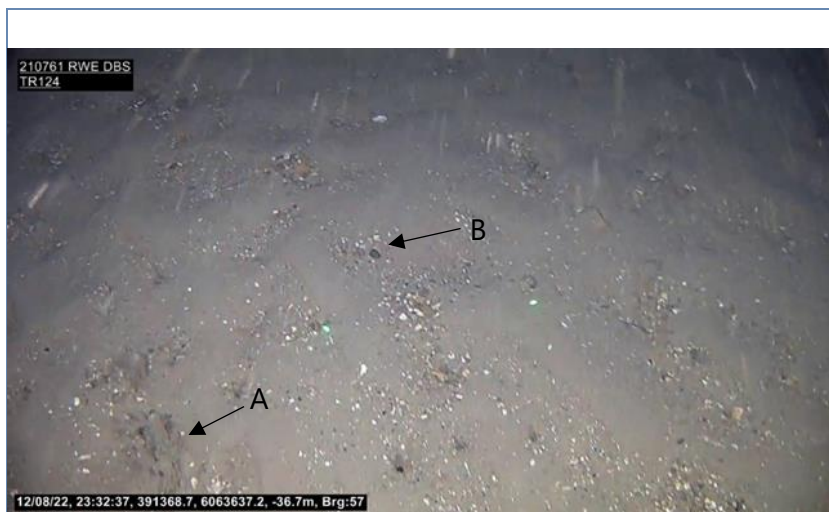
210761\_ST124\_001

A: Faunal turf (Hydrozoa/Bryozoa)

B: Piddock burrows (Imparidentia)

Clay exposures, potentially representing the UK BAP listed habitat, were observed from the seabed photographic data at six stations (stations ST001, ST003, ST048, ST061, ST124 and ST181). No peat was observed from the seabed photographic data or samples.

Consolidated mud was observed at six stations (stations ST001, ST003, ST048, ST061, ST124 and ST181). Round holes characteristic of piddock burrows were observed patchily in these sediments, and therefore the UK BAP listed priority habitat ‘Peat and clay exposures with piddocks’ is potentially present at these stations.

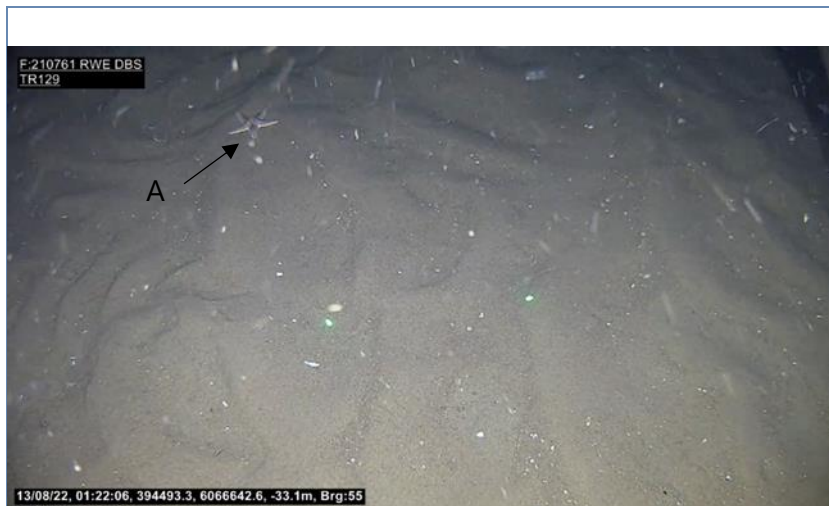
**Photograph:**  
210761\_ST129\_13

**Sediment Type:**  
Rippled sand/muddy sand with shell fragments

**Fauna:**  
A: Starfish (*Astropecten irregularis*)

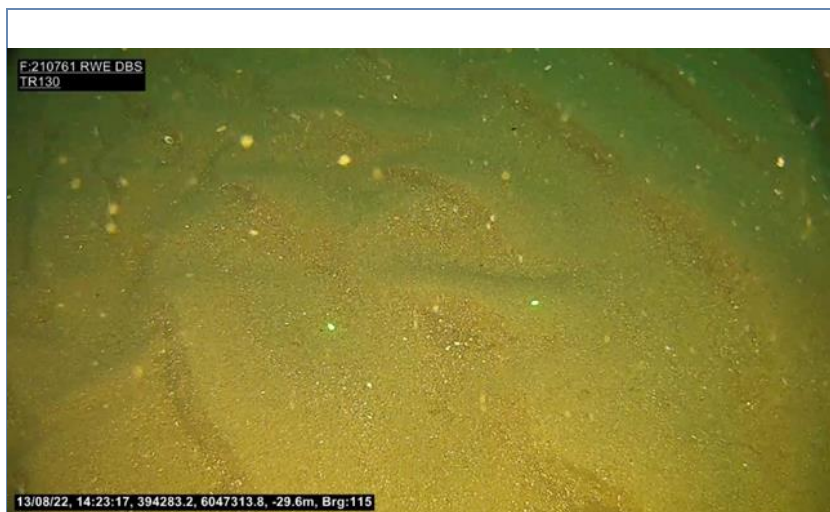
**Photograph:**  
210761\_ST130\_01

**Sediment Type:**  
Rippled sand with shell fragments

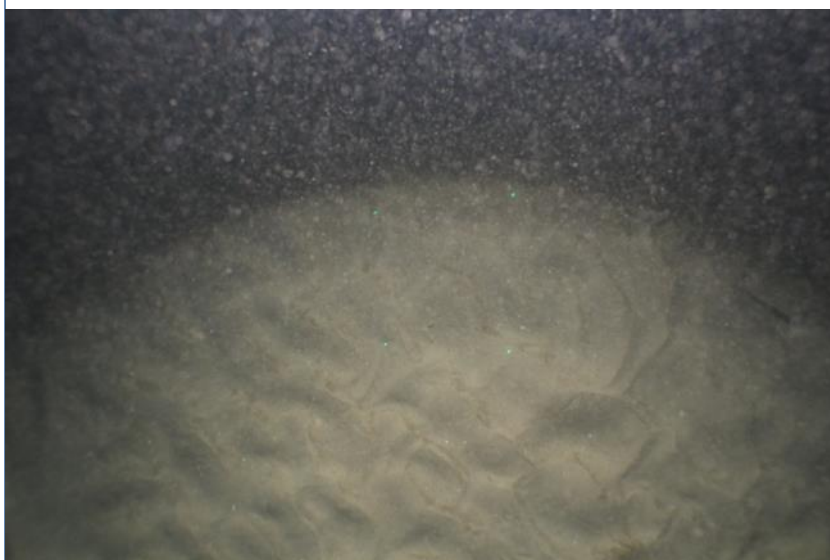
**Photograph:**  
210761\_ST132A\_01

**Sediment Type:**  
Rippled sand/muddy sand with shell fragments

**Fauna:**  
No fauna identified

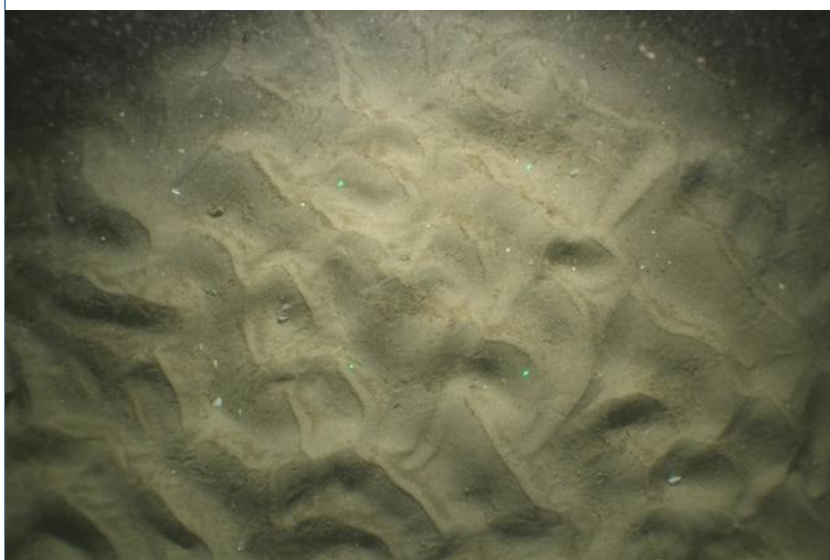
**Photograph:**  
210761\_ST132A\_04

**Sediment Type:**  
Rippled sand/muddy sand with shell fragments

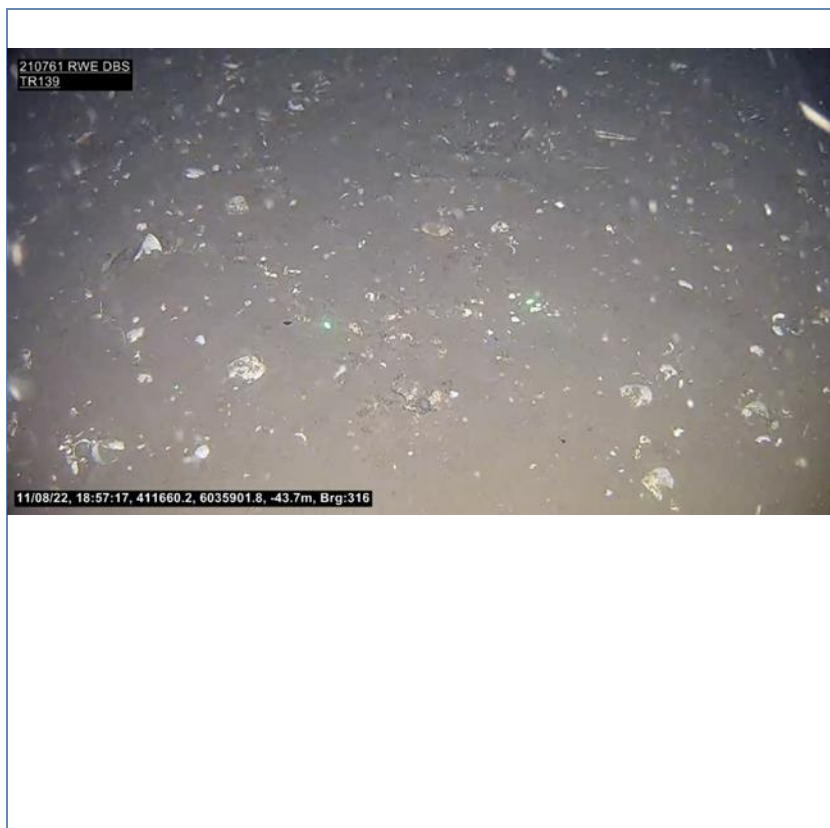
**Photograph:**  
210761\_ST139\_01

**Sediment Type:**  
Muddy sand with shell fragments and pebbles

**Fauna:**  
No fauna identified

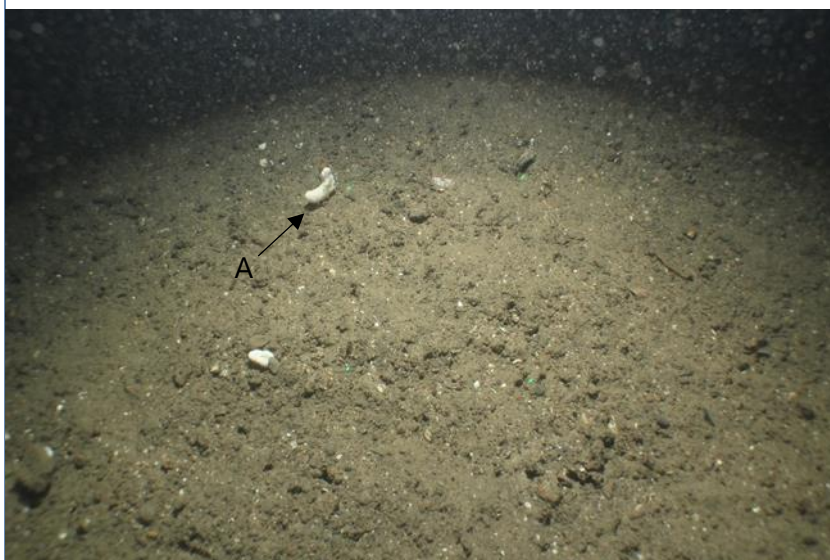
**Photograph:**  
210761\_ST161\_01

**Sediment Type:**  
Muddy ?sandy gravel inc. shell  
fragments and pebbles

**Fauna:**  
A: Soft coral (*Alcyonium digitatum*)

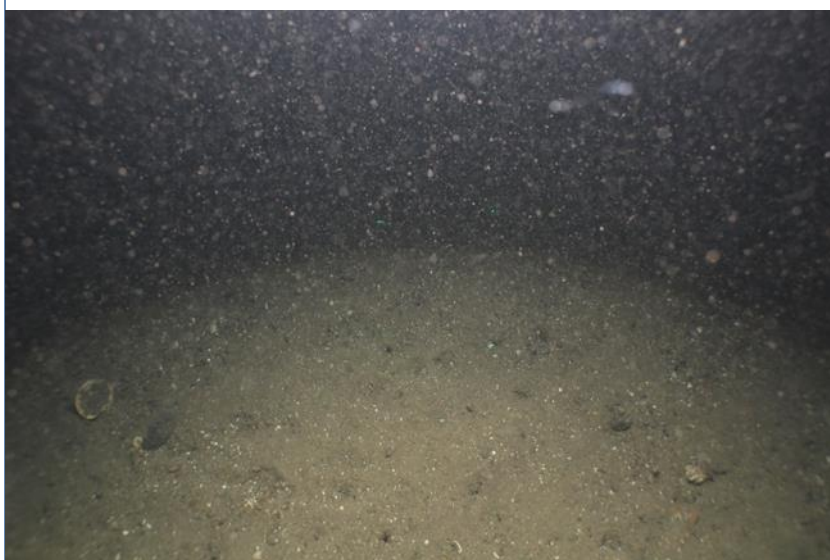
**Photograph:**  
210761\_ST161\_17

**Sediment Type:**  
Muddy ?sandy gravel inc. shell  
fragments and pebbles

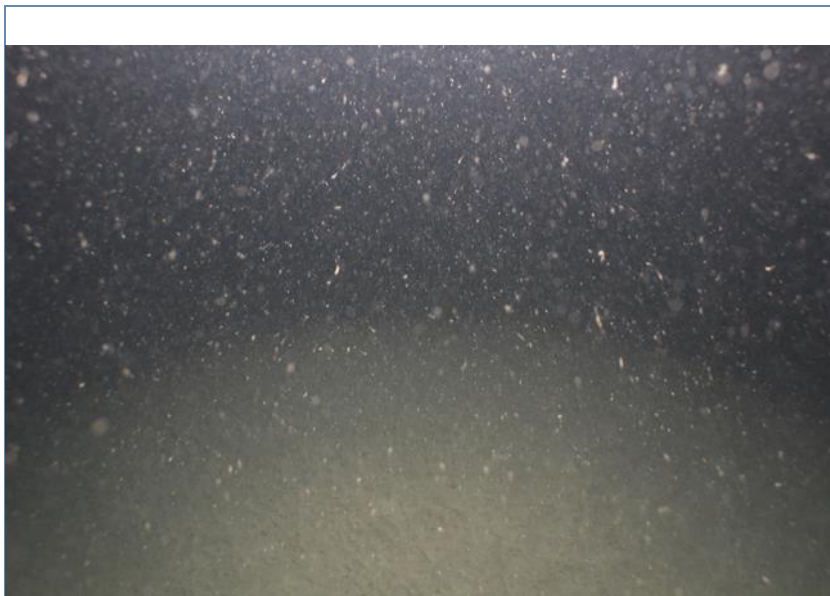
**Photograph:**  
210761\_ST181\_01

**Sediment Type:**  
Mud/sandy mud with occasional cobbles and boulders

**Fauna:**  
No fauna identified

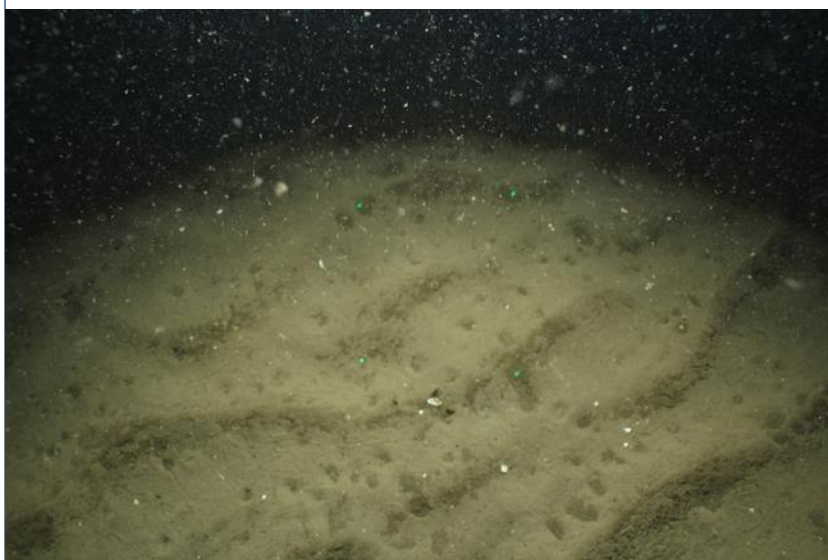
**Photograph:**  
210761\_ST184\_01

**Sediment Type:**  
Rippled muddy sand/sandy mud with  
shell fragments

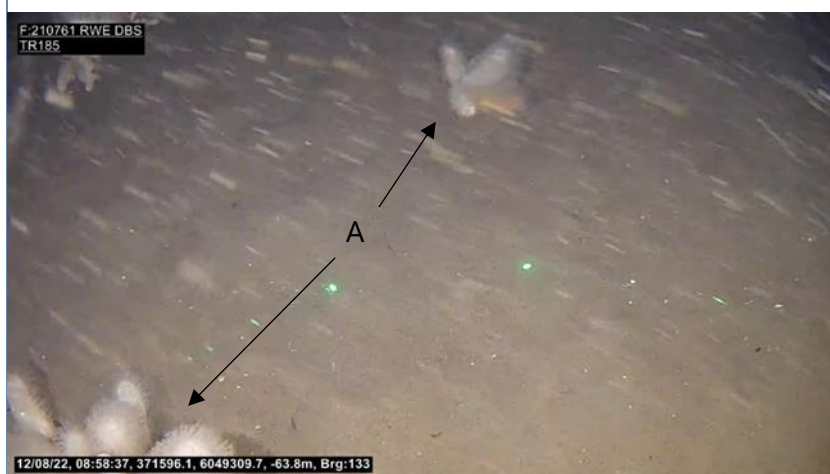
**Photograph:**  
210761\_ST185\_01

**Sediment Type:**  
Rippled gravelly sand with shell fragments, pebbles and cobbles

**Fauna:**  
A: Soft coral (*Alcyonium digitatum*)

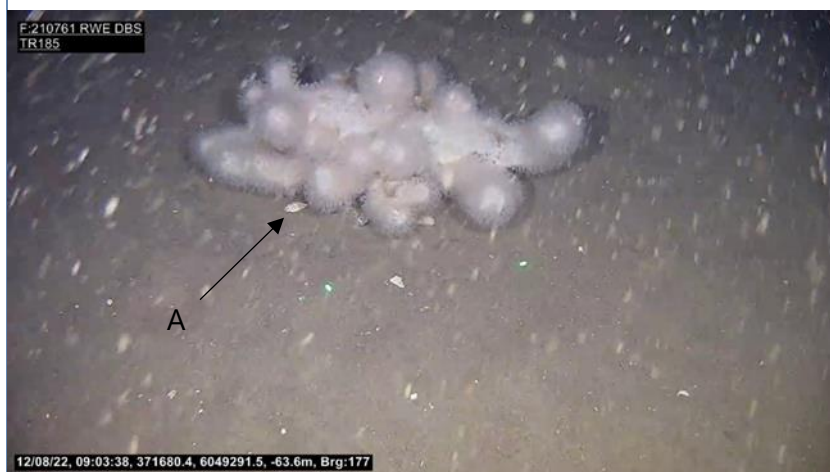
**Photograph:**  
210761\_ST185\_17

**Sediment Type:**  
Rippled gravelly sand with shell fragments, pebbles and cobbles

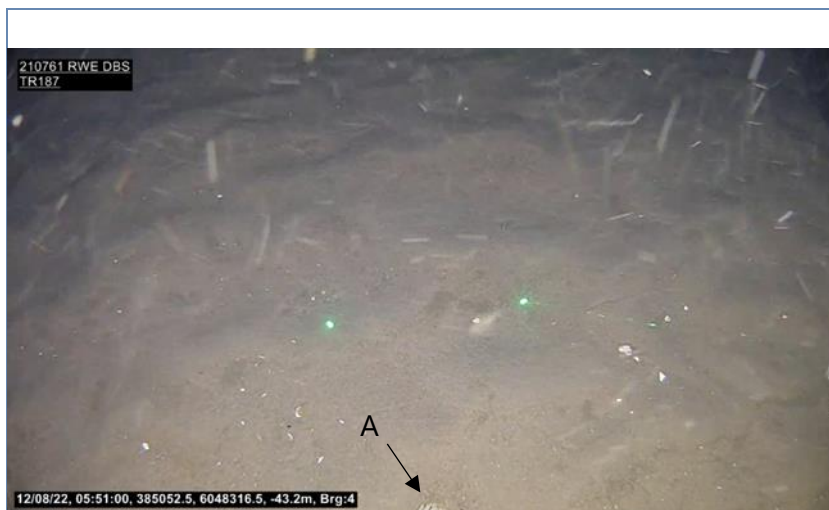
**Photograph:**  
210761\_ST187\_01

**Sediment Type:**  
Rippled sand/muddy sand with shell fragments

**Fauna:**  
A: Crab (Brachyura)

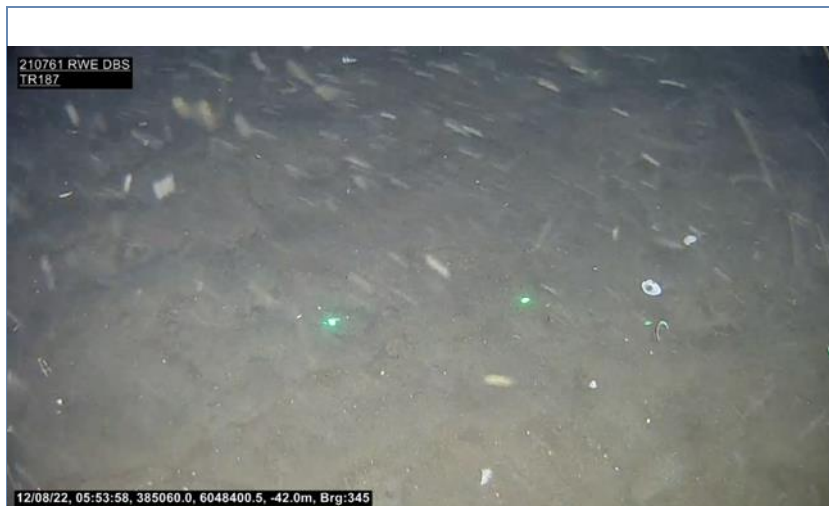
**Photograph:**  
210761\_ST187\_11

**Sediment Type:**  
Rippled sand/muddy sand with shell fragments

**Fauna:**  
No fauna identified

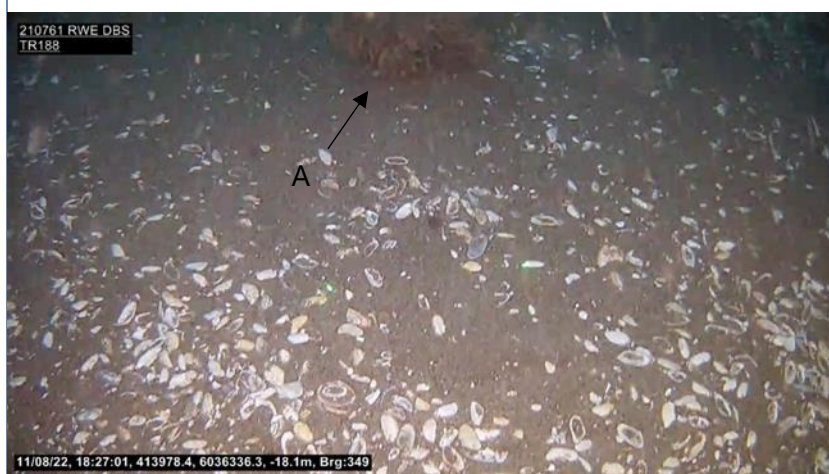
**Photograph:**  
210761\_ST188\_01

**Sediment Type:**  
Rippled sand with a varying proportion of shell fragments

**Fauna:**  
A: Faunal turf (Hydrozoa/Bryozoa)

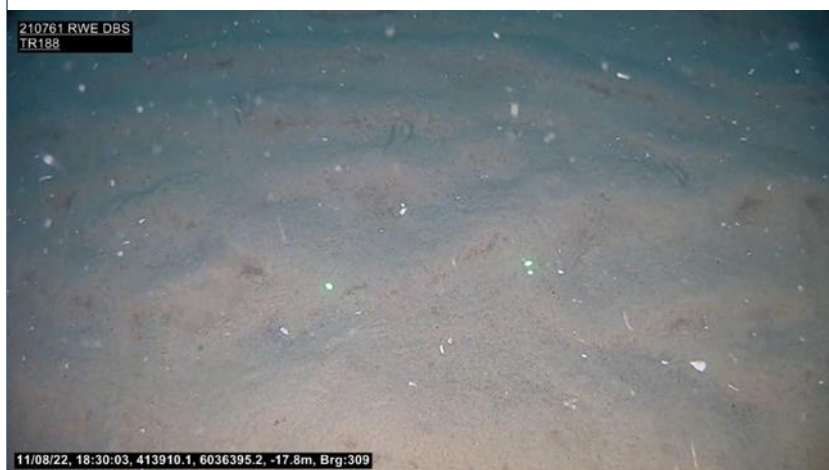
**Photograph:**  
210761\_ST188\_18

**Sediment Type:**  
Rippled sand with a varying proportion of shell fragments

**Fauna:**  
No fauna identified

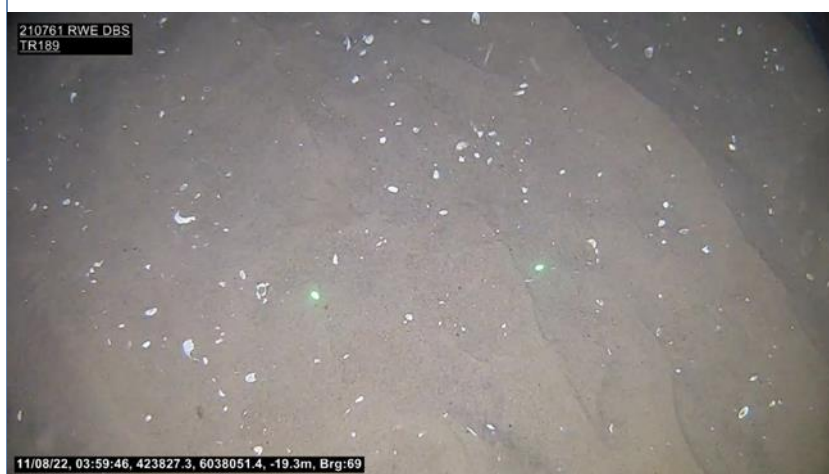
**Photograph:**  
210761\_ST189\_03

**Sediment Type:**  
Rippled sand with shell fragments  
and pebbles

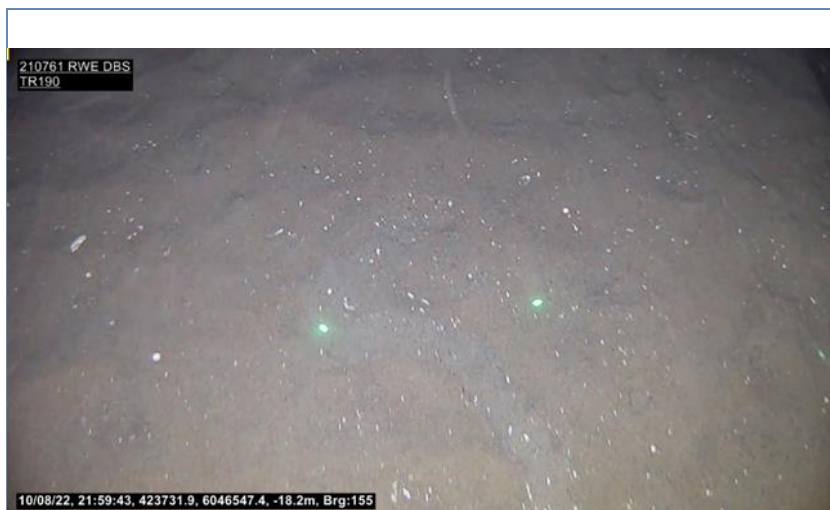
**Photograph:**  
210761\_ST190\_02

**Sediment Type:**  
Rippled sand with shell fragments  
and pebbles

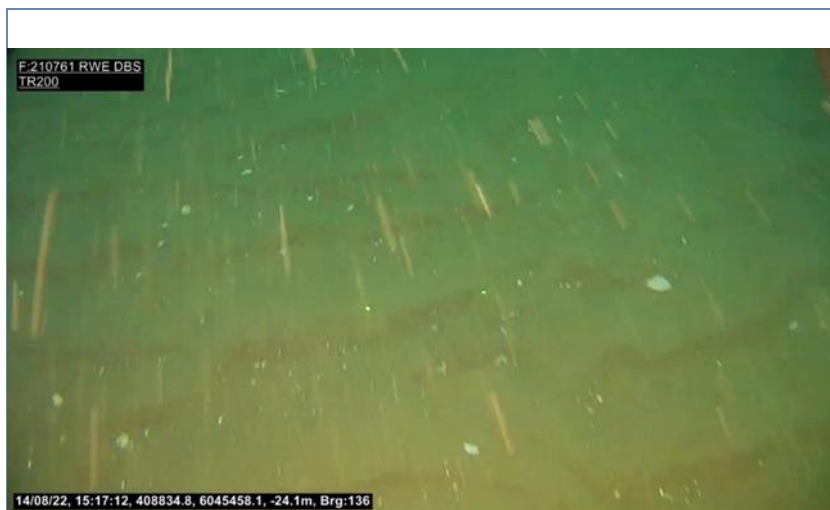
**Photograph:**  
210761\_ST200\_01

**Sediment Type:**  
Rippled sand with shell fragments

**Fauna:**  
No fauna identified

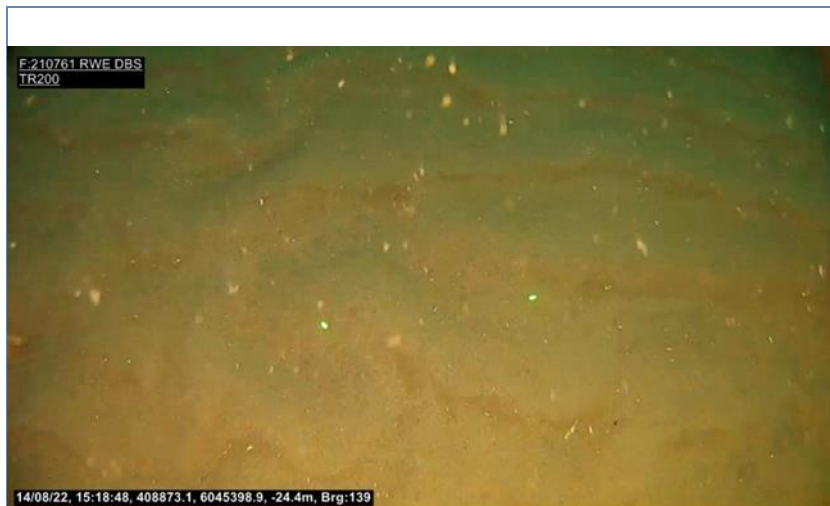
**Photograph:**  
210761\_ST200\_03

**Sediment Type:**  
Rippled sand with shell fragments

**Fauna:**  
No fauna identified

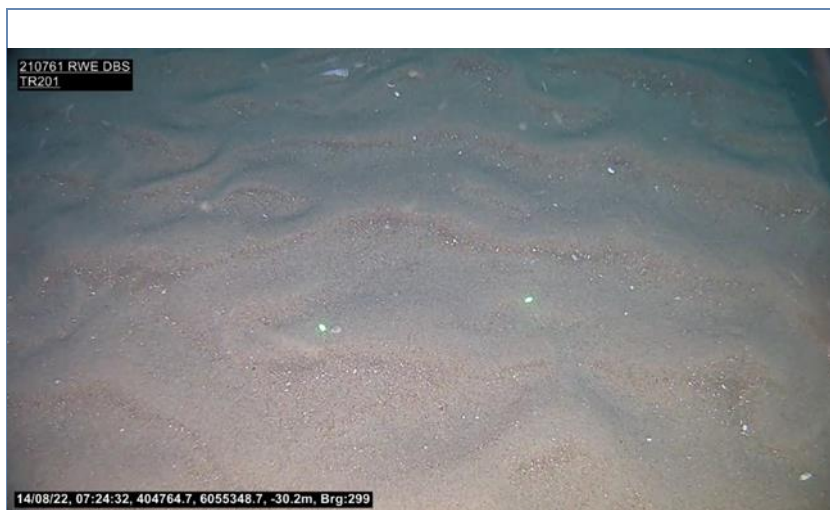
**Photograph:**  
210761\_ST201\_01

**Sediment Type:**  
Rippled sand with shell fragments

**Fauna:**  
No fauna identified

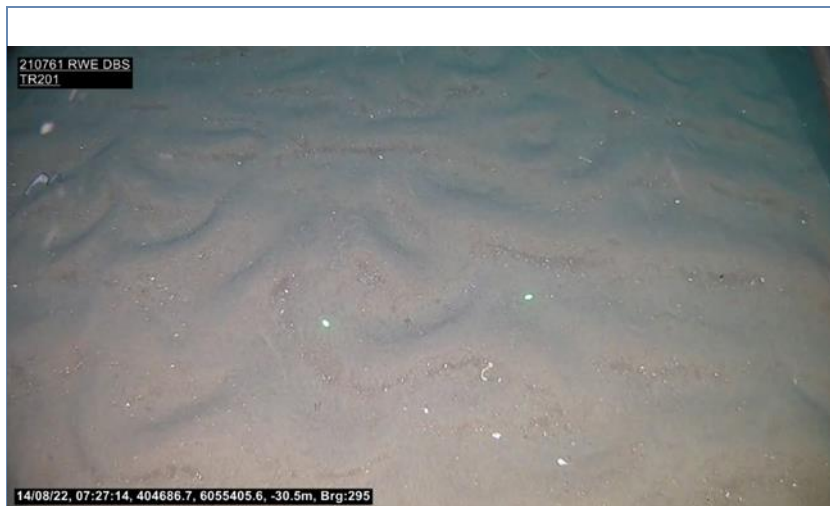
**Photograph:**  
210761\_ST201\_07

**Sediment Type:**  
Rippled sand with shell fragments

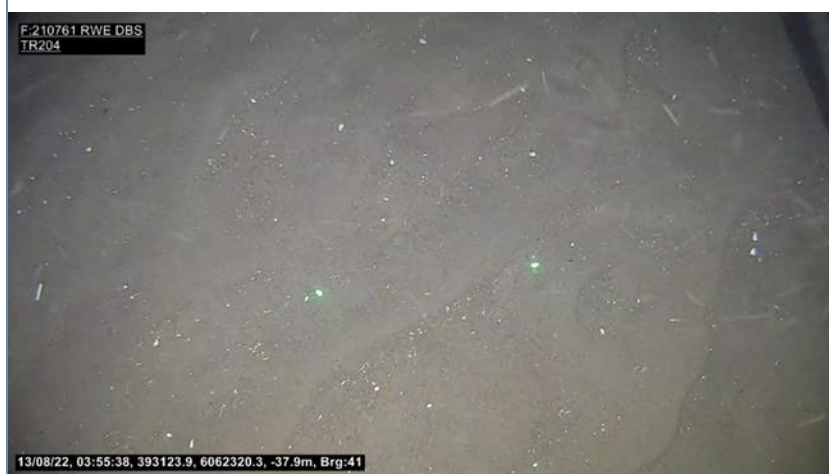
**Photograph:**  
210761\_ST204\_02

**Sediment Type:**  
Rippled sand with shell fragments

**Fauna:**  
No fauna identified

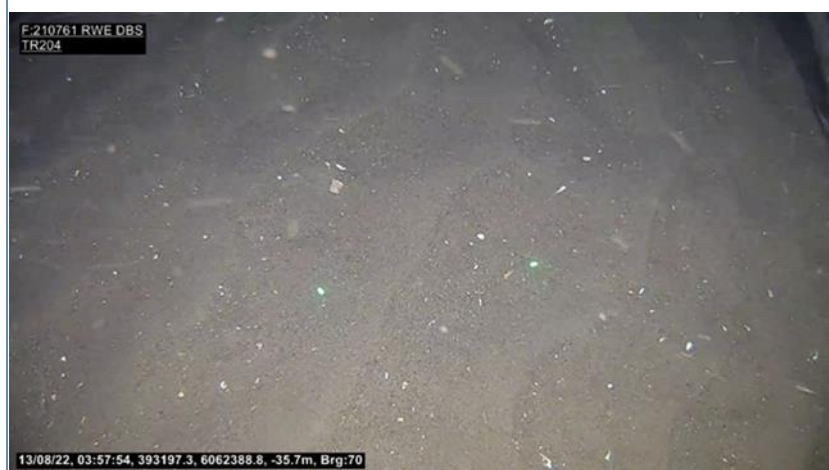
**Photograph:**  
210761\_ST204\_13

**Sediment Type:**  
Rippled sand with shell fragments

**Fauna:**  
No fauna identified
