# **Dogger Bank South Offshore Wind Farms**

**Preliminary Environmental Information Report  
Appendix 9-3 Environmental Features Report**

# **DBS WPM1 WPM2 WPM3 – Environmental Features Report**

Dogger Bank South Site Investigation | Southern North Sea  
Survey Period: 6 to 19 August 2022

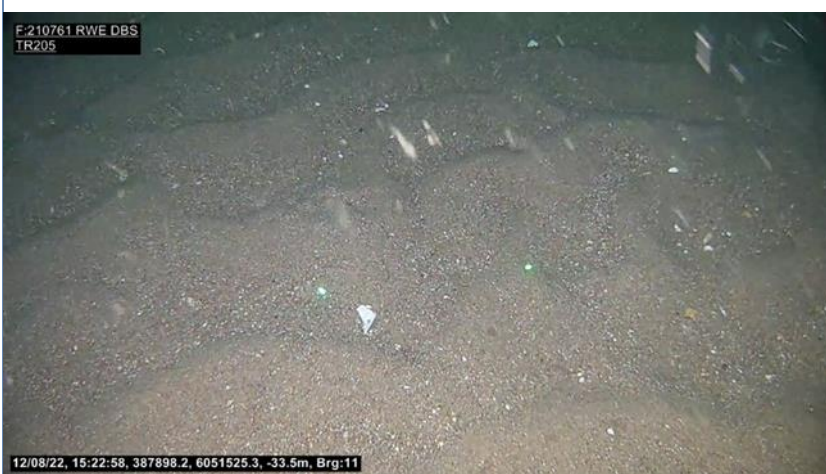
**Photograph:**  
210761\_ST205\_01

**Sediment Type:**  
Rippled sand with shell fragments  
and patches of pebbles

**Fauna:**  
No fauna identified

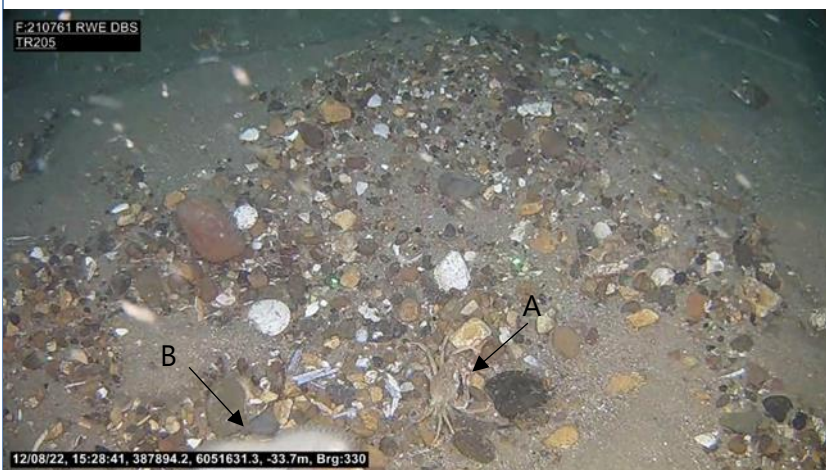
**Photograph:**  
210761\_ST205\_23

**Sediment Type:**  
Rippled sand with shell fragments  
and patches of coarse sediment  
(pebbles)
